Hanford Lessons Learned Man Lift Fatalities

Lesson Learned Summary

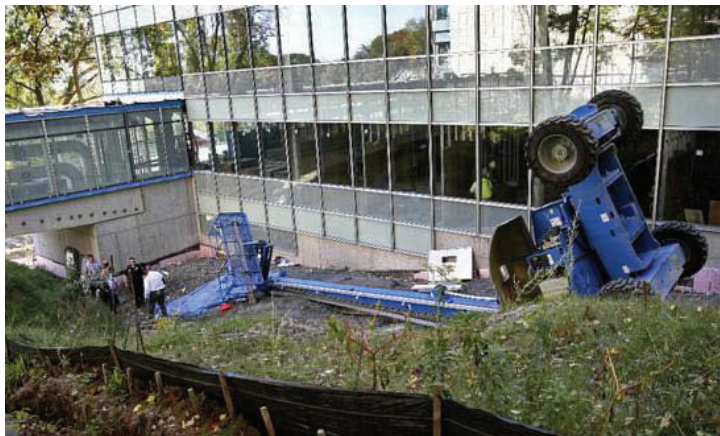
A double fatality occurred when a man lift toppled over at a construction site. The two men were operating a telescopic boom on uneven ground and had incorrectly positioned the Lift's counter weight on the downhill side of the slope.

On October 10, 2008, two contractors were working on the east exterior façade utilizing the boom. The contractors began to reposition the boom uphill while standing on the platform with the arm extended, on an uneven slope, causing it to fall backwards, and resulting in the death of both individuals.

- ◆ **The work area where the boom was operating was not level** – Lifts/booms should only operate on a suitable, firm, level surface.
- ◆ **Counter weight and extension boom positioned improperly** – The contractors began to reposition the boom uphill while standing on the platform with the arm extended, on an uneven slope. The counter weight was located on the downhill side, shifting the center of gravity to the downhill side, causing it to flip backwards.

- ◆ **Failure of tilt sensor and audible alarm** – The tilt sensor is specifically designed to alert the operator(s) in the lift basket, via audible alarm, when an unsafe condition (non-level working orientation) is being approached. The resulting OSHA investigation discovered that the Tilt Alarm had been disconnected, although when and by whom was never fully understood.

- ◆ Only operate on suitable, firm and level surfaces
- ◆ Never operate drive system while boom in extended position
- ◆ Ensure Pre-Task planning accounts for all operating conditions and parameters related to the specific equipment being used
