**PROPOSAL FOR ADMINISTRATIVE
NO FURTHER ACTION
ENVIRONMENTAL RESTORATION
SITE 104, PCB SPILL, COMPUTER FACILITY
OPERABLE UNIT 1302**

August 1994

**SITE 104, PCB Spill, Computer Facility
OU 1302**

SANDIA NATIONAL LABORATORIES/NEW MEXICO

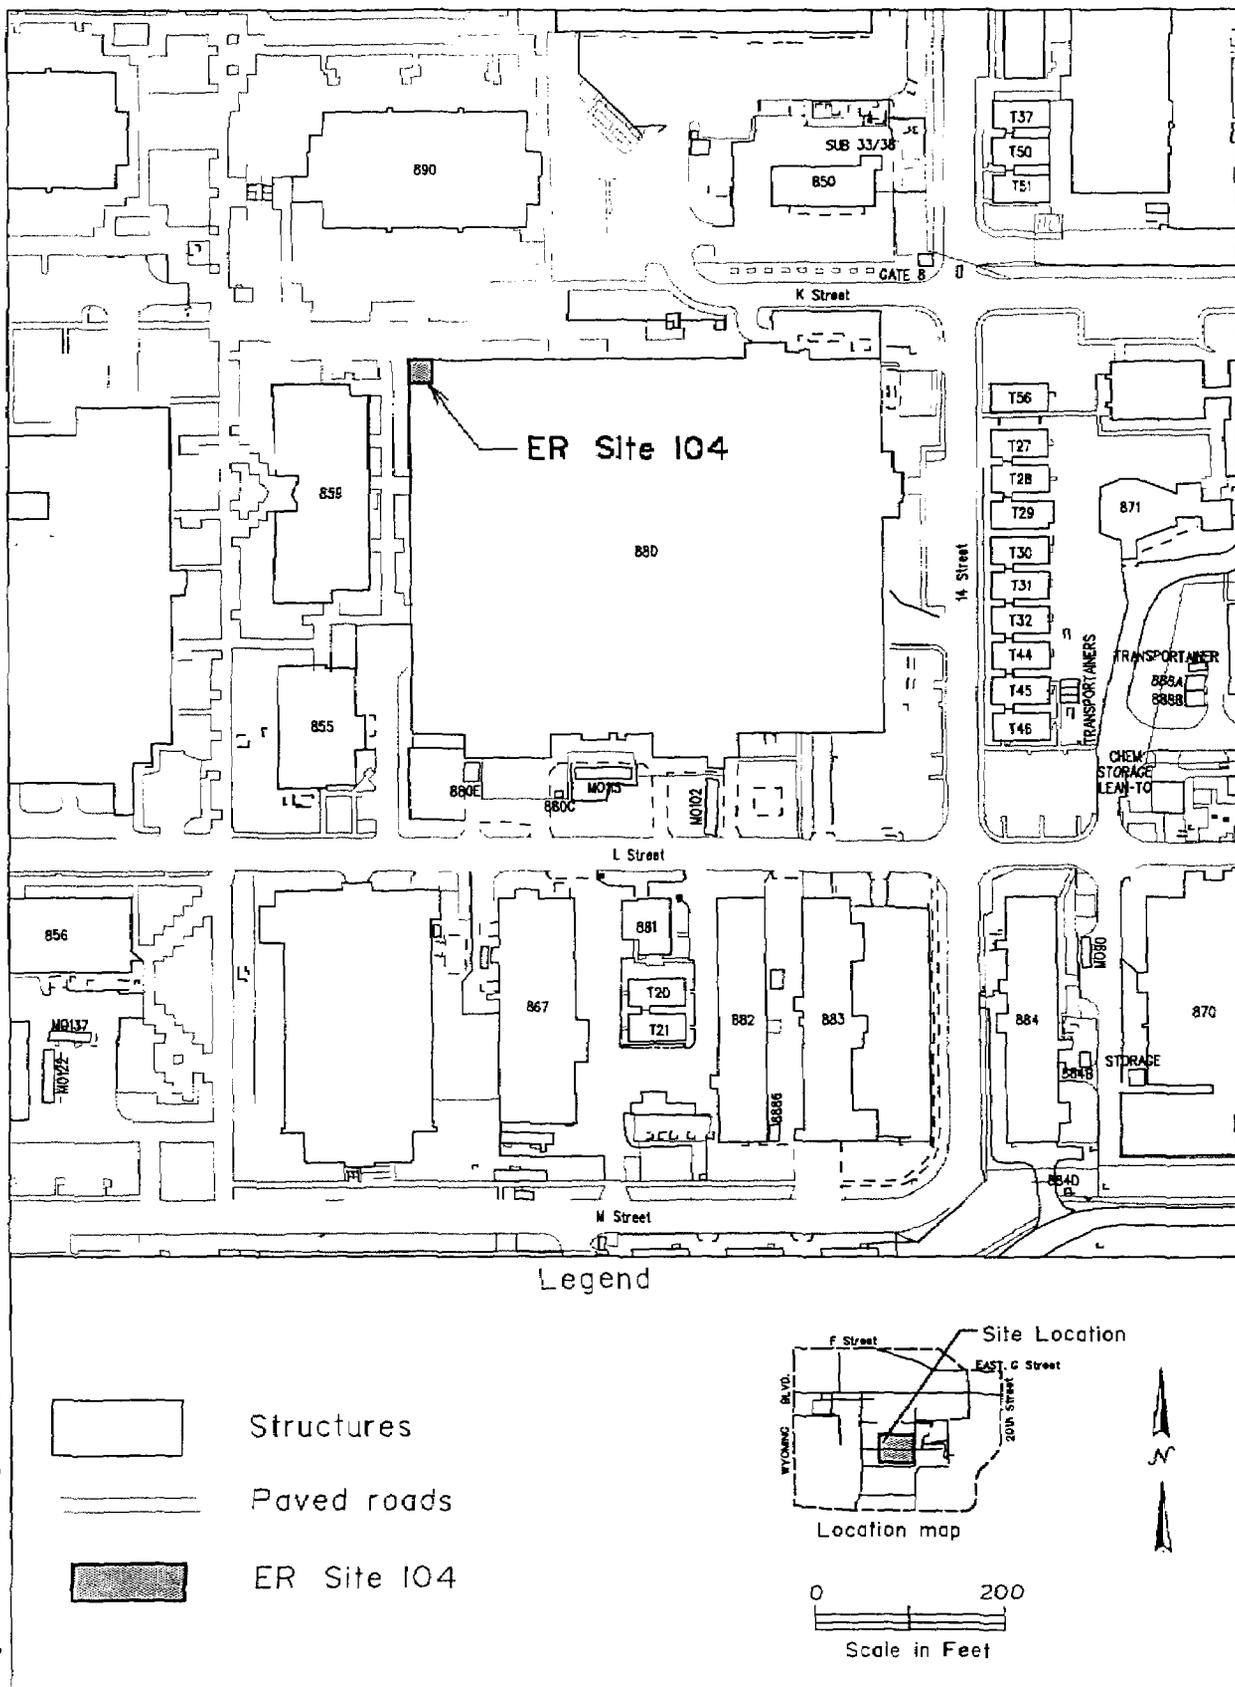
The computer facility is located in Building 880. Engineering drawings of this building (SNL/NM 1962, SNL/NM 1983) identify a small room in the northwest corner as the "Equipment Room." It is assumed that this equipment room (attachment A; Figure 5.11-1) is the site of the PCB spill mentioned in the Comprehensive Environmental Assessment and Response Program (CEARP) Report (DOE 1987). Engineering drawings (SNL/NM 1962) describe this room as having a floor sloping to a sump in the northwest corner of the room. This sump and pump system is identified as being connected to the sanitary sewer.

Figure 5.II-1
Location of ER Site 104, PCB Spill, Computer Facility.
