INTERNATIONAL ASSOCIATION OF FIRE FIGHTERS

Energy Storage Systems and Fire Fighter Response Safety

Sean DeCrane, Director
Health and Safety Operational Services

June 6, 2023

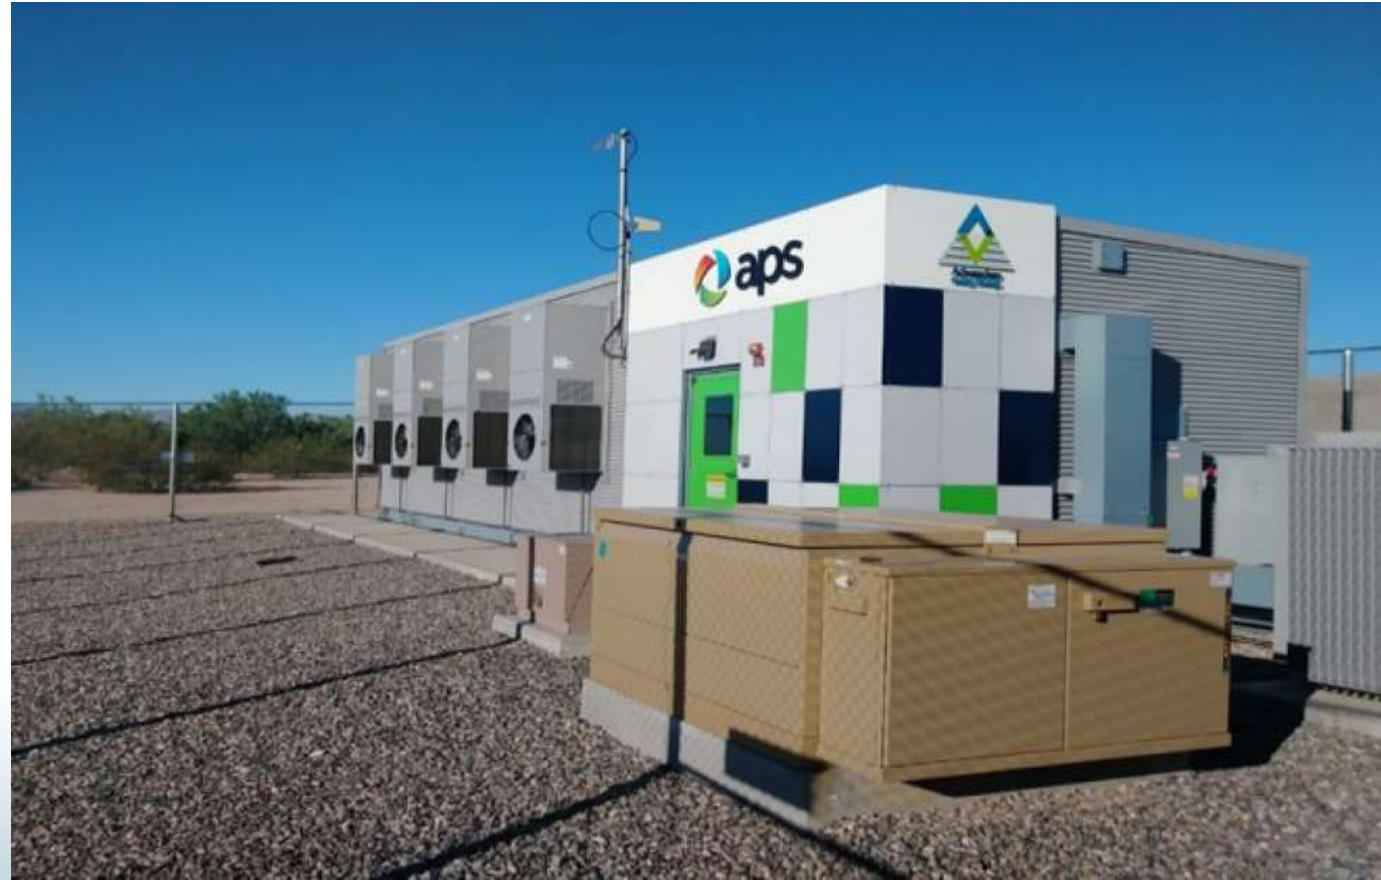
2 MW/2.16 MWh lithium-ion battery ESS

Four firefighters (Peoria HAZMAT team) seriously injured

Four firefighters (Surprise E304) held overnight for suspected exposure to HCN

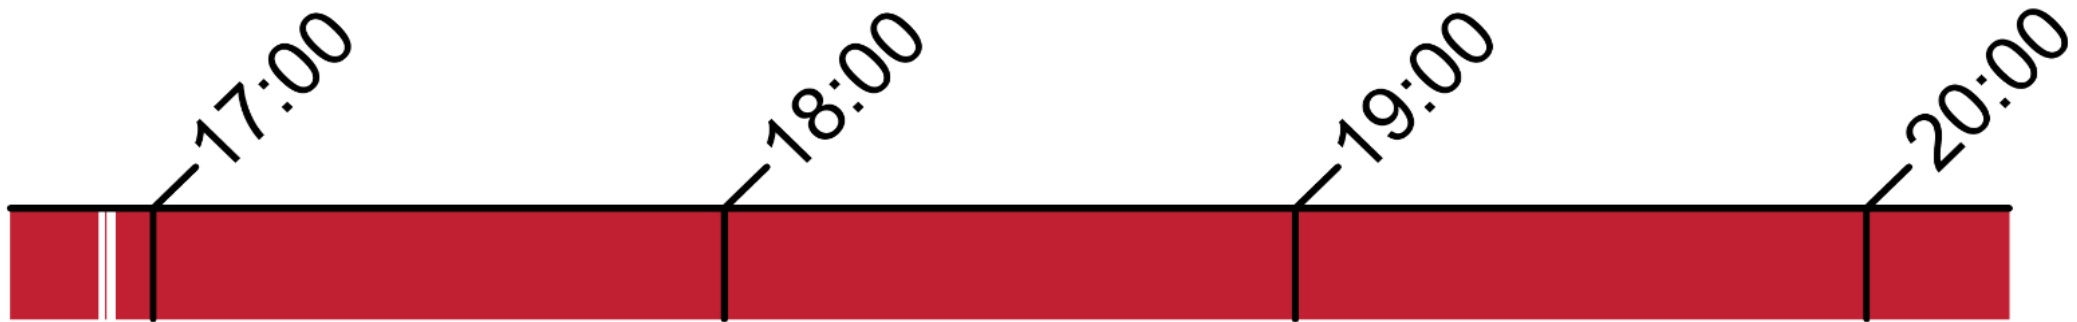
16:54:30 — Minimum battery cell voltage in Rack 15 began to decrease.

16:54:44 — Air temperature measurements started to rapidly increase.

16:55:20 — VESDA smoke detector registered an alarm condition; all breakers and contactors opened.

16:55:38 — Air temperature measurements peaked at 121.6 F.

16:55:50 — Suppression system discharged.

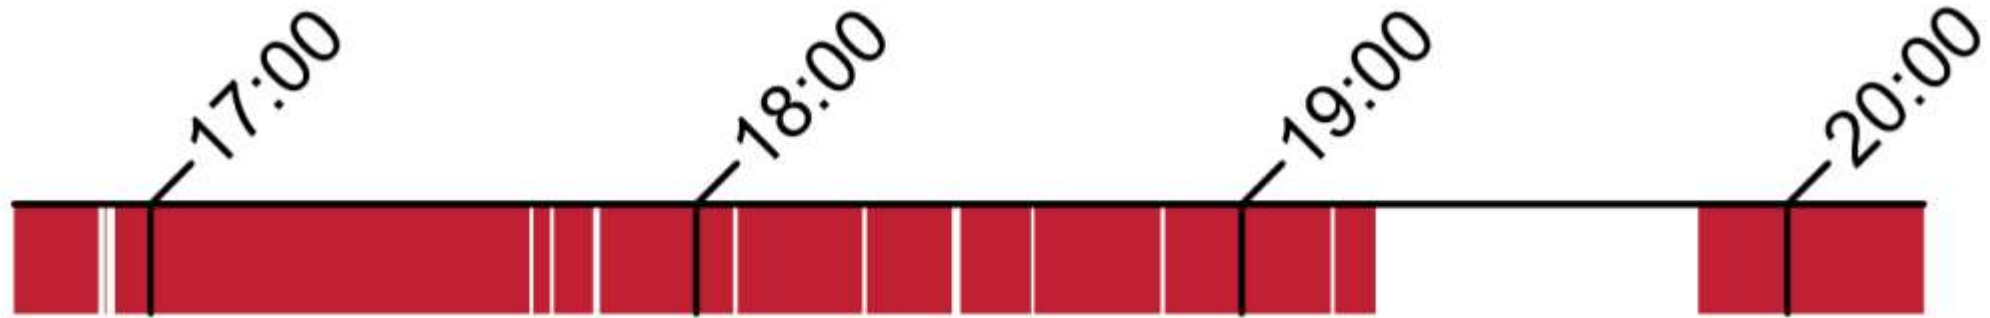
19:15-19:50 — HAZMAT team conferenced with senior fire department officers and developed a plan to render the ESS and hot zone safe.

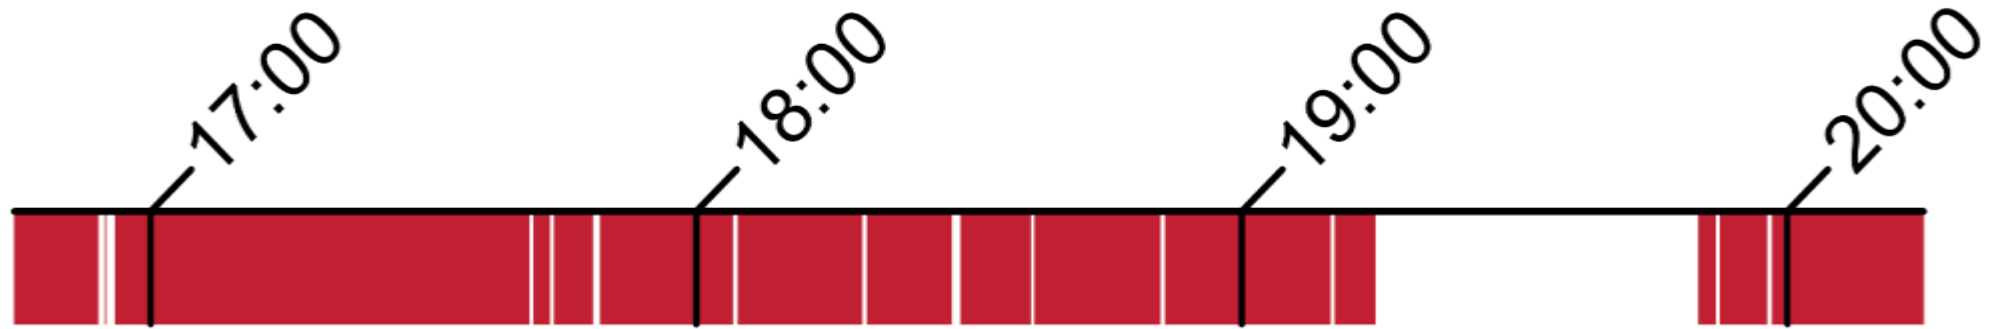
19:50 — The visible gas/vapor mixture was no longer leaking out of the ESS.

19:52:24 — HAZMAT team made final entry into the fenced area around the ESS.

19:58:03 — HAZMAT team pulled hose line to ESS to prepare to open door.

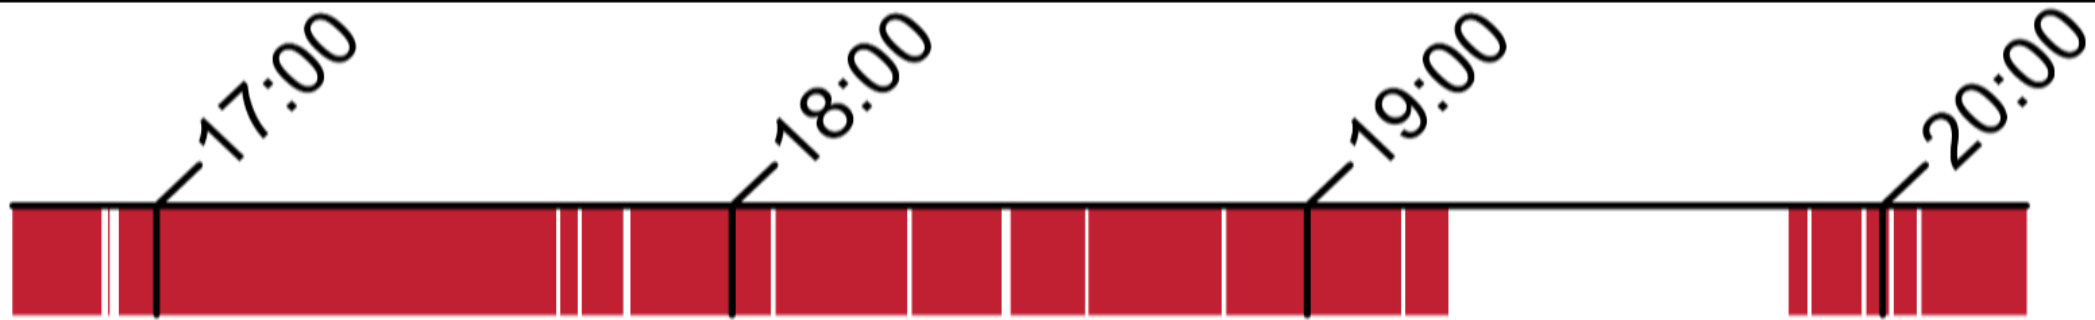
20:00:54 — HAZMAT team opened the door to the ESS.

20:03:49 — Mayday call

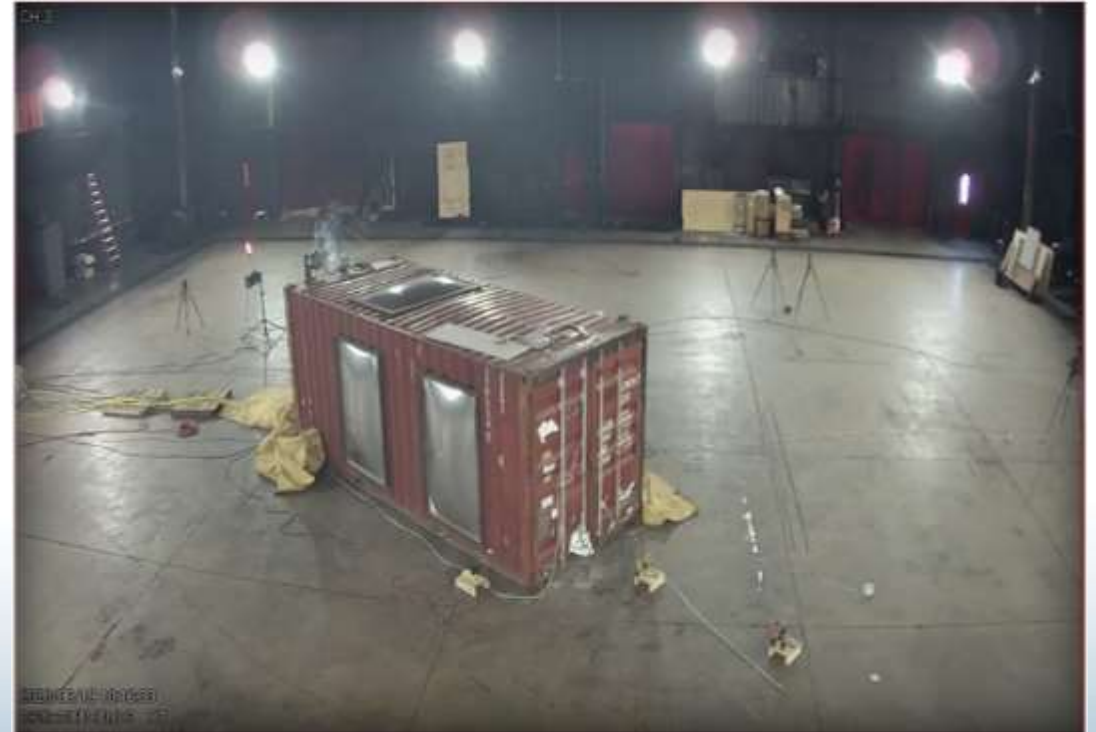
Partial volume deflagration
[TR + 00:00:31]

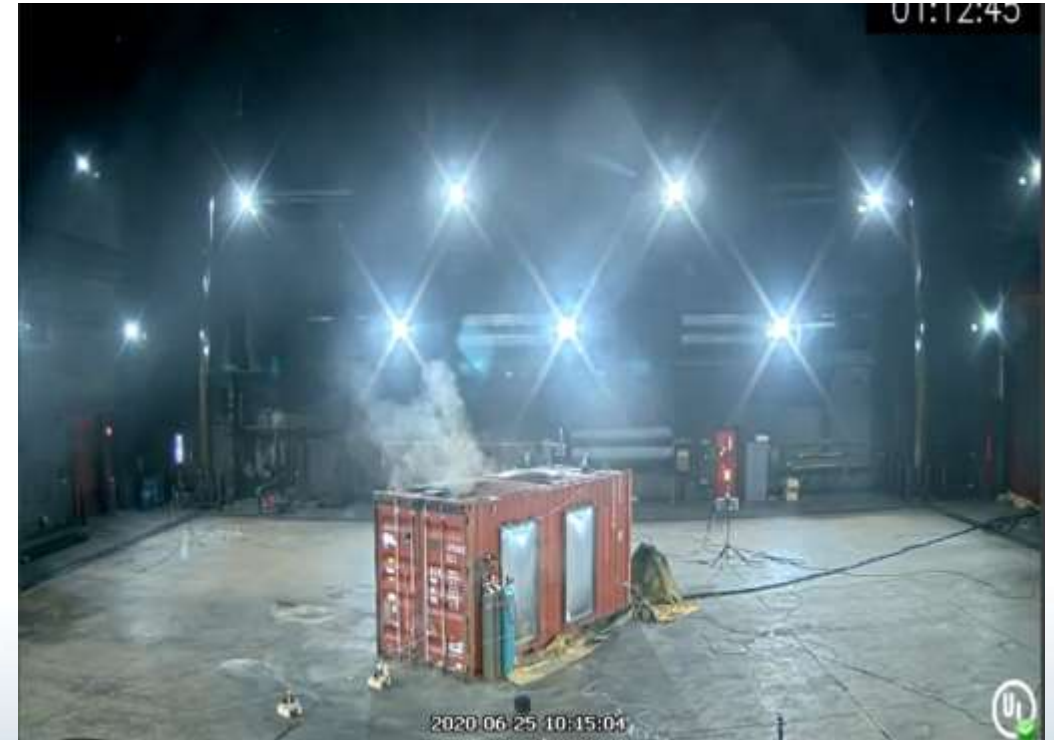
Deflagration
[TR + 00:44:39]

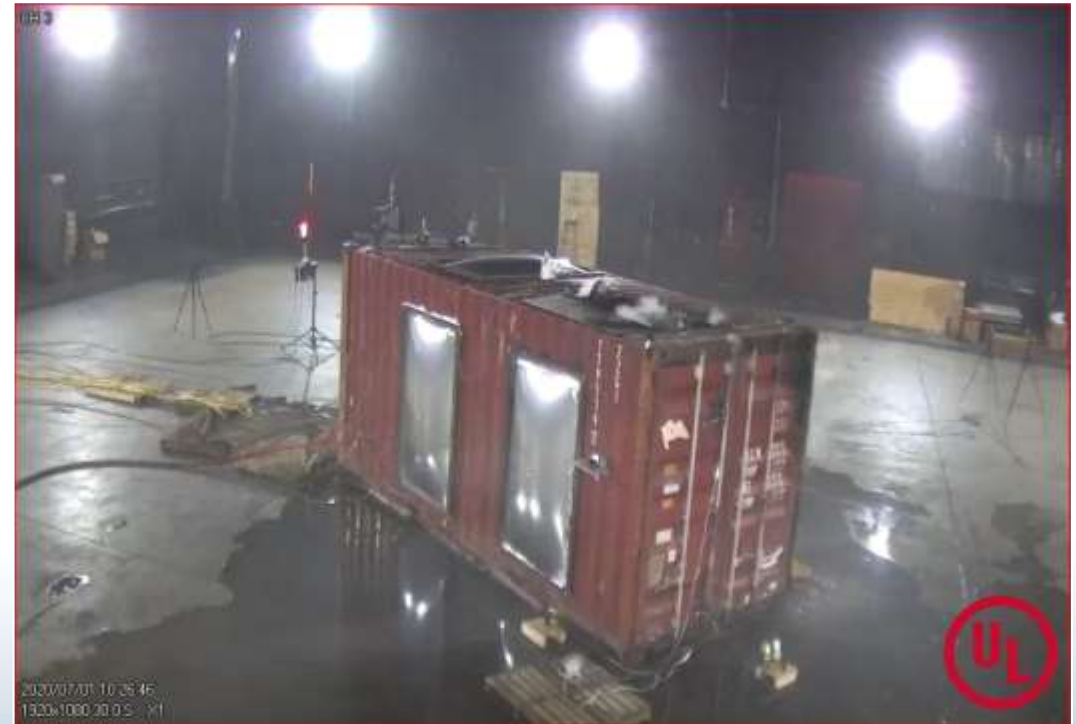
Deflagration
[TR + 00:42:02]

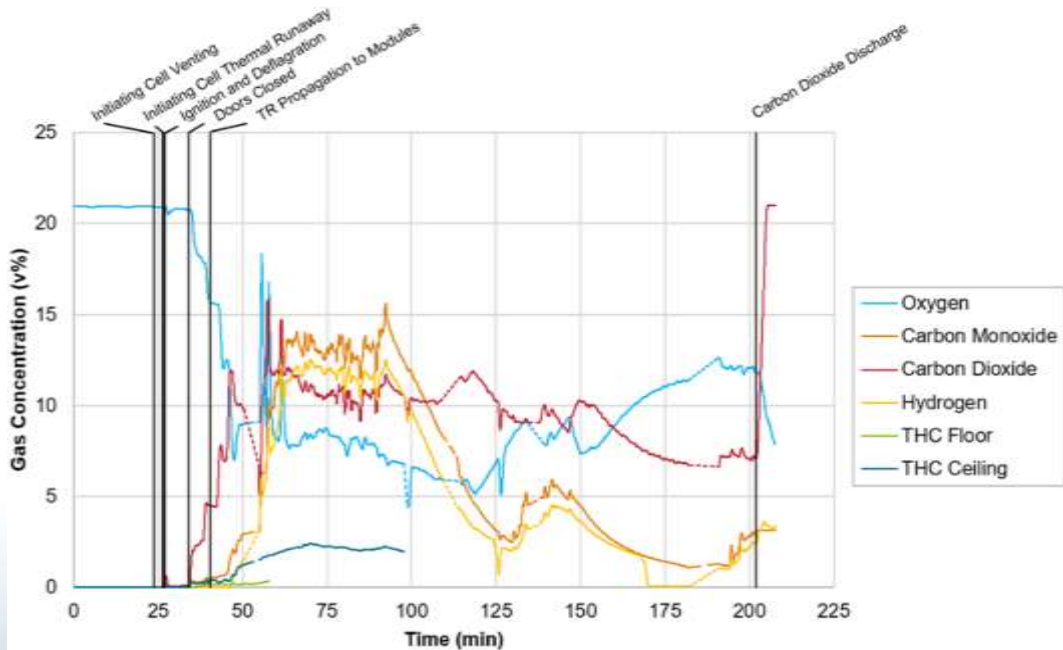
- H_2 : > 10 v%
- CO: 12 v% - 15 v%
- CO_2 : ~10%

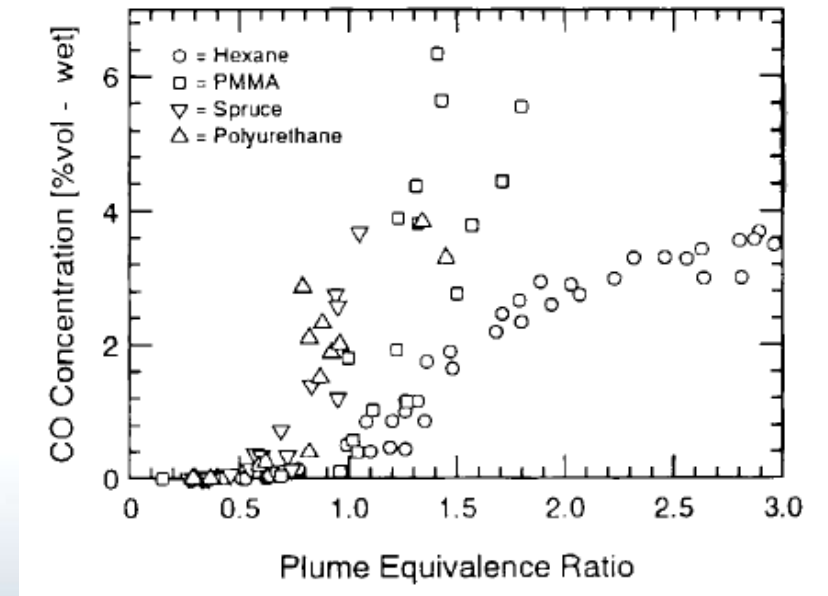
- H_2 = 0 v%
- CO: ~6 v%
- CO_2 : ~10%
