Solar Connectors-  
Tranquillity Solar  
Cantua Creek,  
CA

# Tranquillity Solar

- Location: Cantua Creek, CA
- COD: July 2016
- Size: 200 MW, 1894 acres
- OEMs
  - Inverter: TMEIC Samurai 1833
  - MVT: ABB 34.5kV
  - Module: REC Polycrystalline
  - Tracker: ATI
- Team Lead: Glen Parker
- Site Technicians:
  - Ken Wicker
  - Nick Roussin
  - Anthony Munoz
  - Nickolaus Soerjono

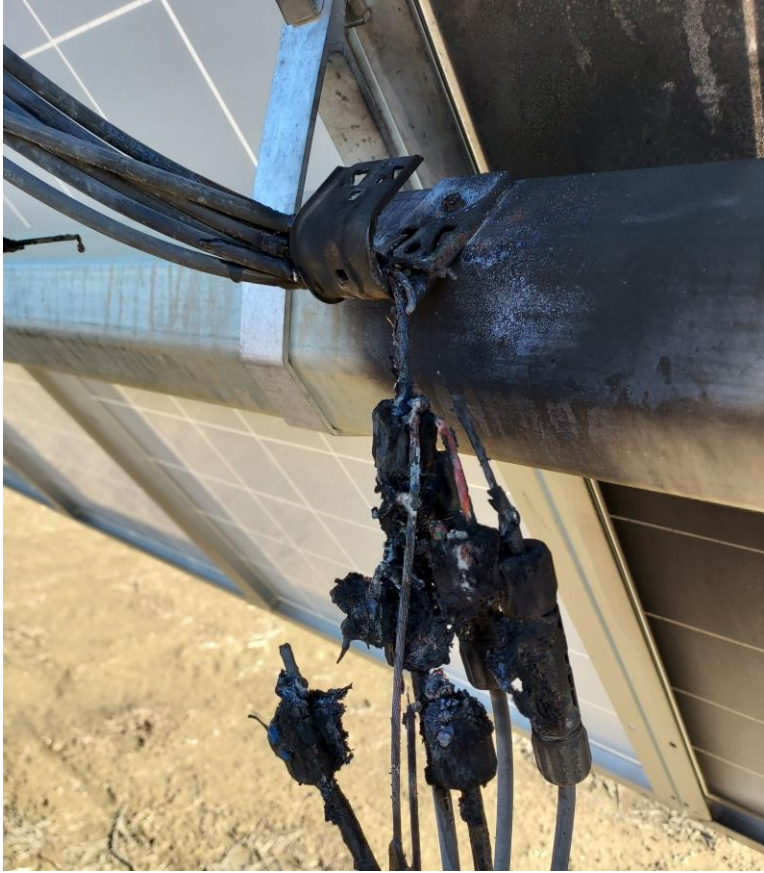
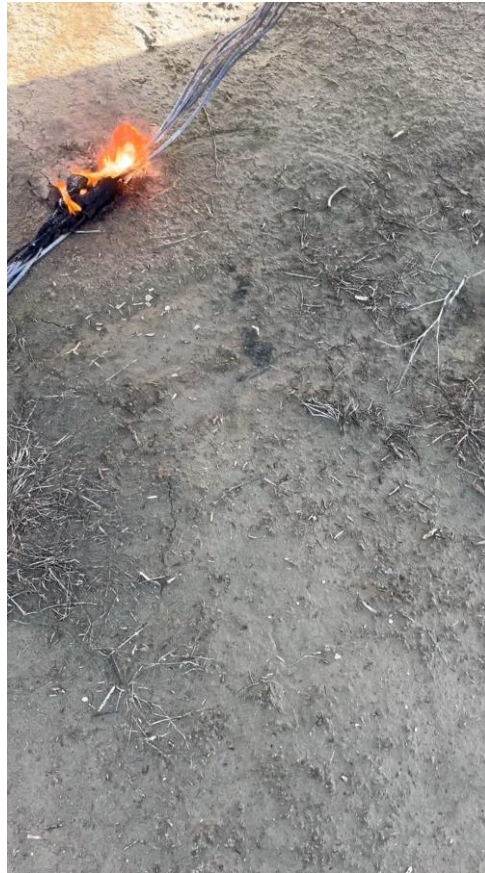
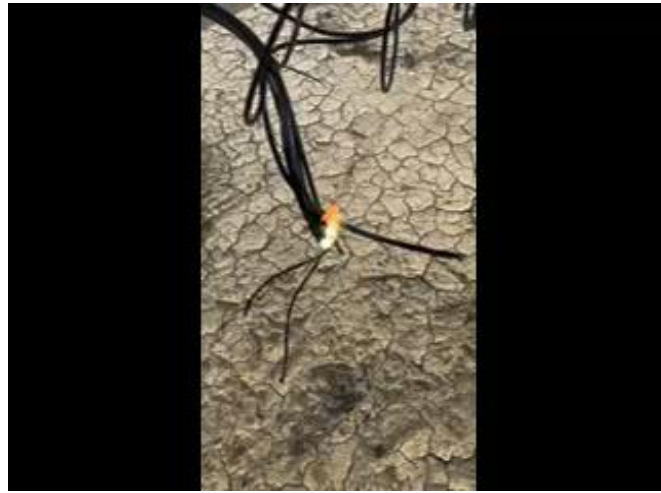
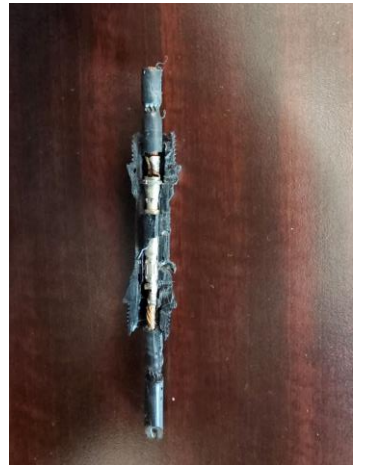
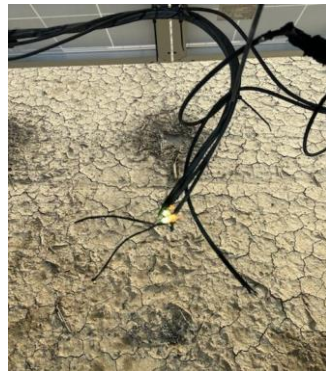
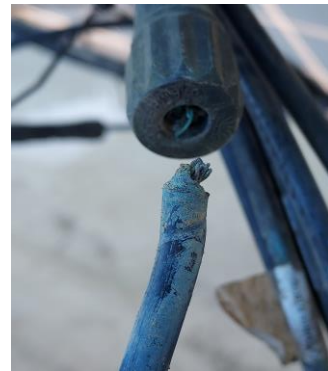
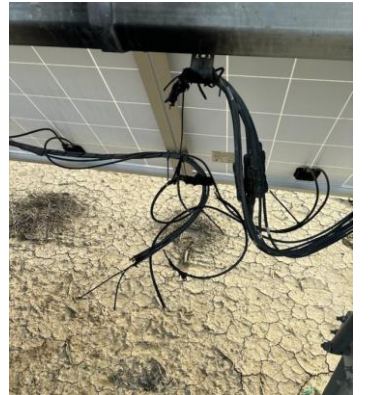
# Tranquillity Connectors

- Amphenol connectors were used in all field made homeruns
- Cross-mated with module to module connectors
- Connectors were poorly assembled by original build crew

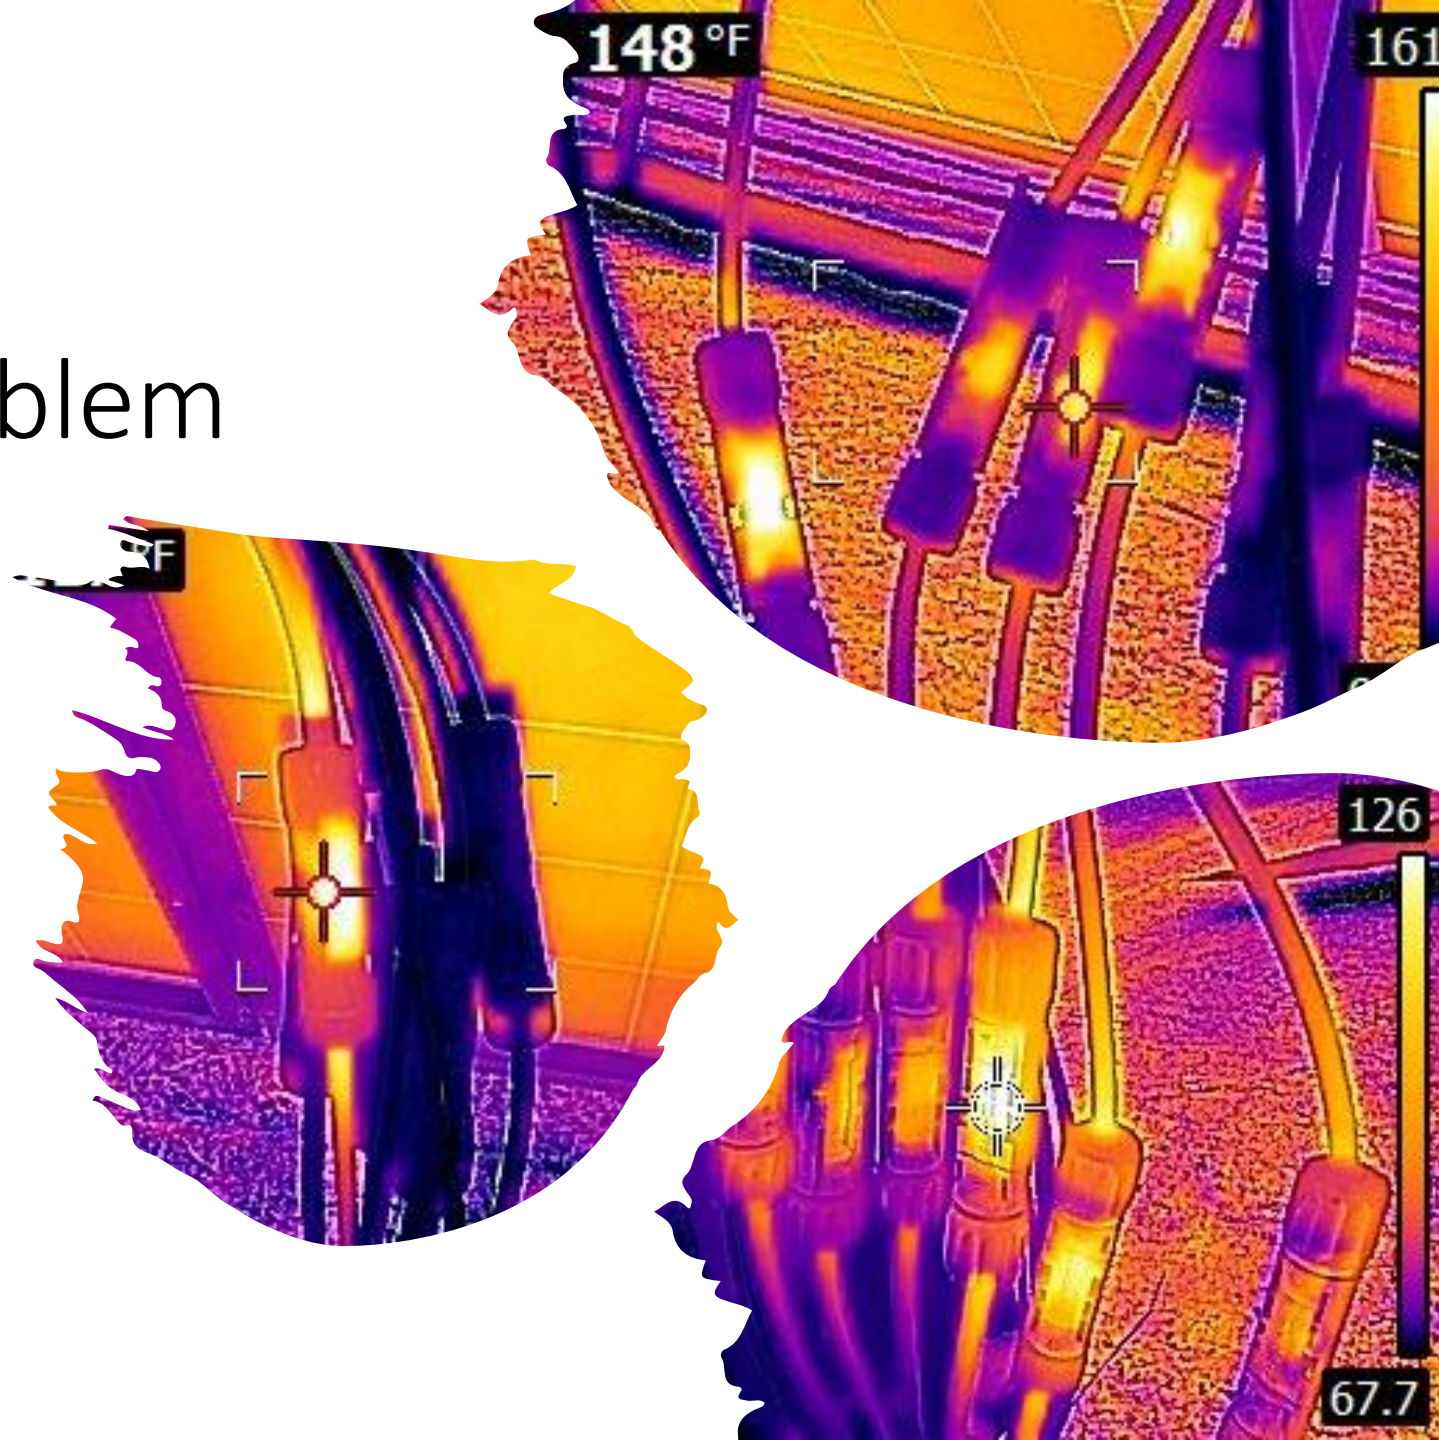
# Identifying The Problem

- Thermal imaging under load is the most efficient way to identify problematic connectors
- Visual inspection to identify cross-mated connector types and other issues that may not be highlighted by thermal imaging
- Tranquillity inspections found roughly 40% of connectors to be a problem
- In excess of 60,000 connectors in need of replacement
