SAND2003-2923
Unlimited Release
Printed August 2003

Aircraft Wire System Laboratory Development: Phase I Progress Report

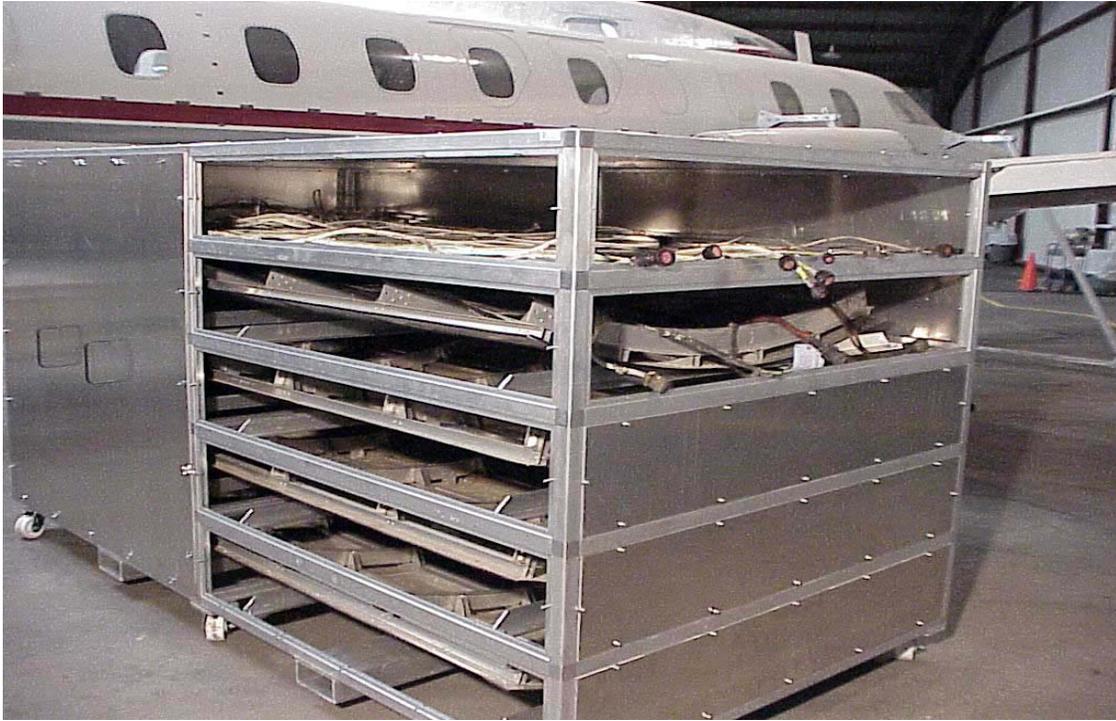
Figure 2. Partially Assembled Wire Harness Enclosure

enclosure at a partial level of assembly. It can be seen in Figure 2 that the lower four cable trays provide a ribbed-structure, metallic ground-plane for harness support and electrical characteristics related to transmission lines. These segments were made by Foster and Miller Metal Works and are used in the test bed. The segments were fabricated to represent Boeing 727 and 737 aircraft ribbed-fuselage structure. Figure 3 is a photograph of a sample segment.

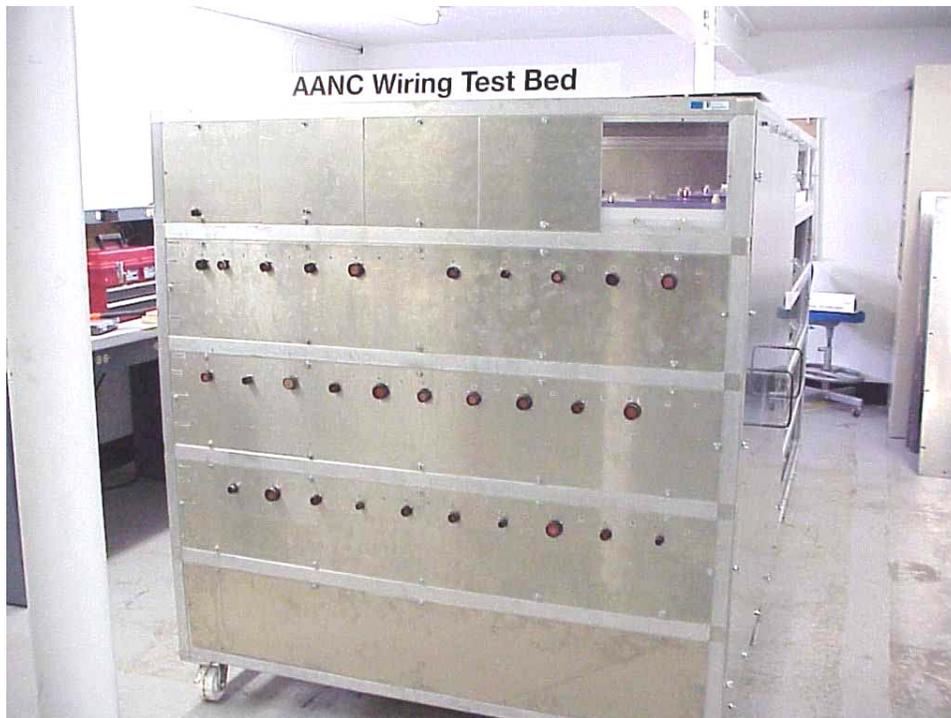
Figure 4. Assembled Wire Harness Enclosure

The removable panels are a quick-connect–disconnect type. The front and rear panels have penetrations to allow harness termination connector panel mounts. The dimensions of these penetrations are in accordance with selection of specific connector types. Lifting portals are welded to the bottom exterior of the enclosure for transportation purposes. The enclosure is mounted on three pairs of neoprene castors for mobility. The fully enclosed test bed is shown in Figure 4. Trays are labeled from 1 to 5, with 3 rows and 22 columns for harness placement per tray.

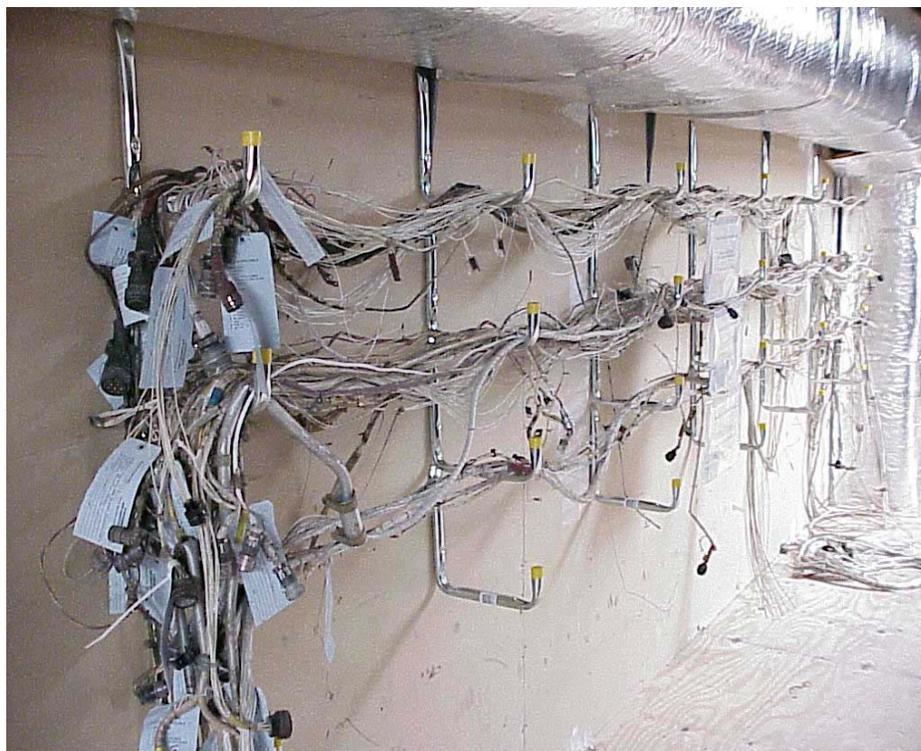
Figure 5. Extracted Harnesses from Retired Aircraft

The test bed has retired and newly fabricated harnesses that include single- and multi-conductor insulated wires that are twisted with and without shielding. Wiring ranges from high-current power cables (awg 8) to small-diameter signal wires (awg 22). Figure 5 is a photograph of inventoried harnesses from Boeing and Douglas retired aircraft. These aged harnesses were obtained from several locations on the aircraft including the EE bay, wheel wells, wing edges, cargo sections, and fuselage. All extracted harnesses are tagged for identification of in-service location and aircraft number, and they were documented on videotape prior to removal. Annex A lists the harnesses acquired.
