## Construction News Sense

September 2008

### Lessons Learned – Electrical Incident

## FMOG Leading Indicators Show Scaffold Concerns

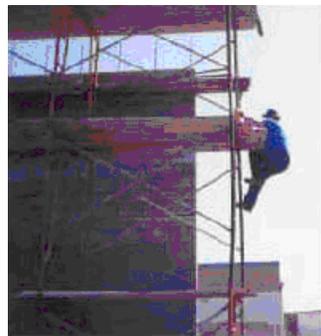
The platform is the work area of the scaffold (except when it is used only as a walkway and safety checks of both the platform structure and its manner of use are required). Once a scaffold is built, even if it is compliant with all standards relating to footings, structure, capacity, etc., it still will not serve as a safe work area if it does not remain upright. Generally, a scaffold will become unstable once its height is four times its smallest base dimension regardless of whether it is plumb and square. Extreme weather or damage to structural components can also affect scaffold stability.
