**PROPOSAL FOR ADMINISTRATIVE
NO FURTHER ACTION
ENVIRONMENTAL RESTORATION
SITE 20, SCHOOLHOUSE MESA BURN SITE
OPERABLE UNIT 1334**

August 1994

Prepared by
Sandia National Laboratories/New Mexico
Environmental Restoration Project
Albuquerque, New Mexico

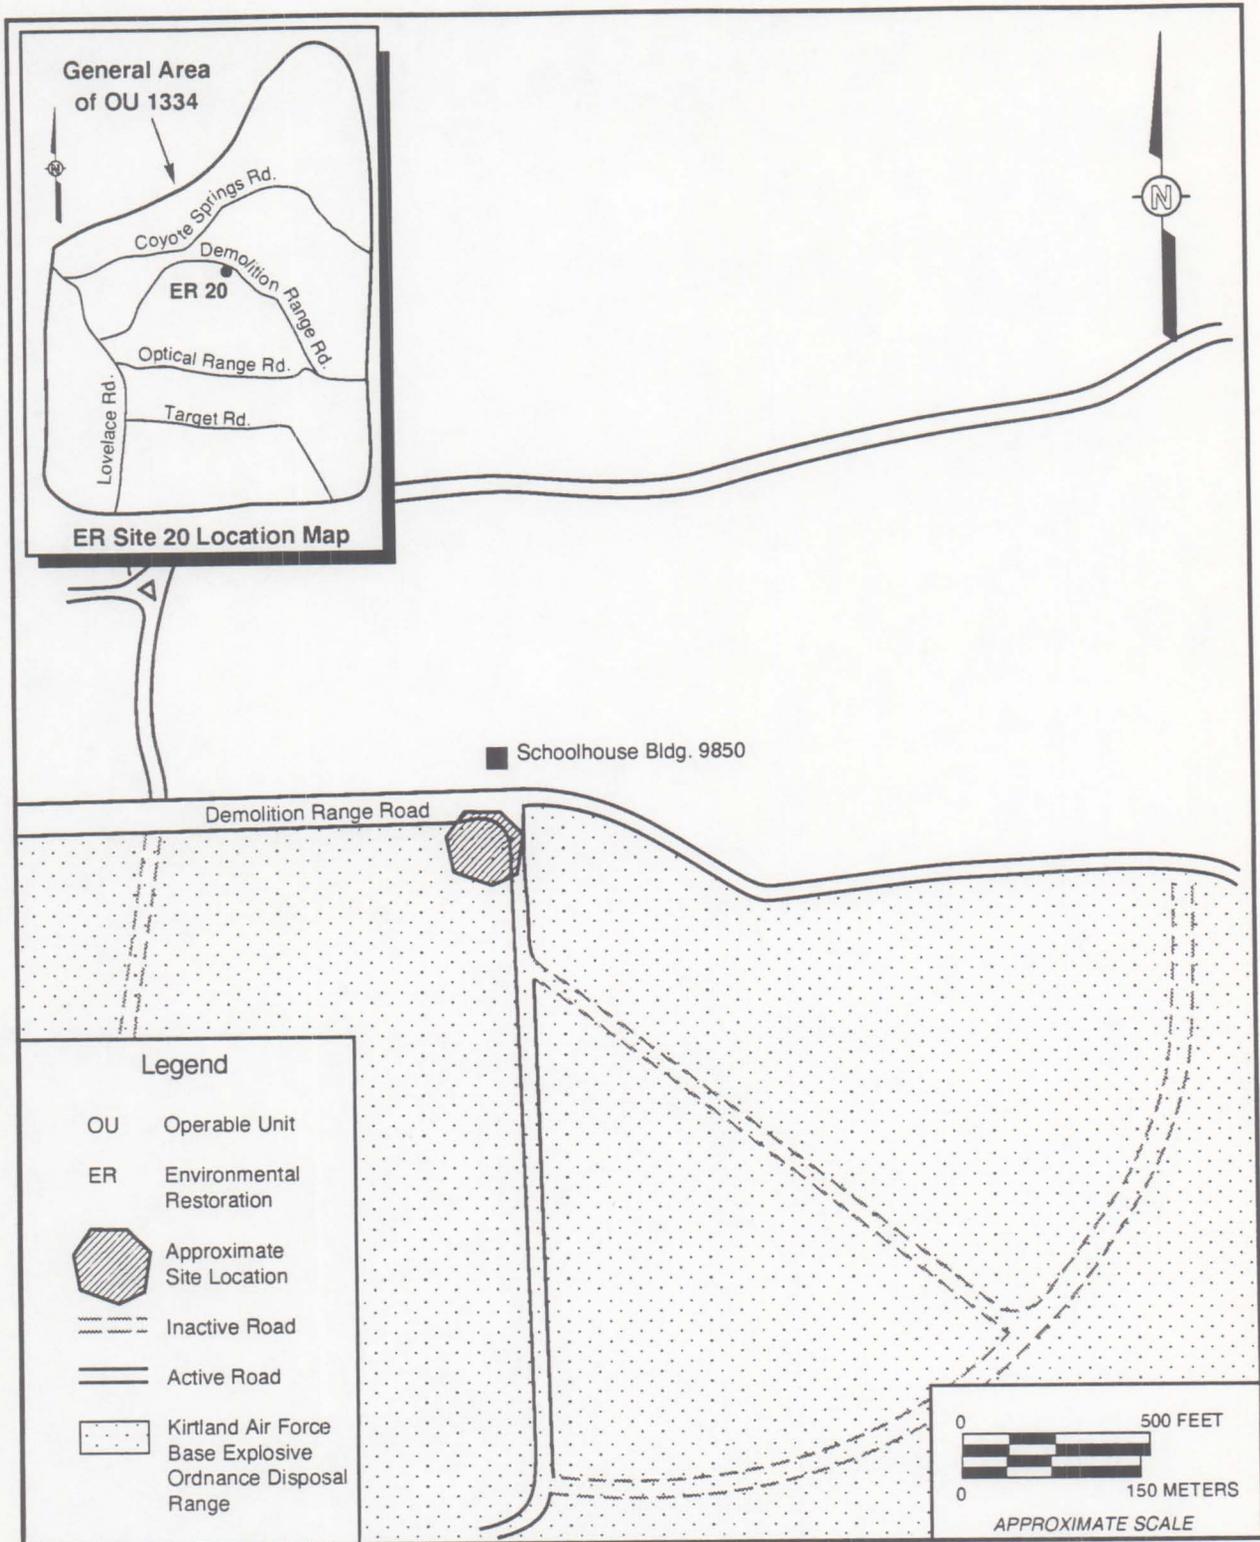
Figure 2-1
Site Map of ER Site 20, Schoolhouse Mesa Burn Site

ER Site 20 was used to conduct small-scale pool fire tests in the summer of 1957 at the approximate site location indicated on Figure 2-1 and Figure 2-2. Tests were conducted with a Polaris missile reentry vehicle containing a beryllium heat shield case, and no DU was used in the tests (20-7, 20-9). The objective of the tests was to simulate an aircraft crash or fire to determine whether a thermal battery in the reentry vehicle would sense a fire or whether a "squib" would enable earlier detection. A "squib" is an electrical device containing a propellant (e.g., gunpowder) that provides enough force to close a switch. A "squib" is also known as a "Bellows Motor." An official SNL/NM report was not generated regarding these testing activities (20-11, 20-12).

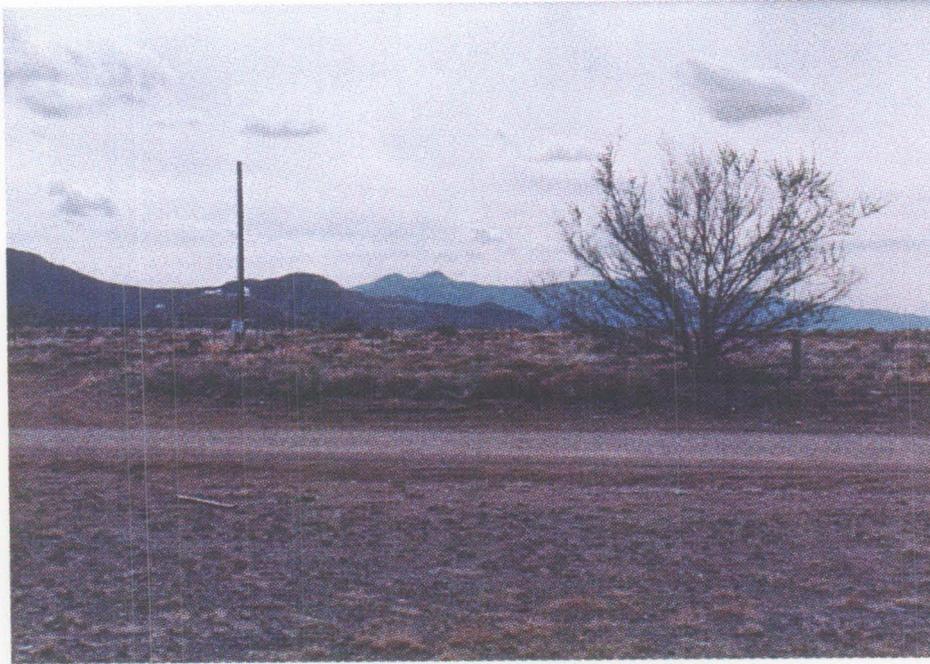
Figure 2-2
ER Site 20 Photograph

Area used for burn testing in 1957, ER Site 20. Test equipment was removed after the 3 tests. View to the south.

There is no physical evidence of activities associated with the 1957 burn tests at ER Site 20, because the burns were contained in a metal pan, and the pan was removed after completing the tests. This is supported by a 1961 aerial photograph that shows no sign or trace of any activities associated with the burn tests (USGS 1961). Additionally, there is no documented evidence that hazardous waste or constituents were ever released into the environment.

SNL/NM is proposing an administrative NFA decision for ER Site 20 because the SWMU was designed and operated to prevent the release of hazardous waste or constituents to the environment (Criterion B). No visual evidence remains at this site, because trial and test burns carried out in the summer of 1957 were contained in a metal burn pan that was removed after completing the tests. The JP-4 fuel used in these tests was completely combusted, and the water was allowed to evaporate, leaving a residue in the bottom of the burn pan which was removed with the pan. A 1961 aerial photograph reveals no signs or traces of the burn tests (USGS 1961).
