**PROPOSAL FOR ADMINISTRATIVE
NO FURTHER ACTION
ENVIRONMENTAL RESTORATION
SITE 21, METAL SCRAP (COYOTE SPRINGS)
OPERABLE UNIT 1334**

August 1994

Prepared by
Sandia National Laboratories/New Mexico
Environmental Restoration Project
Albuquerque, New Mexico

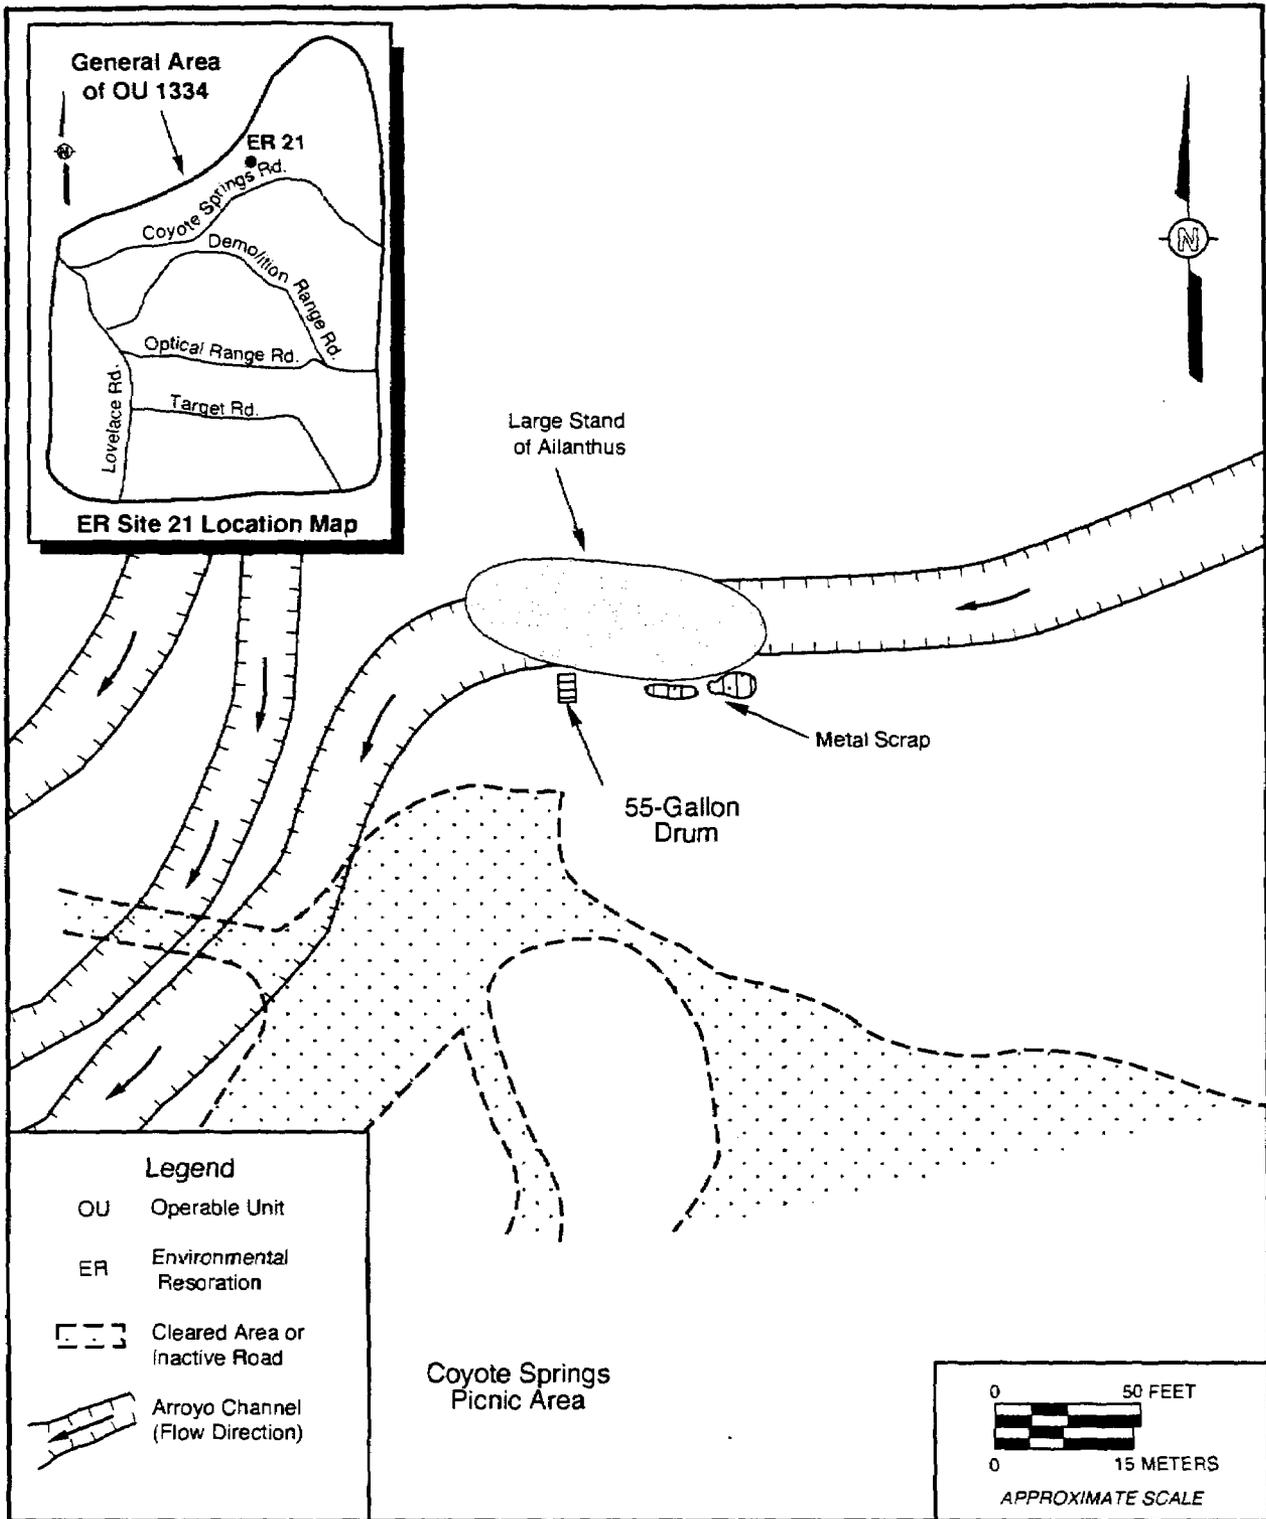
Figure 2-1
Site Map of ER Site 21, Metal Scrap

ER Site 21 consists of one empty rusted 55-gal drum (Figures 2-1 and 2-2) and some scrap metal lying in a heavily vegetated area of *Ailanthus* (*Ailanthus altissima*) near an arroyo channel. The origin of the metal drum and scrap metal is unknown. No documentation of activities that occurred at this SWMU have been found. Interviews with current and former SNL/NM employees (21-20 through 21-25) revealed no information concerning waste management activities at this SWMU. This area is currently used by KAFB as a training and bivouac area (21-14, 21-18).

SNL/NM is proposing to remove the drum and metal scrap from the site as nonhazardous solid waste under a voluntary corrective measure.

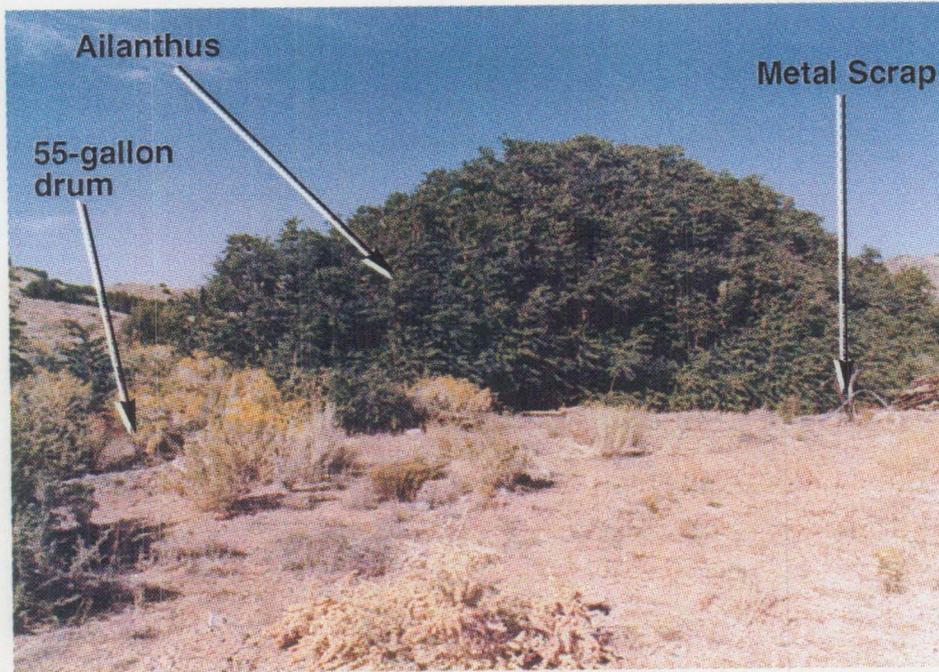
Figure 2-2a. Metal scrap, drum, and Ailanthus cluster, ER Site 21. View to the east.

Recent site inspections found an empty rusted 55-gal drum and some scrap metal on the ground. However, there is no visual evidence to suggest the drum ever contained hazardous materials or that a release occurred at the site. Interviews with current and former SNL/NM personnel revealed no information concerning waste management activities (21-20 through 21-23, 21-25). This is supported by aerial photographs (USGS 1951, USGS 1961, USGS 1967, USGS 1971, and USGS 1991) that show a farm house and associated structures prior to 1971 and an absence of structures at the time of the 1971 photograph. None of the aerial photographs show cultural features that suggest the site was used to dispose of hazardous constituents.

Subsequent to the CEARP inspection, the EPA conducted a RFA (EPA April 1987) and reported that several partially buried 55-gal drums were at the site. However, recent site inspections found one empty, rusted 55-gal drum and some scrap metal lying on the ground. SNL/NM is proposing to remove the drum and metal scrap from the site as nonhazardous solid waste under a voluntary corrective measure.

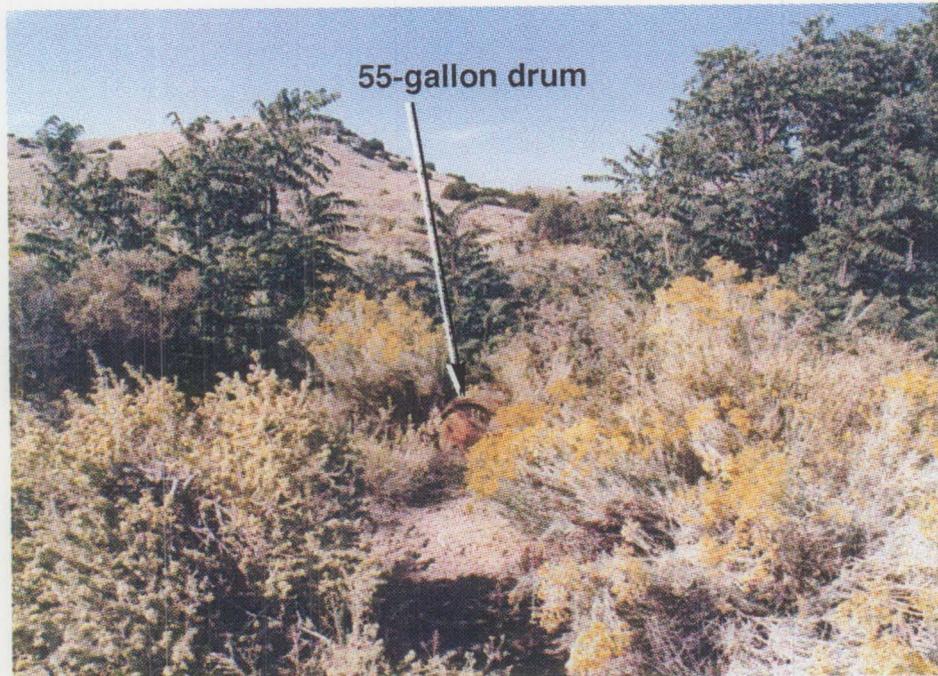
Figure 2-2b. 55-gallon drum at the Coyote Springs dump, ER Site 21. This drum is the primary fixture at this site. View to the north.
