Sandia National Laboratories / New Mexico

**PROPOSAL FOR NO FURTHER ACTION
ENVIRONMENTAL RESTORATION PROJECT
SITE 67, FRUSTRATION SITE
OPERABLE UNIT 1332**

August 1995

**Site 67, Frustration Site
OU 1332**

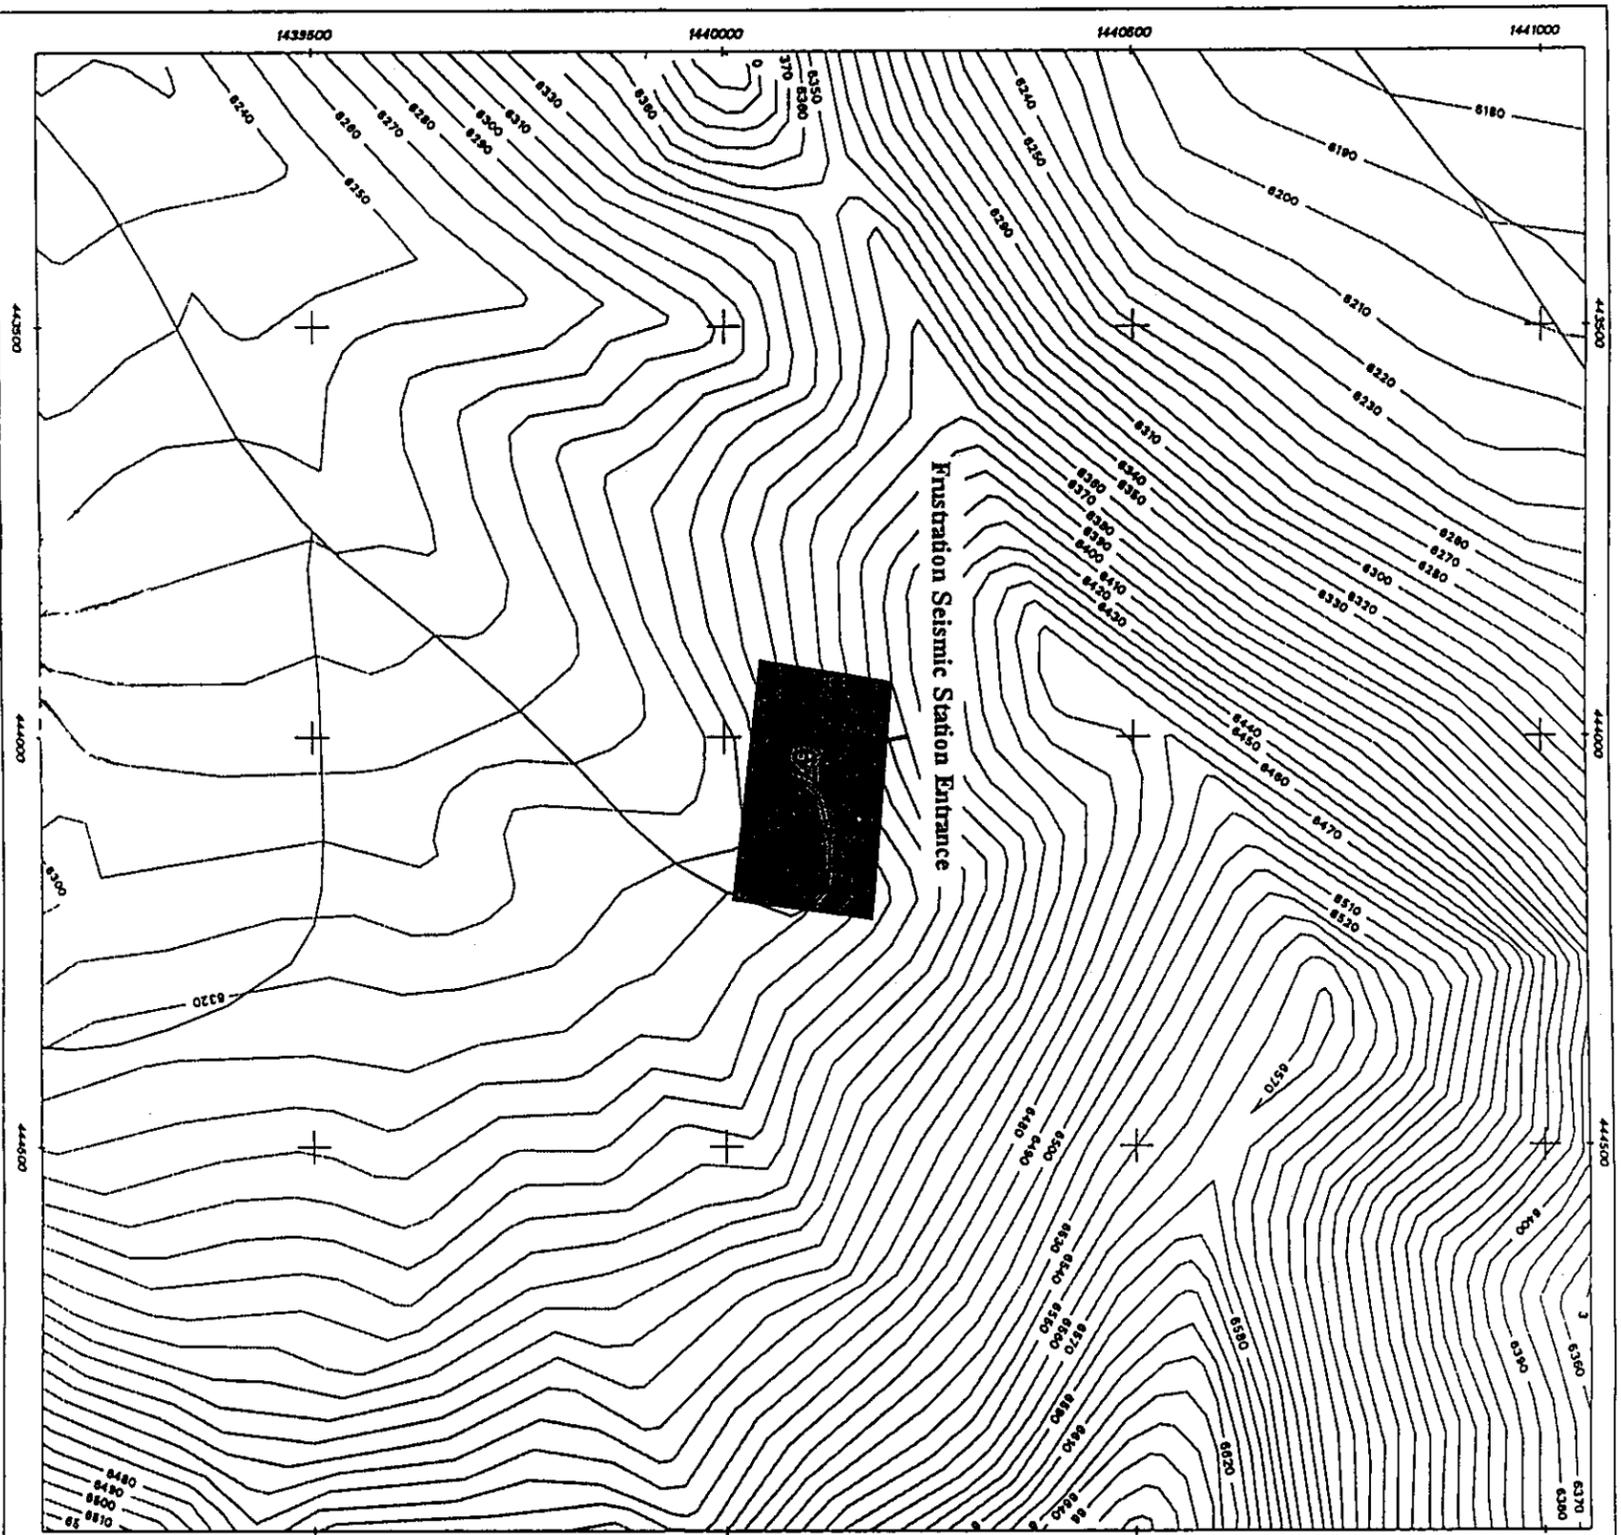
Figure 1
Environmental Restoration Site Atlas
ER Site No. 67
Frustration Site

The Frustration Site is located in the southeastern part of the Coyote Test Field. A dirt road leads directly to the door of the Frustration Seismic Station (Figure 1). Although there are numerous old mineshafts in the area, only the seismic station is defined as ER Site 67. The other mineshafts in the area of ER Site 67 are included in ER Site 28 (Mineshafts) which is also being proposed for NFA.

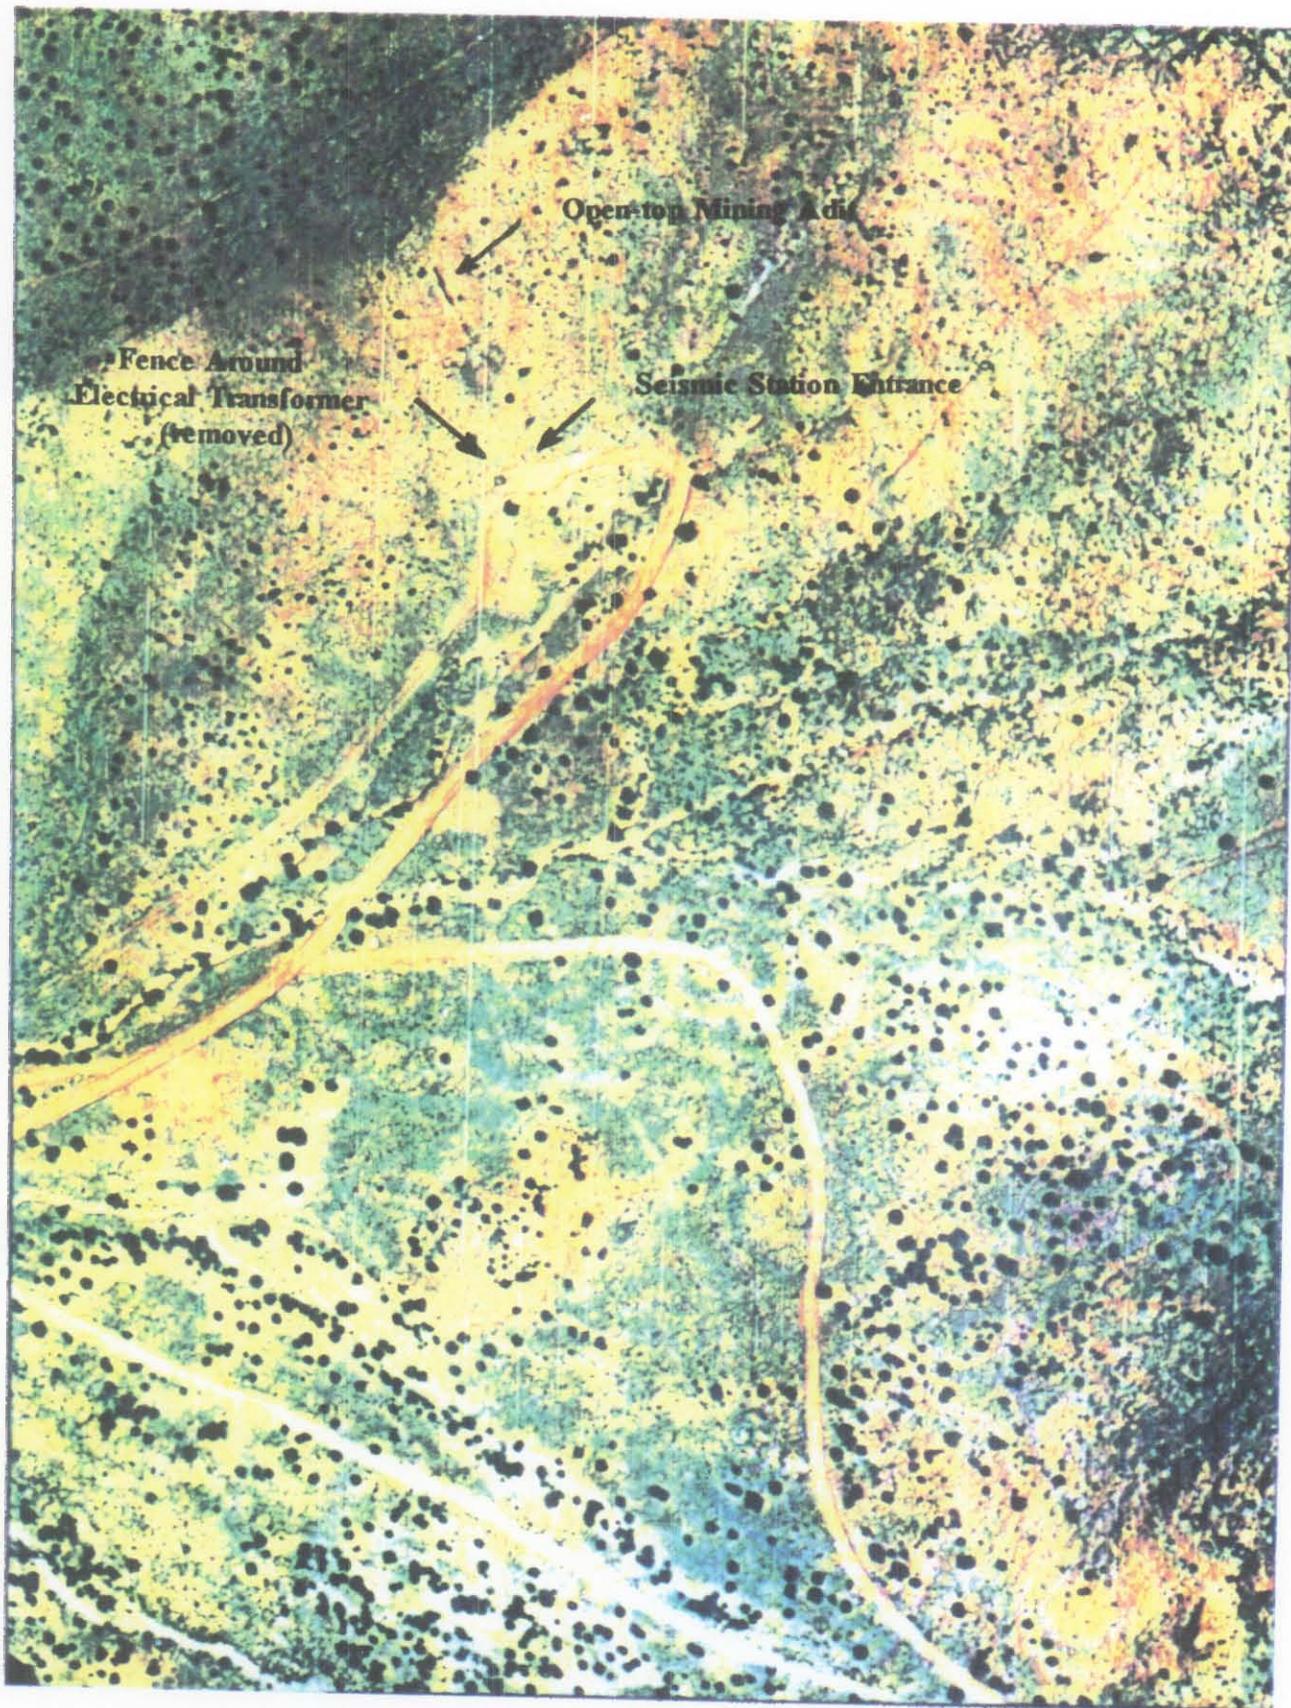
Figure 2. 1971 Aerial Photograph of Frustration Mine Area

There is no interview account of any leaks from the transformer (formerly located in front of the Frustration Site adit) and no visible evidence that any oil leaked onto the ground surface (Figure 2).

In front of the adit that housed the seismic station, a fence which has since been removed enclosed an approximately 8-foot by 10-foot area where an electric transformer had been located. This transformer powered the seismic equipment and lighting inside the site. There is no interview account of any leaks from the transformer and no visible evidence that any oil leaked onto the ground surface (Figure 2).

There is no anecdotal evidence that the electric transformer formerly located in front of the seismic station ever leaked, nor is there visible evidence of any oil leakage.

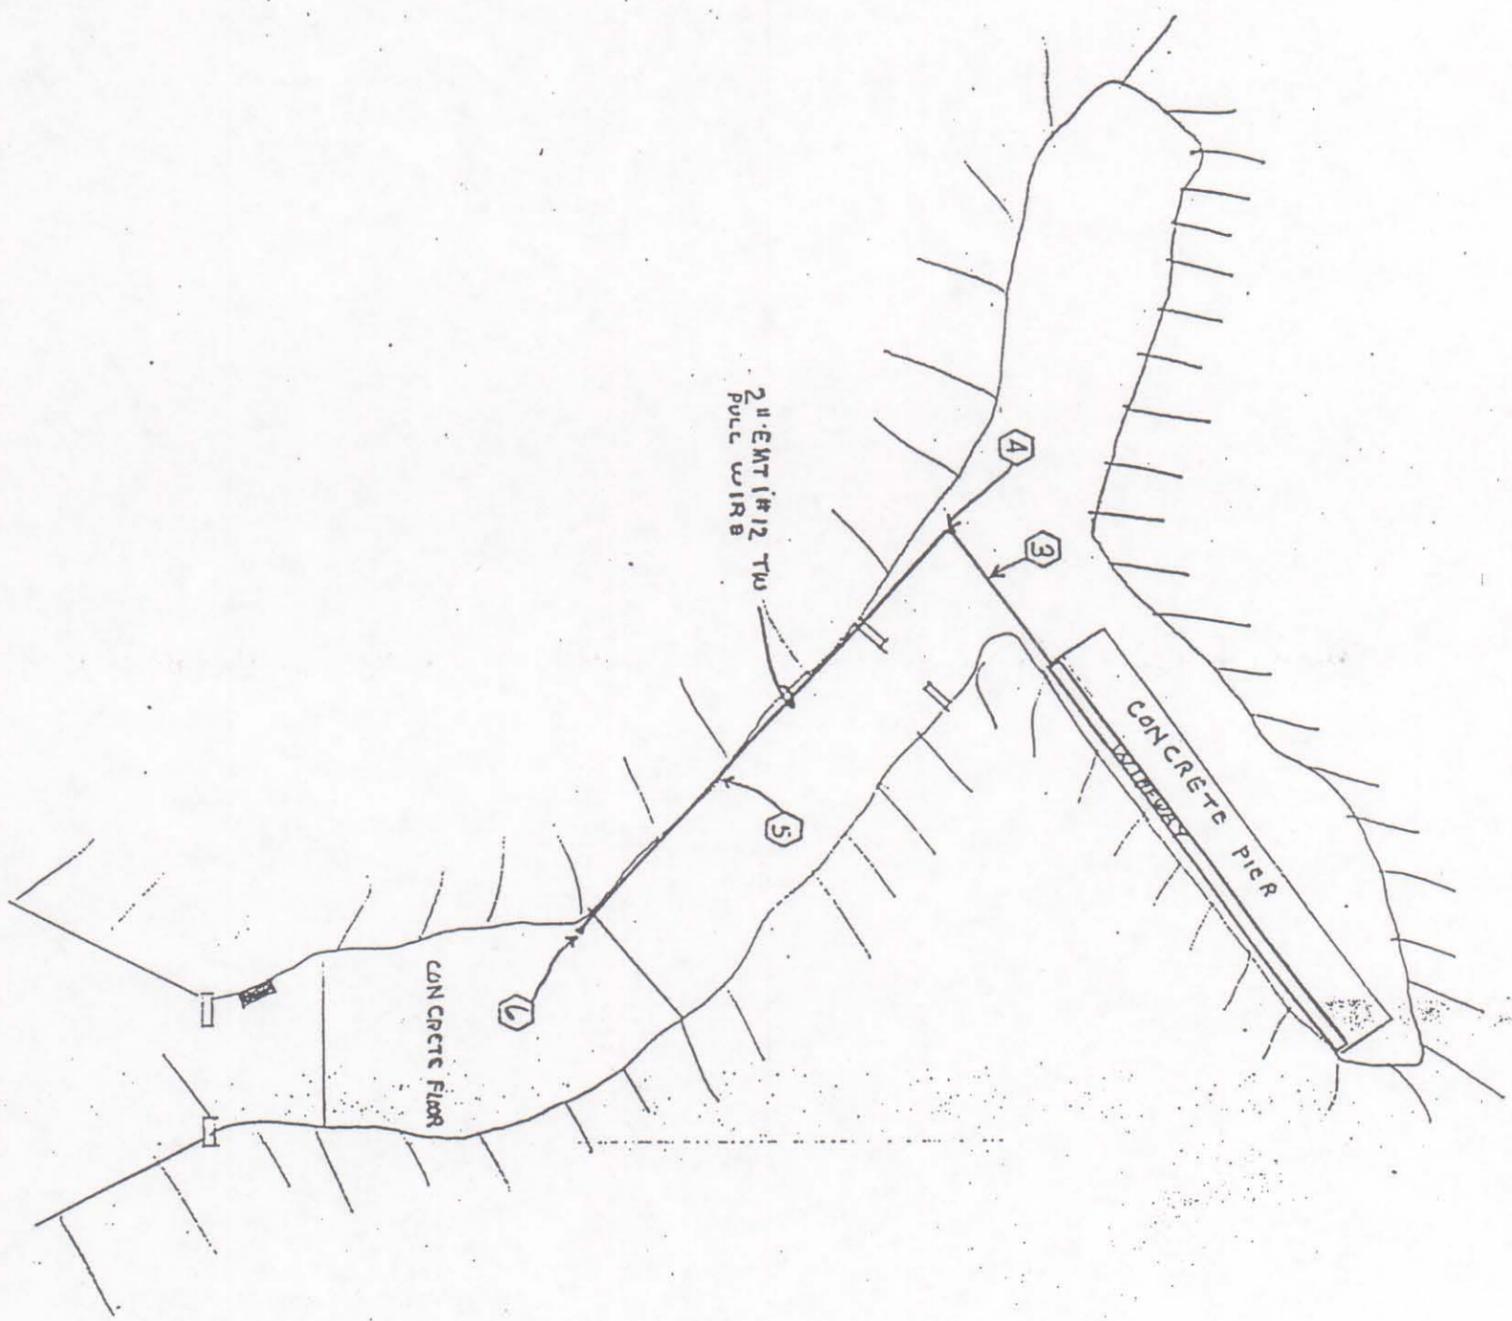
Figure 3

CHARACTERISTICS: 120/208V, 3Φ 4W SN. 100A. PANELBOARD "E" FRAME BKRS. FED BY 3#2-2" C FROM JSKVA. SUBSTATION: ... Φ B AND Φ C CONNECTED TOGETHER

CONNECT Φ B AND Φ C BUSBARS TOGETHER WITH #2 WIRE
RE-CIRCUIT OUTLETS ON CRT. 9 TO CRT. 4

INSTRUMENTATION PLAN
SCALE: 1/8" = 1'-0"

TITLE ELECTRICAL
"FRUSTRATION" SITE

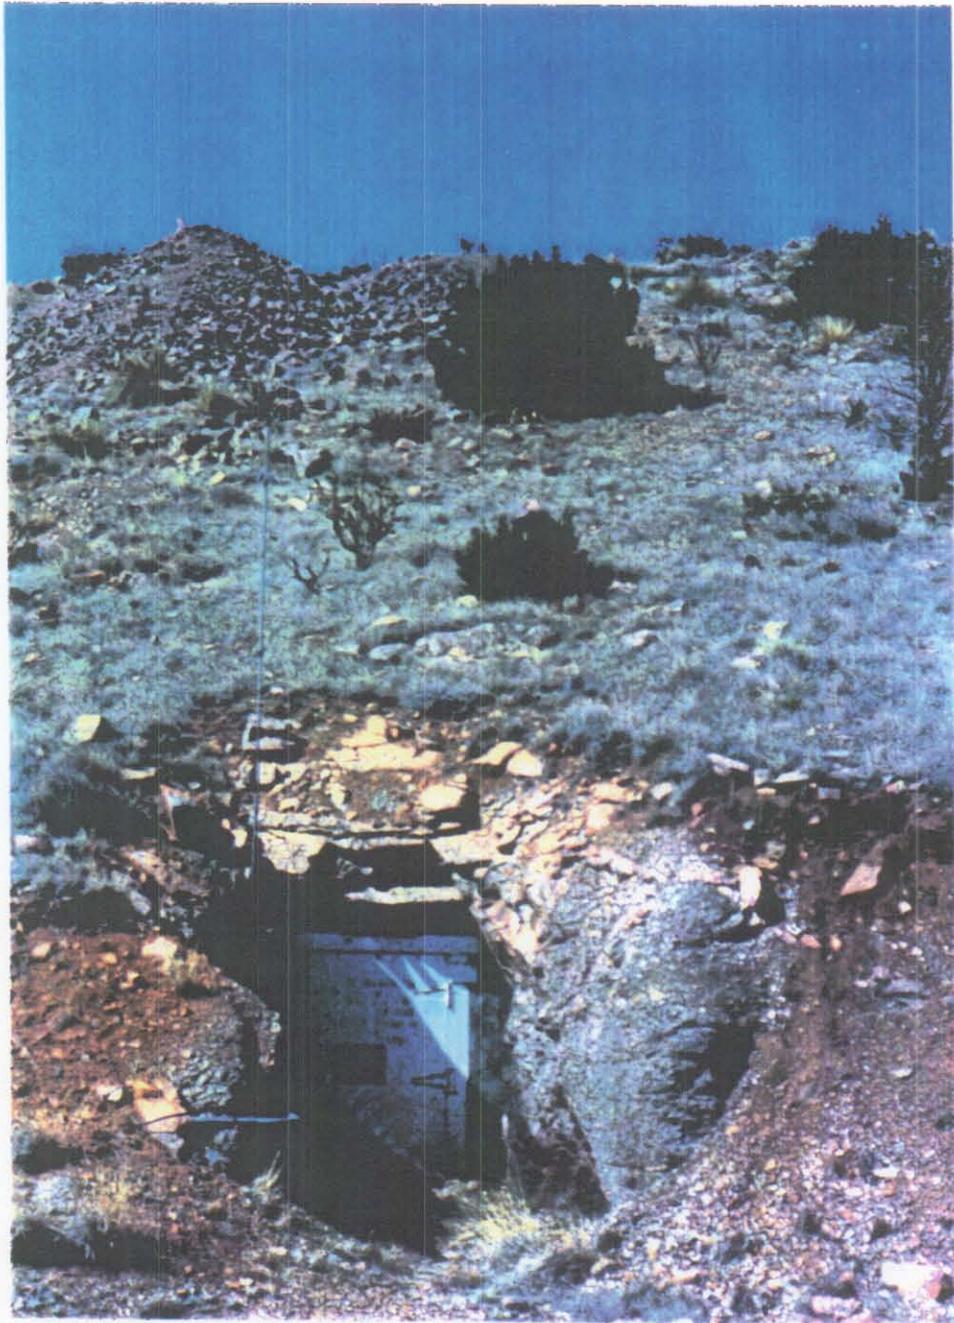
Figure 4. Frustration Seismic Station Entrance

ER Site 67 is comprised of an old mine adit which was used to house an experimental seismic station during the 1960s and 1970s. The abandoned Frustration Seismic Station is located in the old Frustration Mine, a horizontal adit approximately 50 feet deep.

Old mine adits in this area are the remnants of mineral mining activities (fluorite, etc.) conducted by homesteaders around the turn of the century. A portion of the old Frustration Mine was used by SNL/NM to house an experimental seismic station during the 1960s and 1970s. The station was used to record seismic disturbances produced by testing at the Nevada Test Site. The abandoned Frustration Seismic Station is located in a horizontal adit approximately 50 feet deep. Figure 3 is a portion of a 1959 SNL/NM engineering drawing which shows the layout of the mine adit and the electrical circuitry which was installed to run the seismic instrumentation. A sturdy metal door, with the faded words, "Frustration Site" and an Atomic Energy Commission (AEC) warning sign on it, seals the entrance (Figure 4). Inside are the remains of the seismic instrumentation attached to the rock walls, along with the remains of some office furniture.
