**PROPOSAL FOR ADMINISTRATIVE
NO FURTHER ACTION
ENVIRONMENTAL RESTORATION
SITE 69, OLD BORROW PIT
OPERABLE UNIT 1334**

August 1994

Prepared by
Sandia National Laboratories/New Mexico
Environmental Restoration Project
Albuquerque, New Mexico

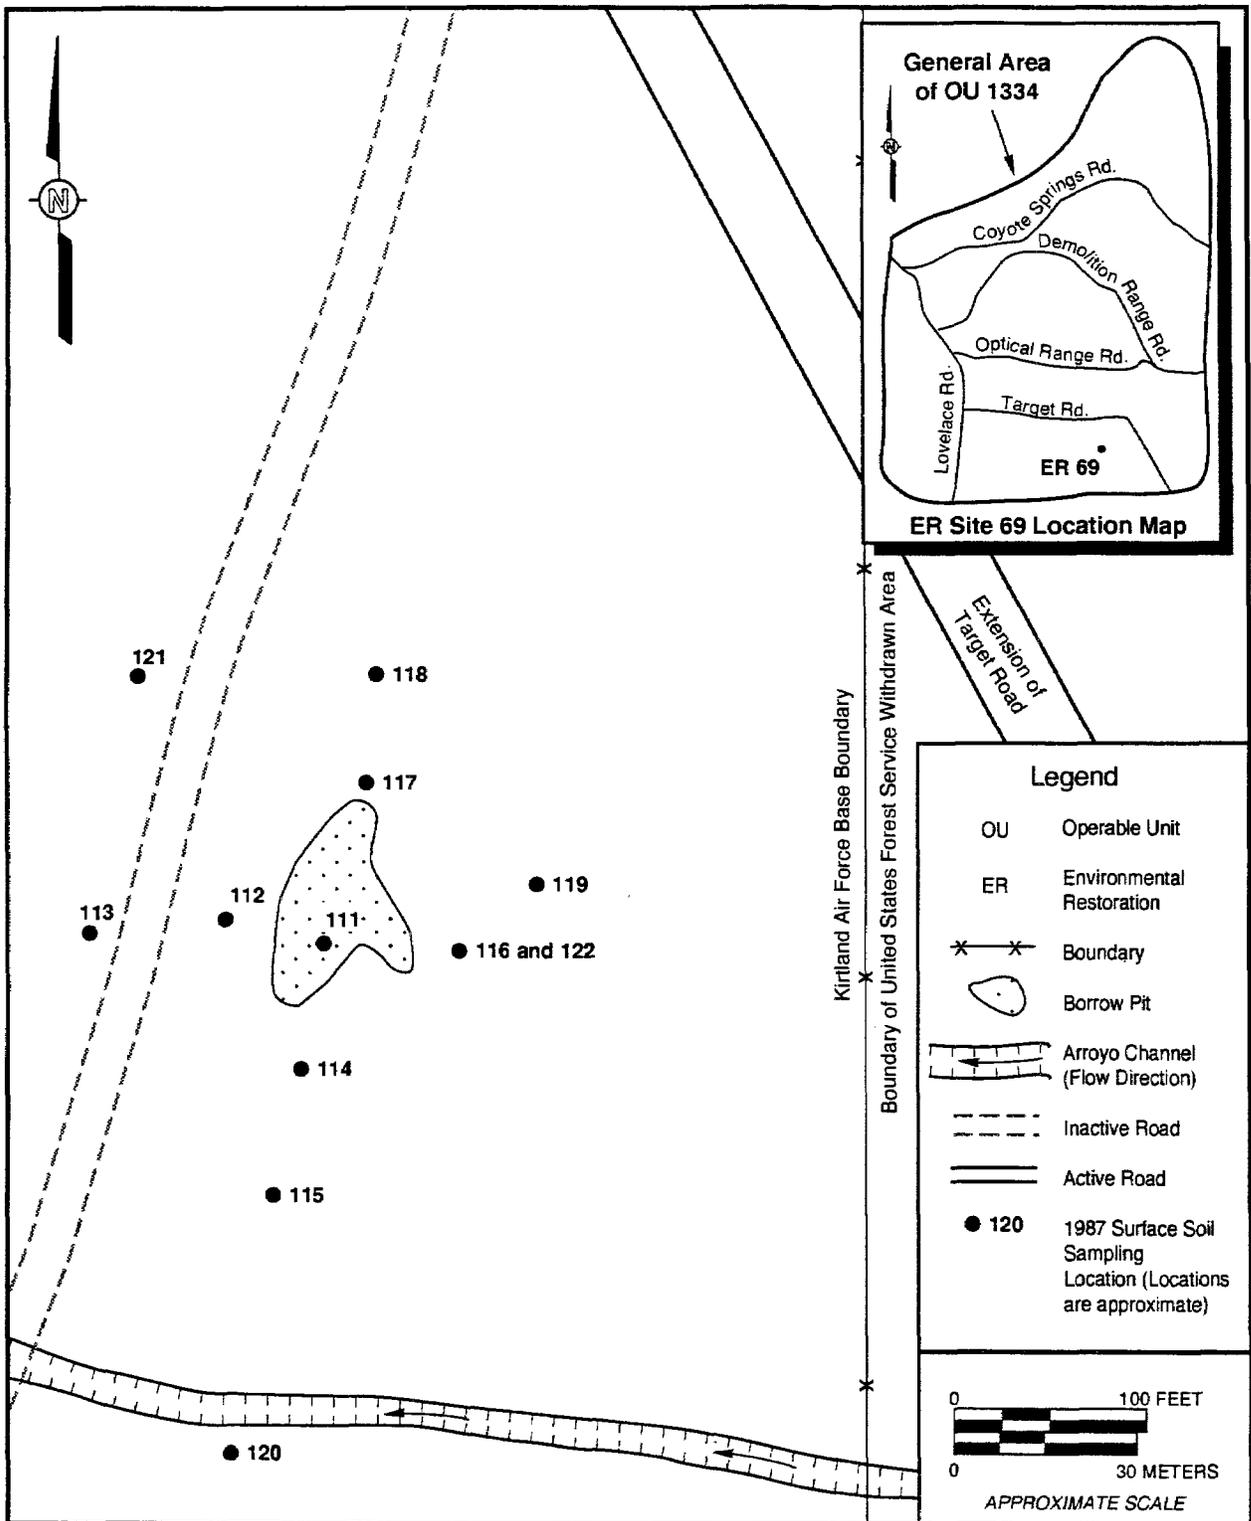
Figure 2-1
Site Map and 1987 Sample Locations for ER Site 69, Old Borrow Pit

ER Site 69 (Figure 2-1) consists of a broad, shallow irregularly shaped pit (Figure 2-2) located approximately 200 ft north of a small unnamed arroyo channel that discharges to the west. Interviews with current and former SNL/NM personnel most familiar with work performed in the vicinity of ER Site 69 produced no information on activities related to this site (69-6 through 69-11). Several ER interview records from ER Site 61 (69-25, 69-26) note that the irregular shape of the depression and lack of an explosion berm are inconsistent with the morphologic features of blast or explosion craters found at known firing sites. The morphology of the pit and the lack of explosives-testing debris suggest that it is most likely a borrow pit.

Figure 2-1 shows the approximate sample locations at the site, and Table 3-1 correlates the sample location and number.

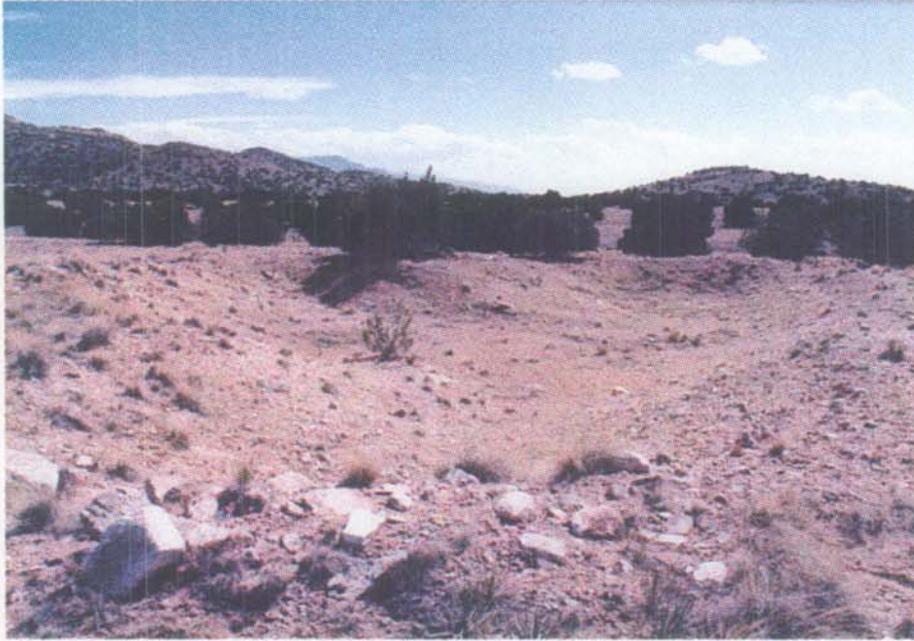
North-south trending borrow pit, ER Site 69. Note irregular, elongated shape is not characteristic of a crater formed from explosive testing. View to the south.

ER Site 69 consists of an irregular shaped pit containing vegetative cover similar to surrounding areas. Explosive experts at SNL/NM indicated that the pit morphology is not consistent with the morphology observed for explosion craters (69-25, 69-26).

The original designation of ER Site 69 as a firing site was based on the presence of firing cables and shrapnel, as noted in the CEARP report (DOE September 1987). This conclusion is in conflict with ER Project interviews, the morphology of the pit, and aerial photographs. During recent ER site inspections, the old firing cables were found to be military field telephone cable, and the reported shrapnel is metal scrap that does not appear to be related to ordnance (Dan Sandhaus, personal communication). ER Project interviews (69-25, 69-26) note that the morphology of the pit is not consistent with explosion craters at known firing sites. Aerial photographs suggest the pit was formed when material was borrowed to construct the extension of Target Road.
