**PROPOSAL FOR NO FURTHER ACTION
ENVIRONMENTAL RESTORATION PROJECT
SITE 92, PRESSURE VESSEL TEST SITE
(COYOTE CANYON BLAST AREA)
OPERABLE UNIT 1333**

August 1995

**Site 92, Pressure Vessel Test Site (Coyote Canyon Blast Area)
OU 1333**

Prepared by
Sandia National Laboratories/New Mexico
Environmental Restoration Project
Albuquerque, New Mexico

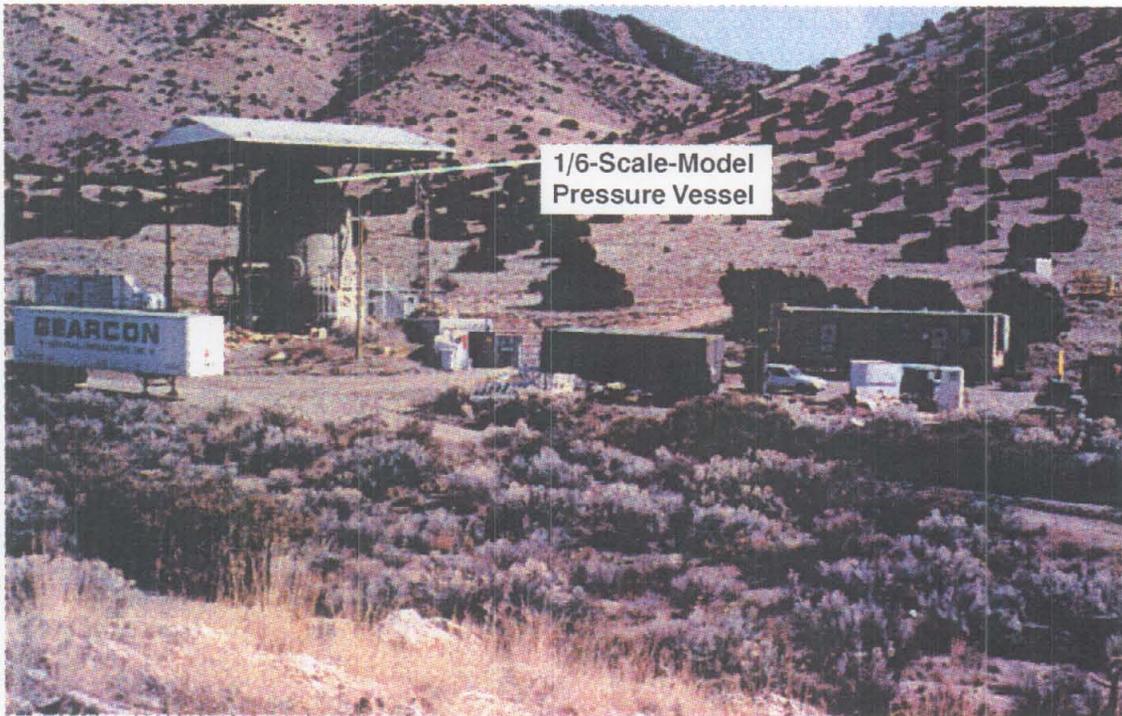
Figure 2-2c. Photograph of the main area of ER Site 92 in November 1992. The 1/6-scale-model pressure vessel is shown under the corrugated roof. View is to the northeast.

All features associated with the main area of ER Site 92 are currently present at the site. They include a 1/6-scale-model pressure vessel covered by a corrugated metal roof and associated features (trailers, transformers, compressors, camera bunkers, and water tanks). The features associated with the inactive southern area of the site include a 1/32-scale-model pressure vessel and metal scrap derived from the explosive failure of the 1/8-scale-model pressure vessel. These are the only physical structures associated with ER Site 92 activities, as evidenced by historical aerial photographs that indicate no other activities or structures were present at ER Site 92 (SNL/NM August 1994).

Although the main area of ER Site 92 is capable of supporting additional testing operations, the site has not been used by SNL/NM Organization 6642 since 1992 (92-2, 92-27). Pressure vessel testing is currently conducted at Technical Area III, although ER Site 92 remains in a stand-by mode to accommodate future test activities should a need arise.
