NUREG/CR-6810
SAND2003-0840P

Overpressurization Test of a 1:4-Scale Prestressed Concrete Containment Vessel Model

Sandia National Laboratories

**U.S. Nuclear Regulatory Commission
Office of Nuclear Regulatory Research
Washington, DC 20555-0001**

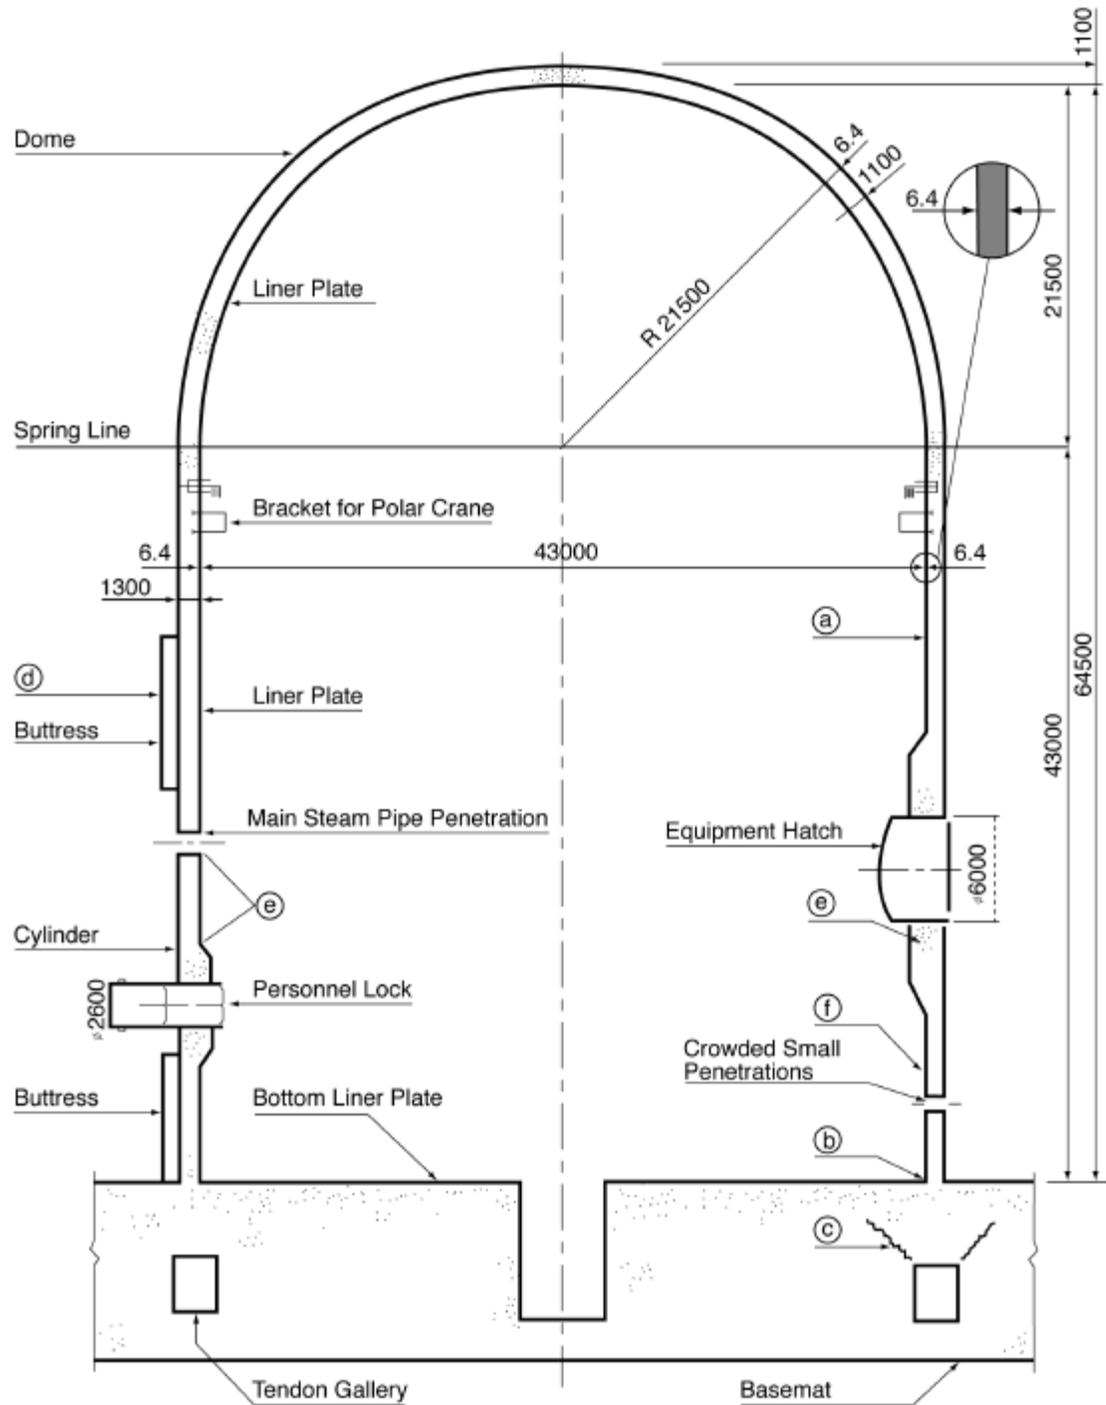
Figure 2.1. Elevation of PCCV Prototype and Potential Failure Locations

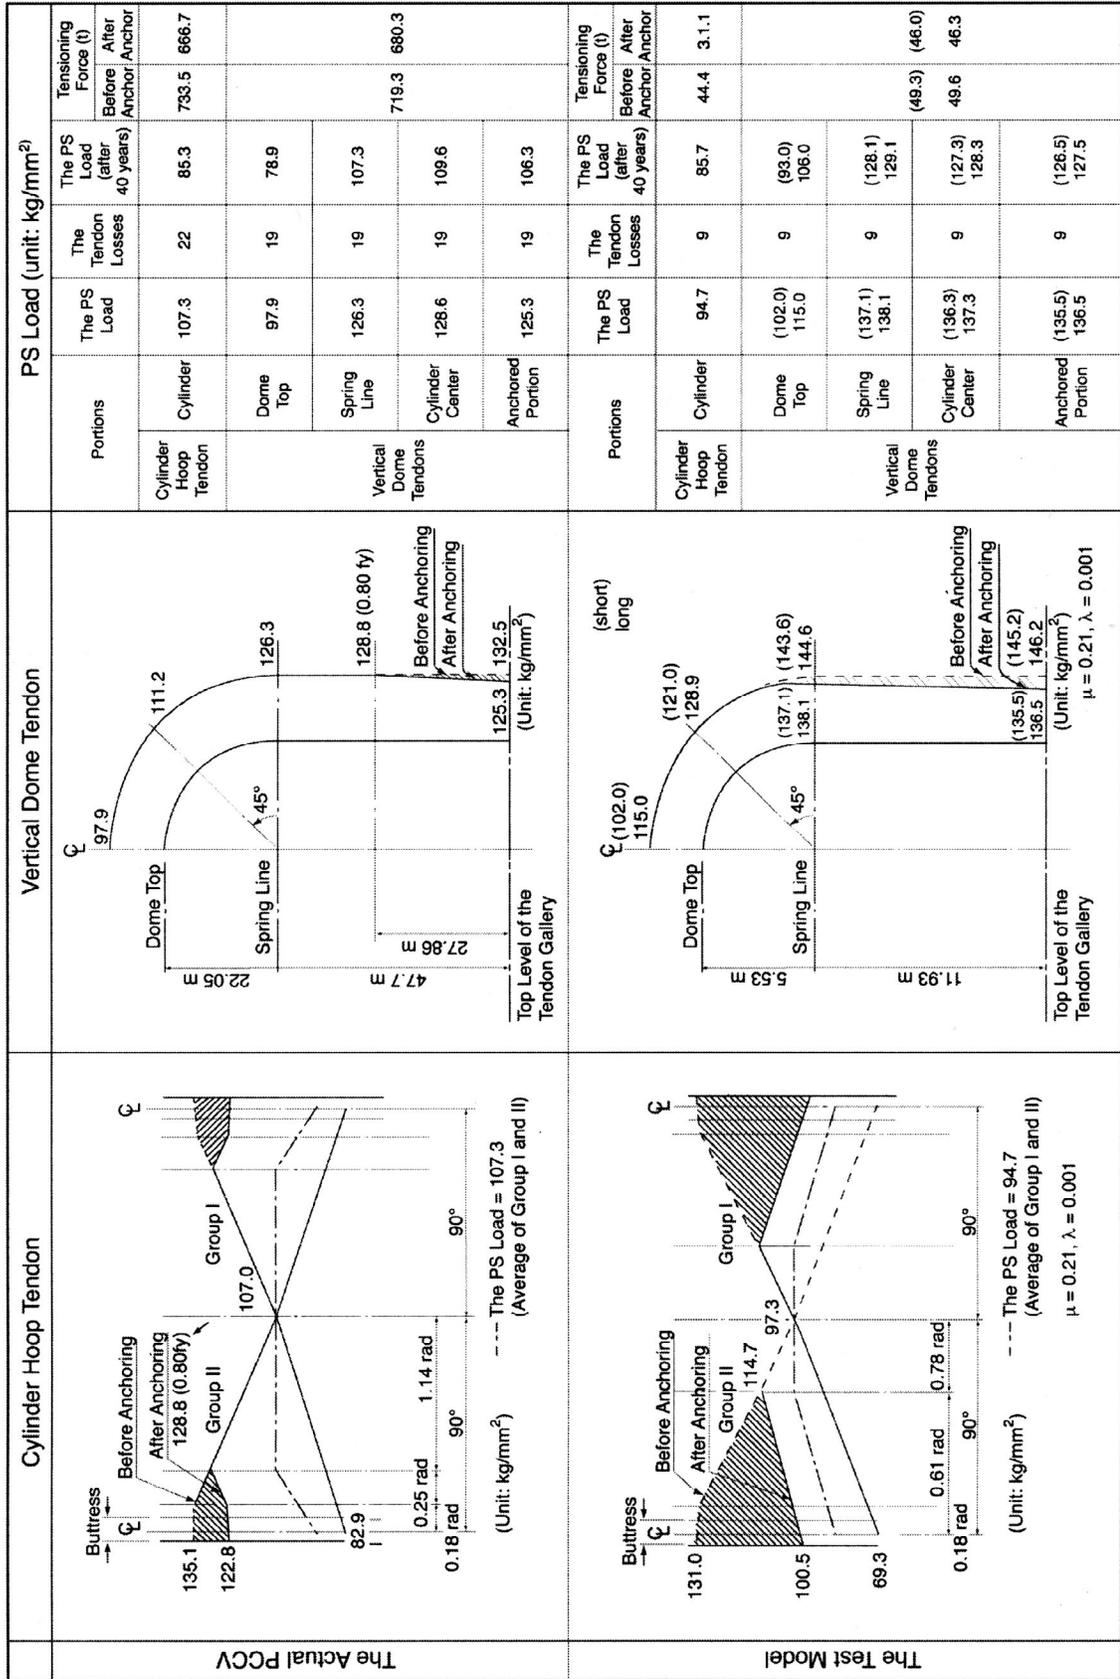
Figure 2.9 PCCV Prototype and Model Tendon Design Stress Profiles

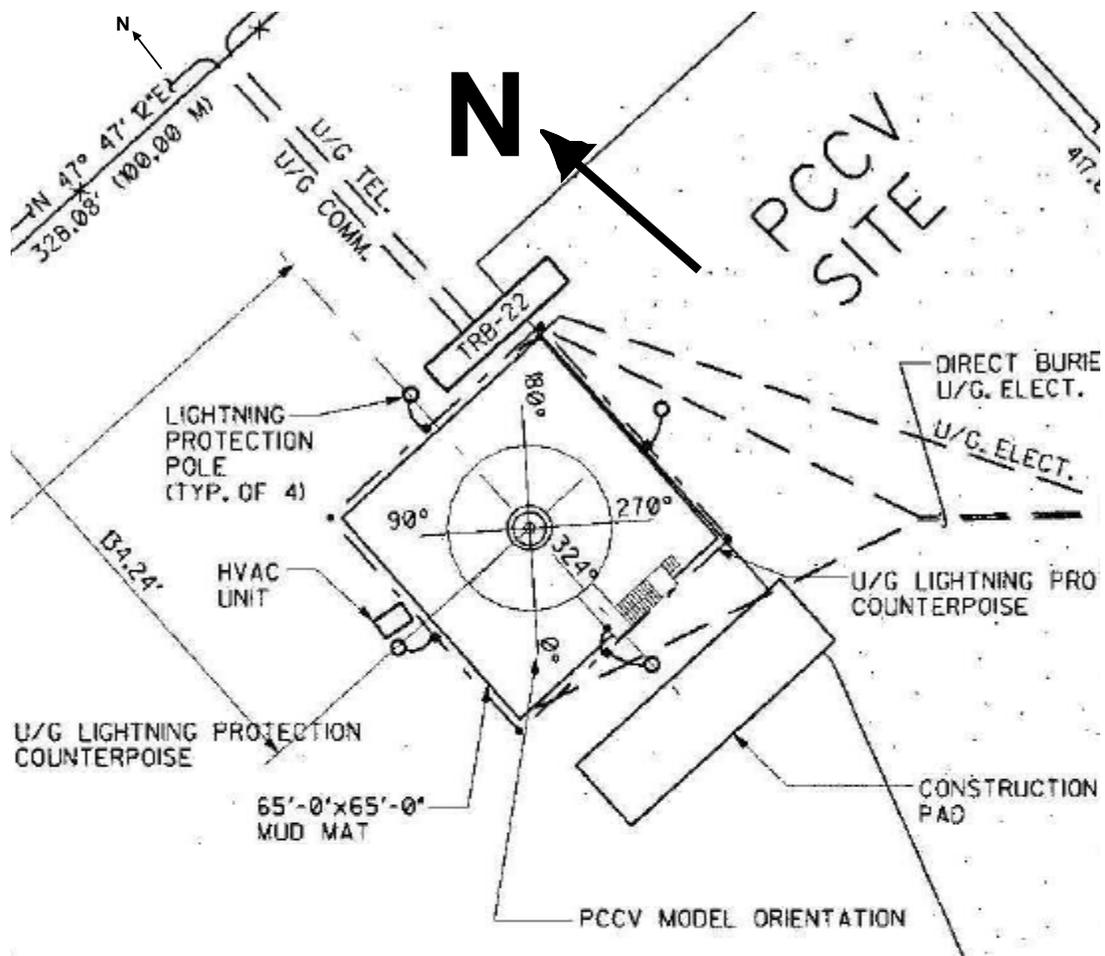
Figure 2.10 PCCV Model Layout

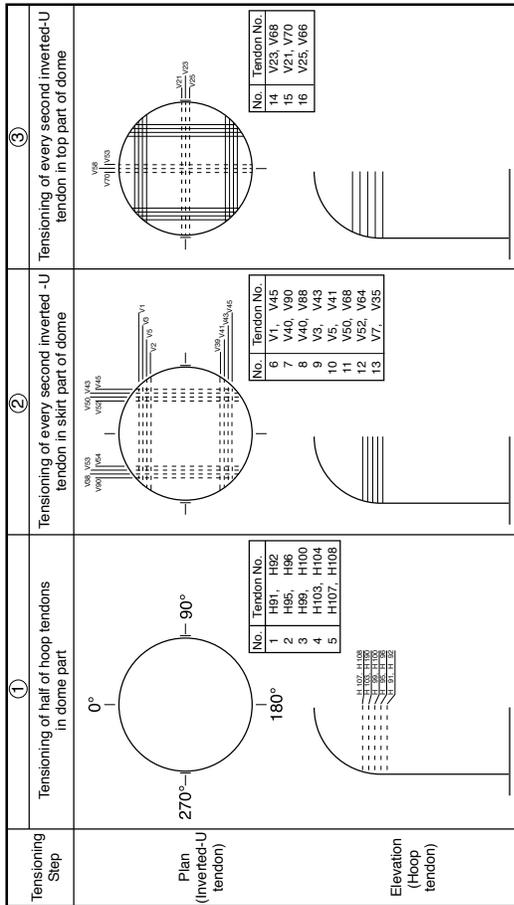
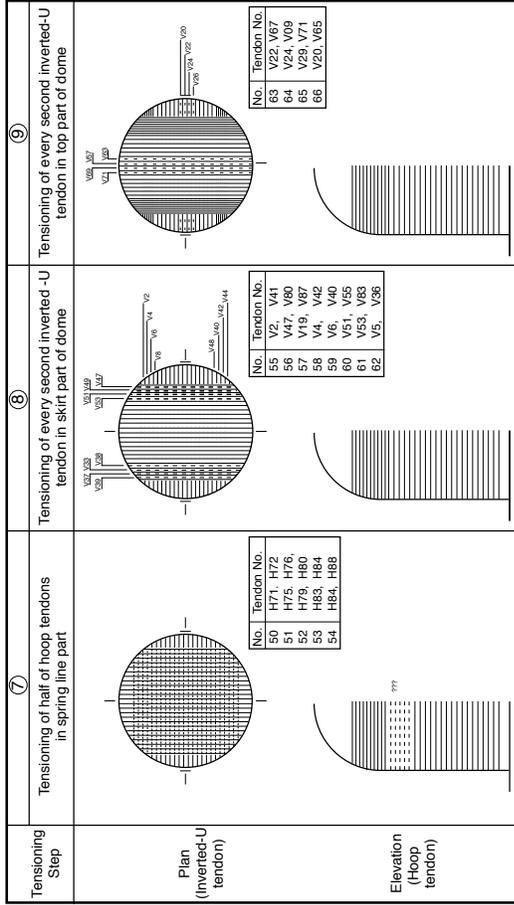
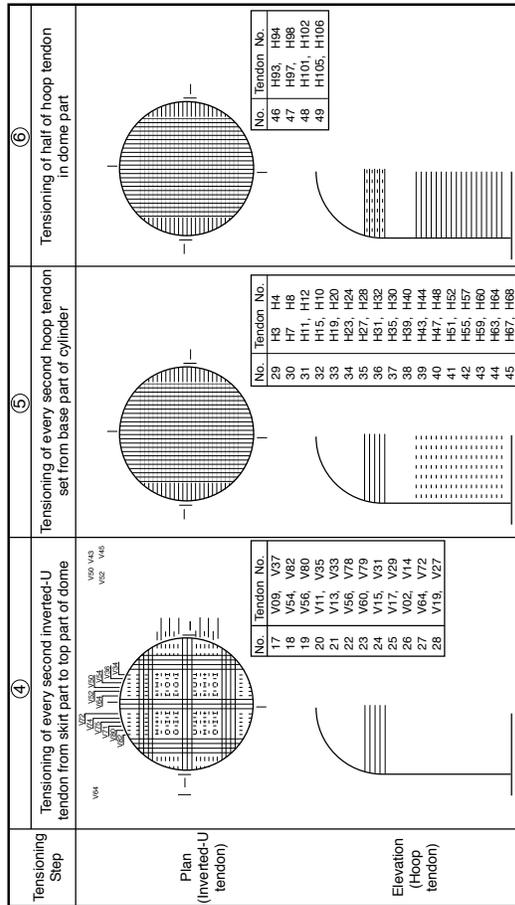
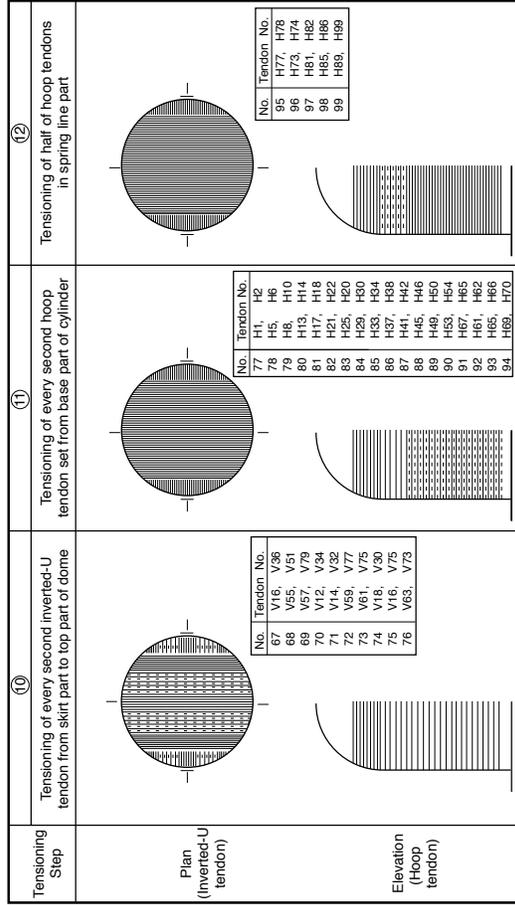
Tensioning Sequence (1/4)

Note: 1. Solid line shows tendon tensioned fully in the previous step.
2. Broken line shows tendon to be tensioned in this step.

Tensioning Sequence (3/4)

Tensioning Sequence (2/4)

Tensioning Sequence (4/4)

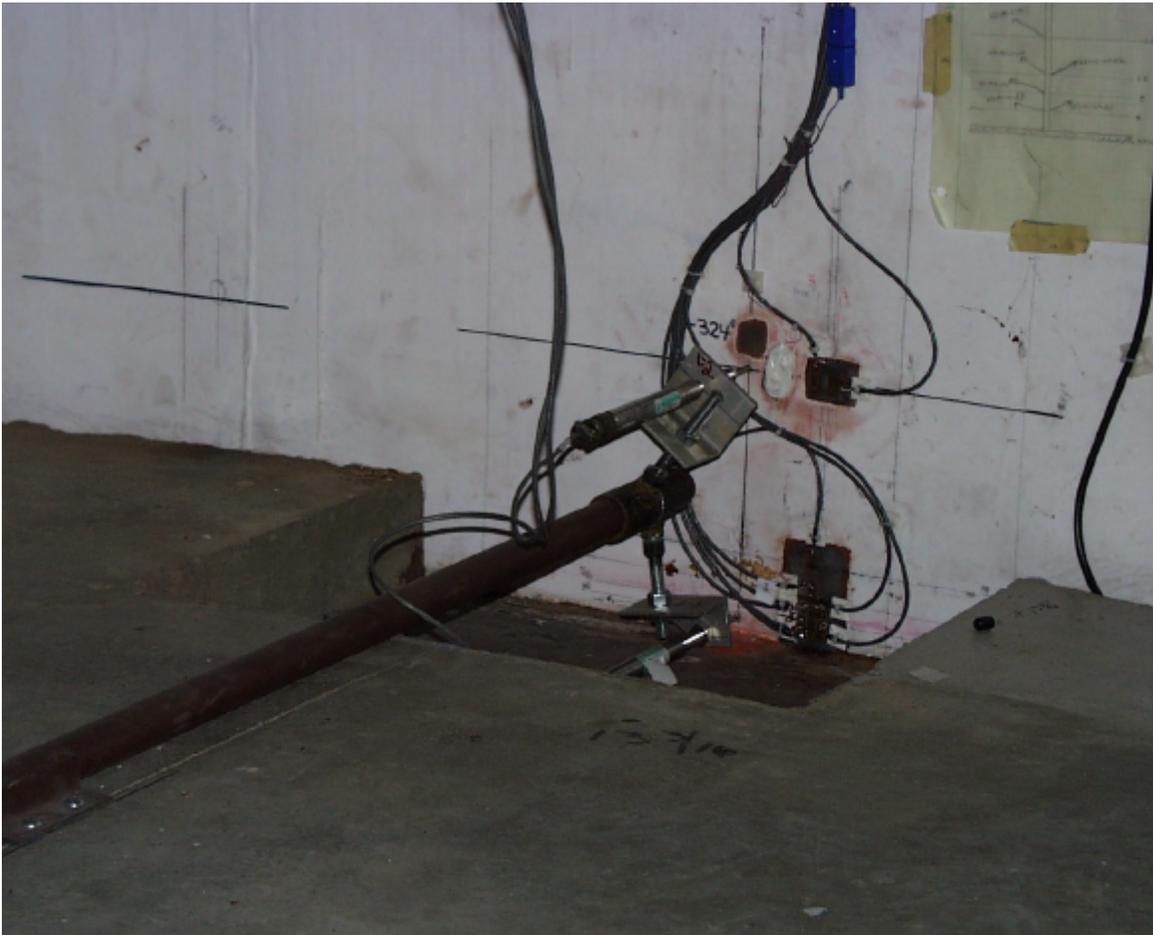
Figure 3.3 LVDTs at Wall-Base Junction (Azimuth 324 degrees, Elev. 0.0 and 250.0)

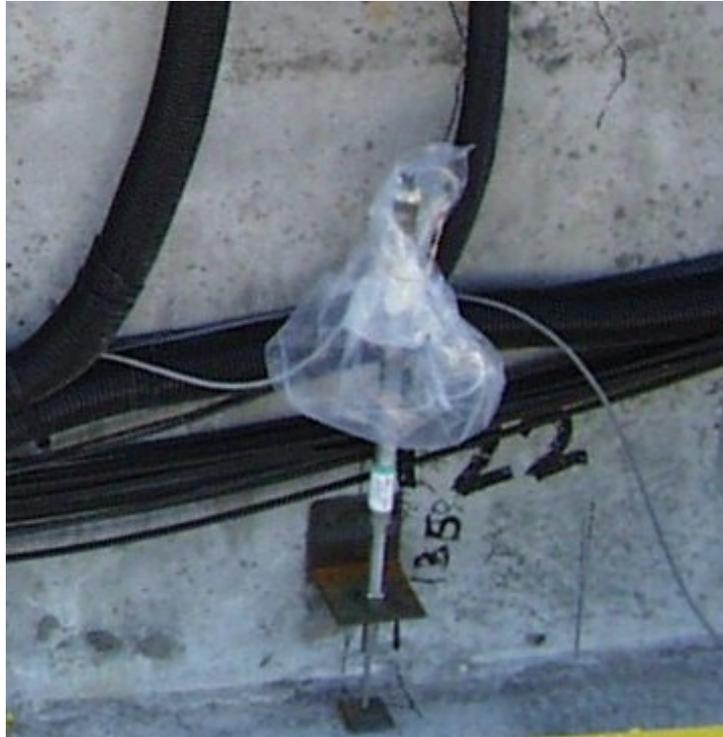
Figure 3.5 External LVDT Measuring Displacement between Basemat and Mudmat

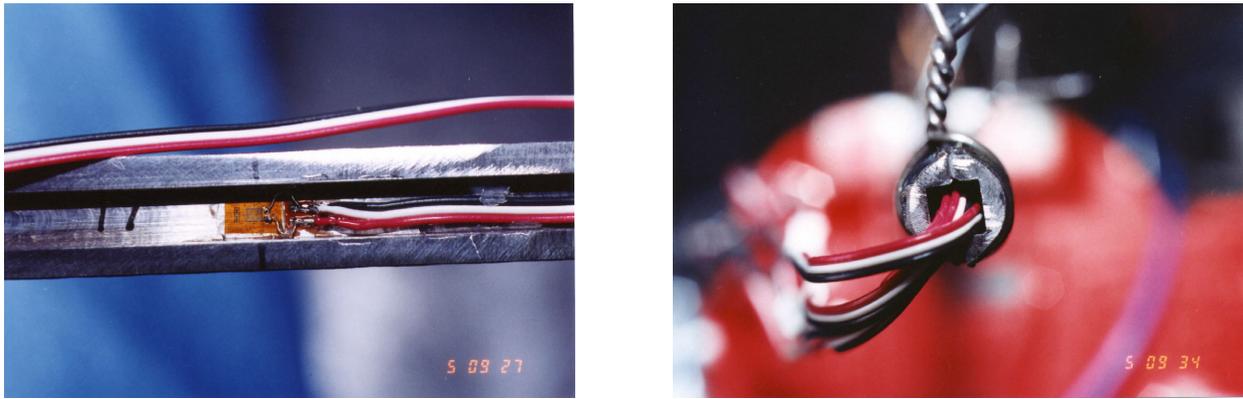
Figure 3.8 Concrete Strain Gage Bars

Specifications for the gage bar strain gages are summarized in Tables 3.9. The configuration of the gage bars is illustrated in Figure 3.8. Sample rebar and gage bar strain gages are compared in Figure 3.9.

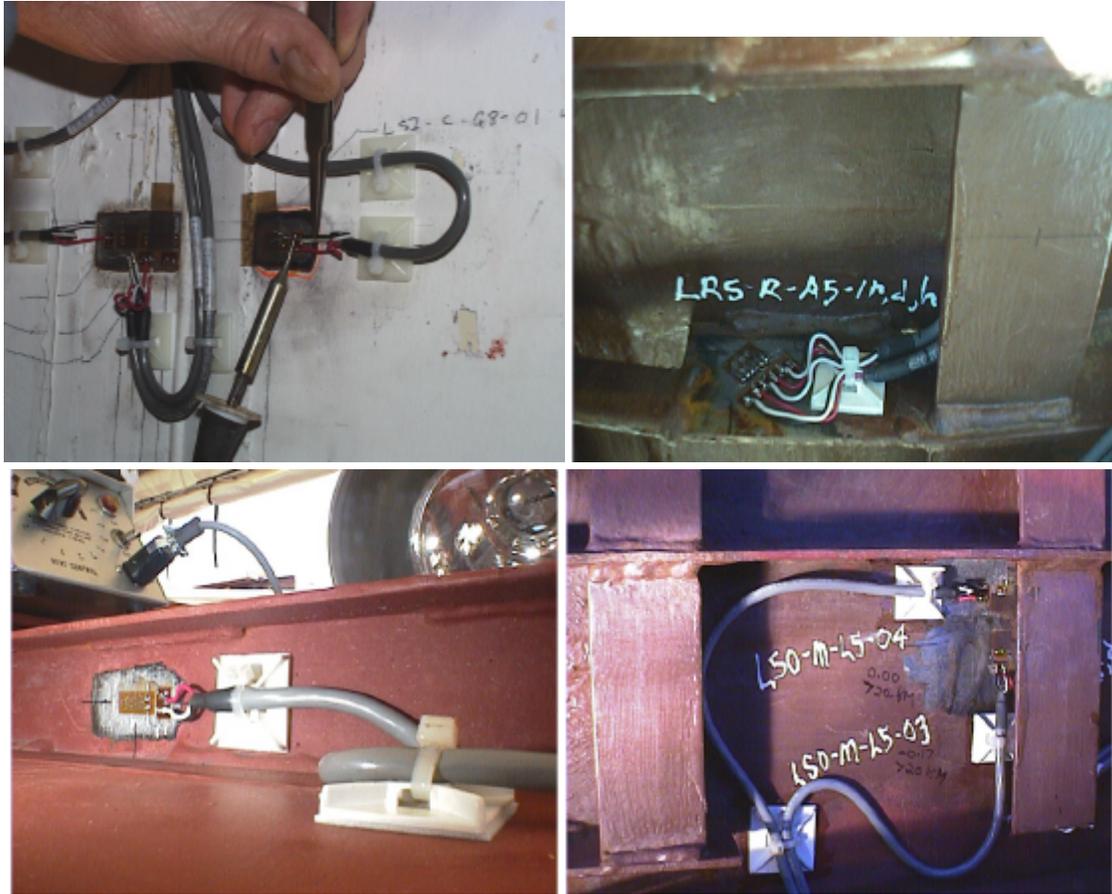
Figure 3.11 Liner and Liner Anchor Strain Gages

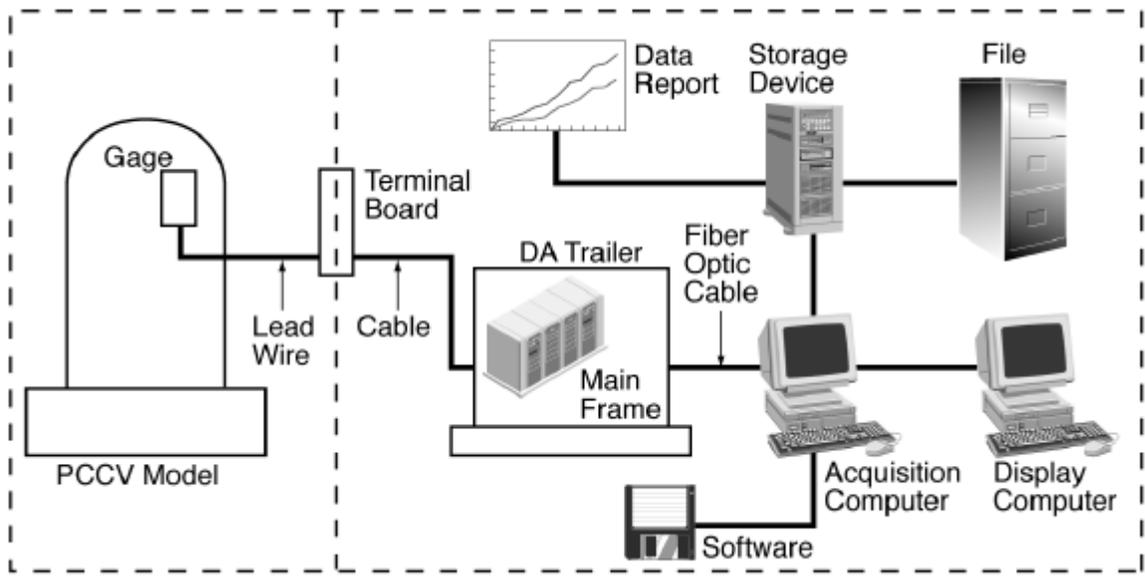
Figure 4.1 PCCV/DAS Hardware Configuration

The primary hardware component involved in the data gathering was the Hewlett Packard 75000 Series B system, which included the HP1302A VXI Mainframe and its associated 5 ½ digit multimeter (HP1326B). Analog signals from the instruments were sent to plug-in cards installed into the mainframe housing. An analog bus jumper connected the signals to the digital multimeter where the analog-to-digital (A-D) conversion occurred.

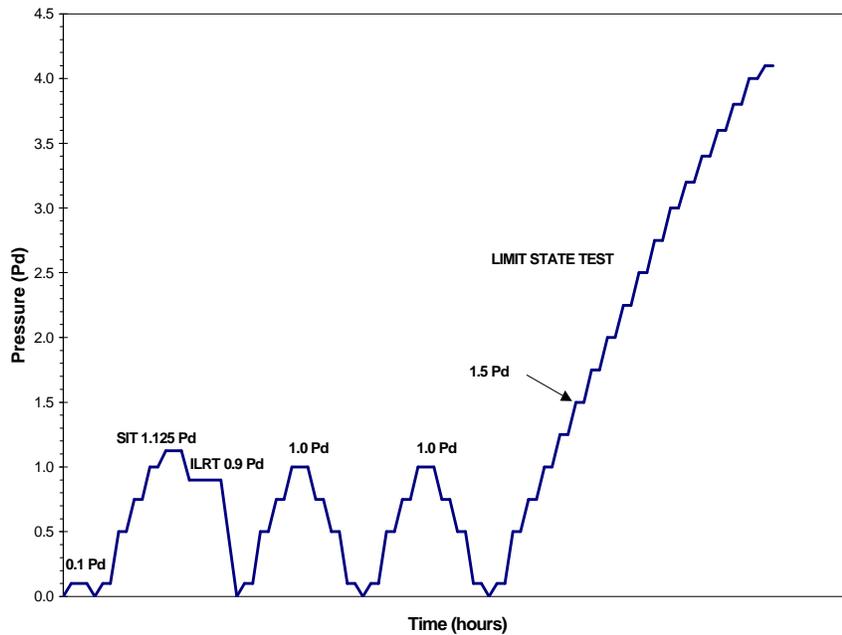
Figure 5.1 Original Pressurization and Depressurization Sequence [34]

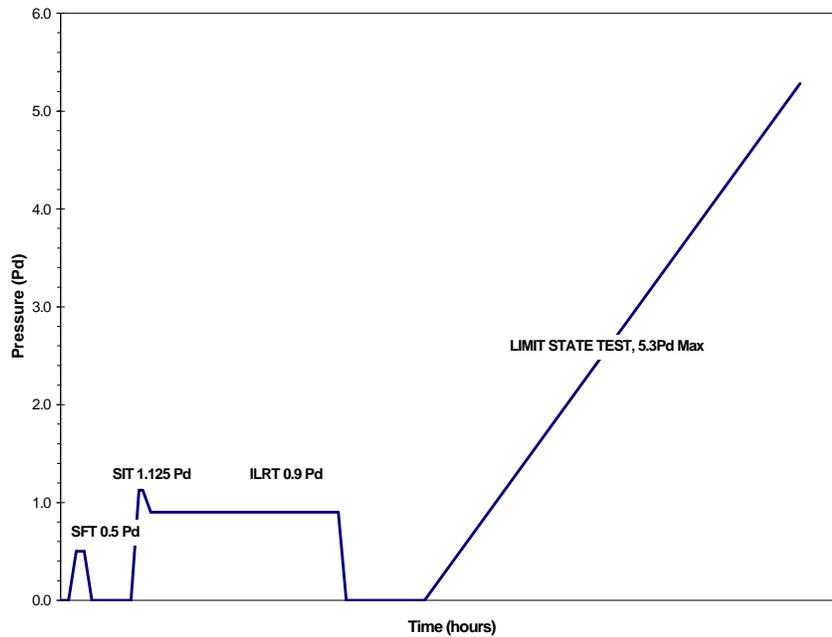
Figure 5.2 Final Pressurization Plan

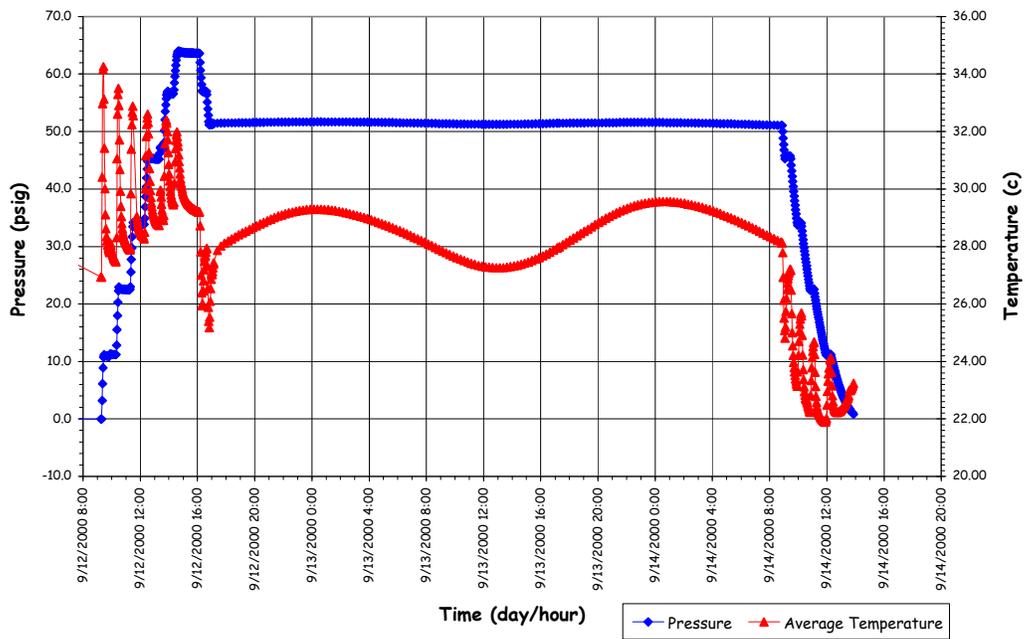
Figure 5.7 Structural Integrity and ILRT Pressure and Temperature Time Histories

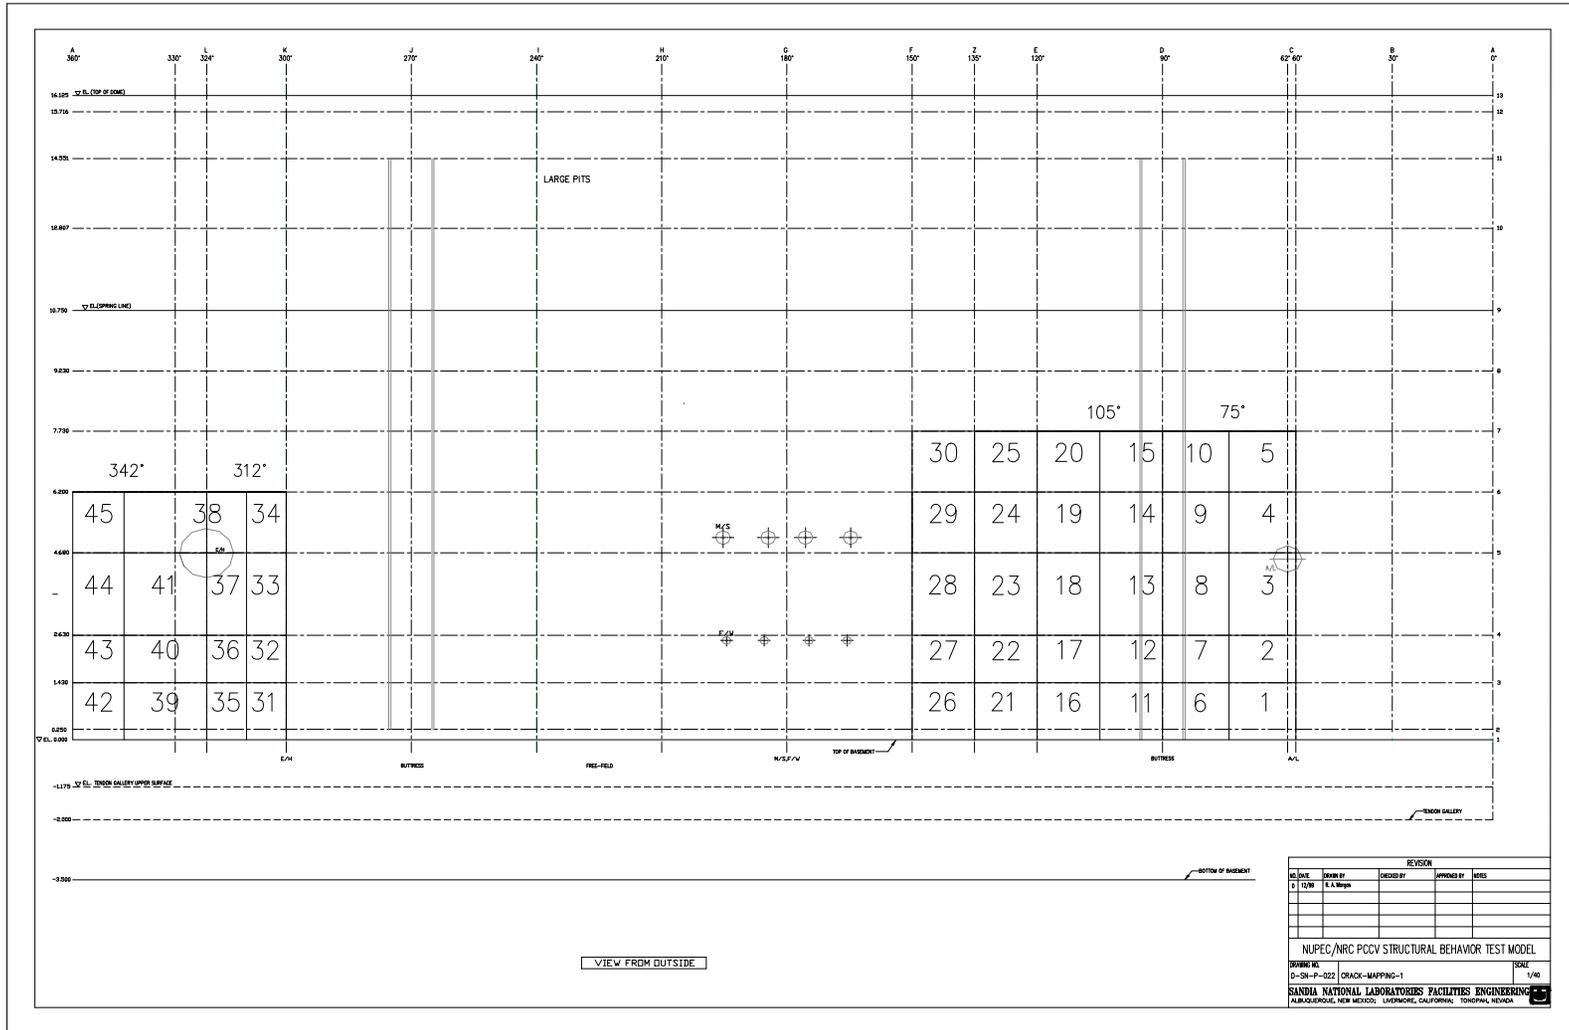
Figure 5.8 Concrete Crack Map Grid

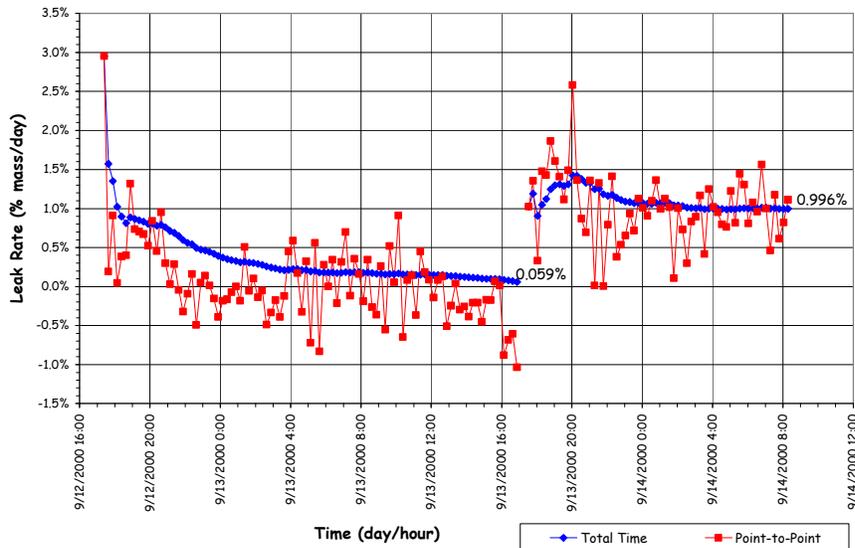
Figure 5.9 Integrated Leak Rate Test Leak Rates

The calculated leak rates during and after the ILRT are shown in Figure 5.9.

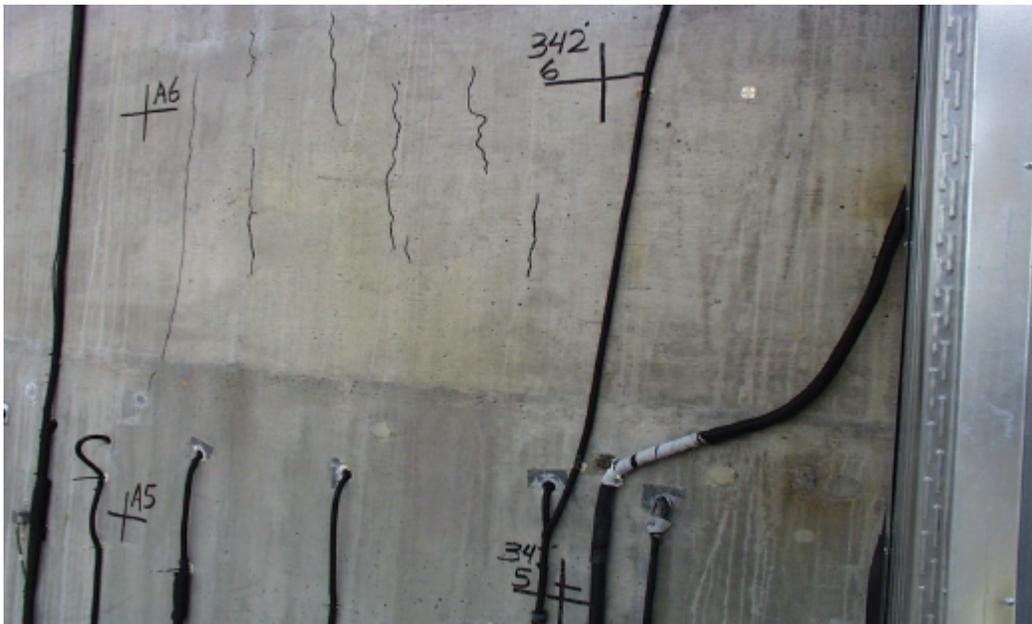
Figure 5.10 Pre-SIT Cracks at Azimuth. 350 degrees, Elev. 4680 to 6200 (Grid 45)

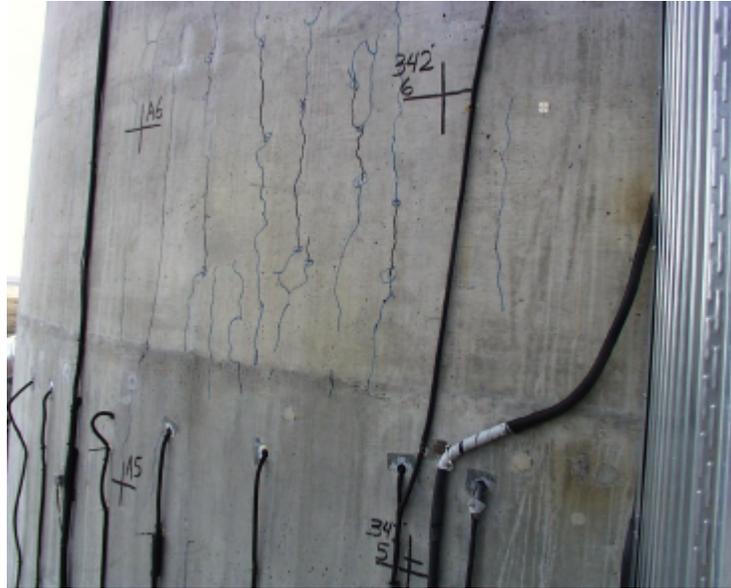
Figure 5.11 Post-SIT Cracks at Azimuth. 350 degrees, Elev. 4680 to 6200 (Grid 45)

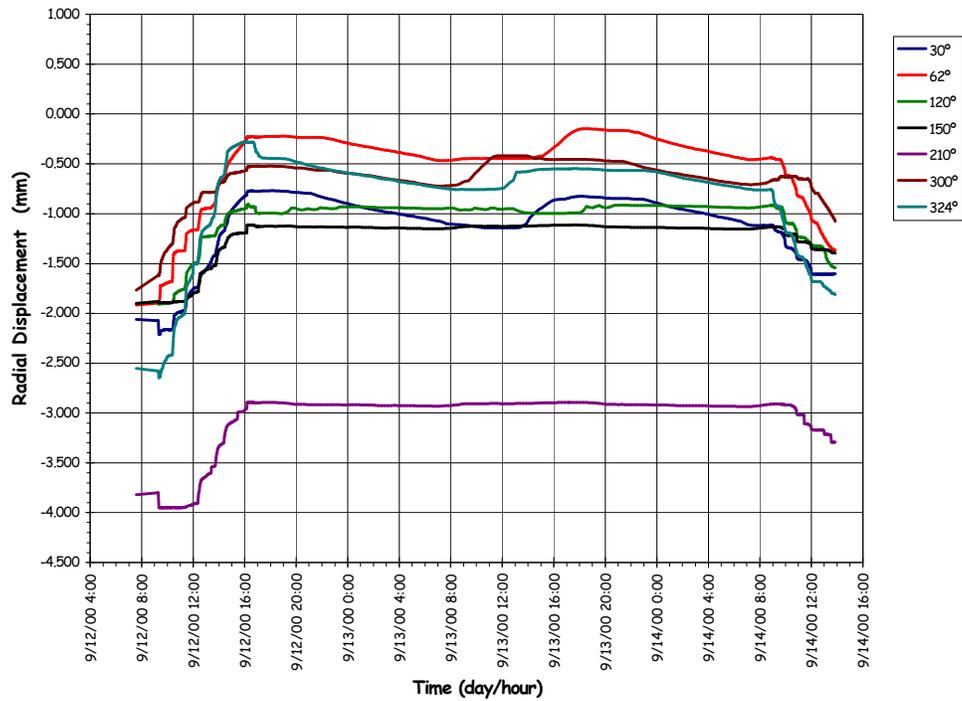
Figure 5.12 SIT/ILRT Radial Displacements at Cylinder Midheight (Elev. 4680)

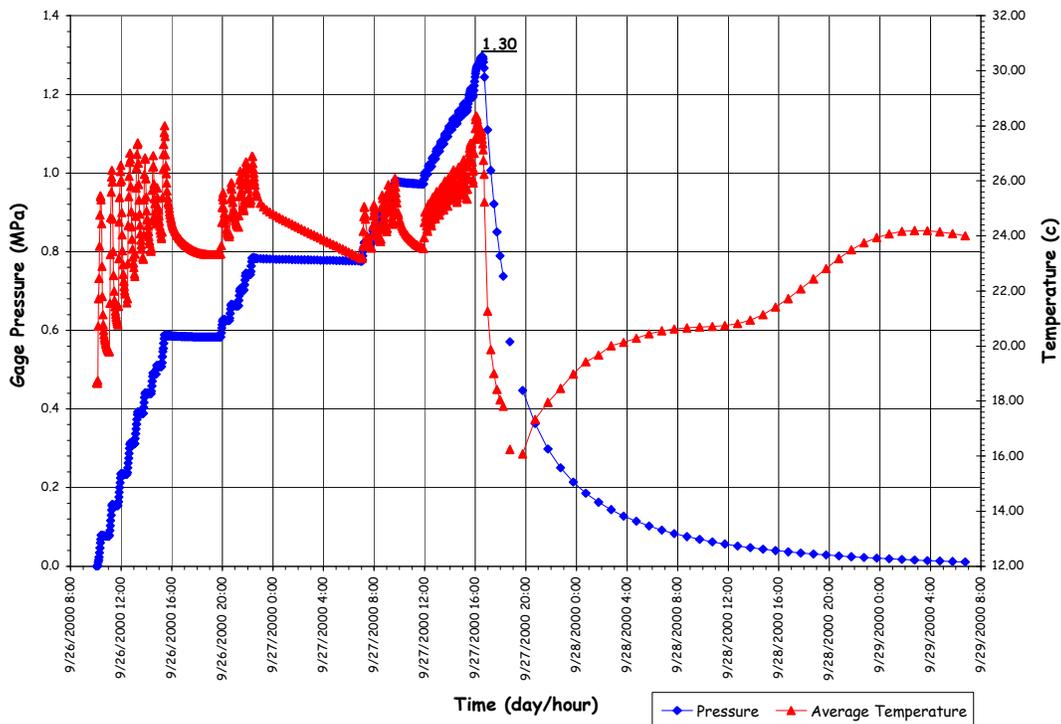
Figure 5.15 Limit State Test Pressure and Average Temperature

The pressure and average temperature time histories during the LST, including depressurization, are plotted in Figure 5.15. The LST followed the planned pressurization sequence up to the point where the model began leaking.

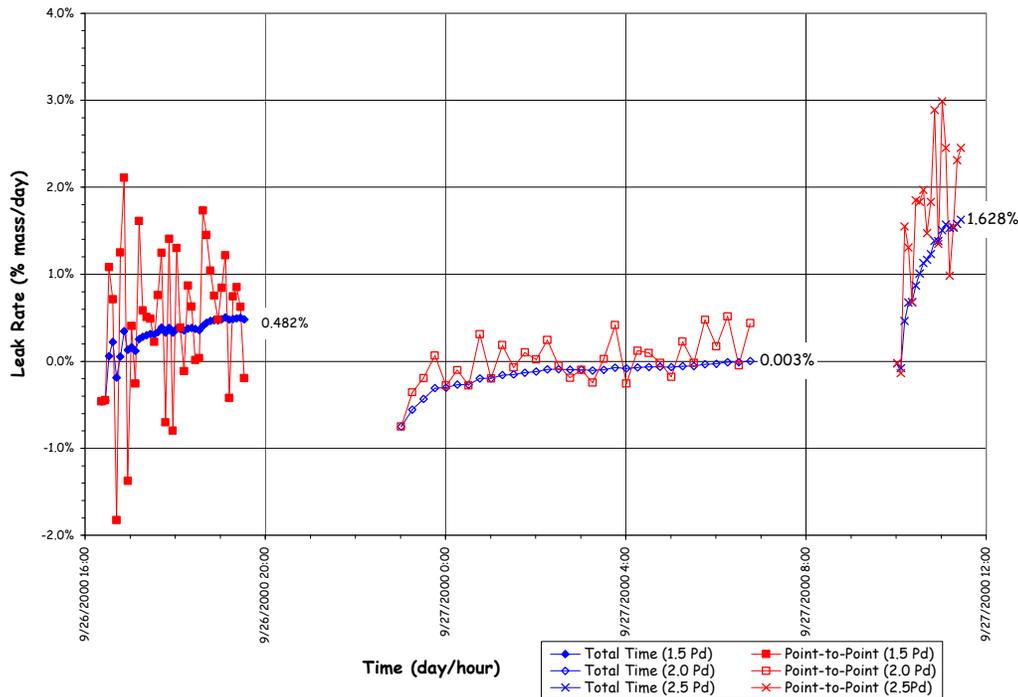
Figure 5.16 LST Calculated Leak Rates at 1.5, 2.0 and $2.5 P_d$

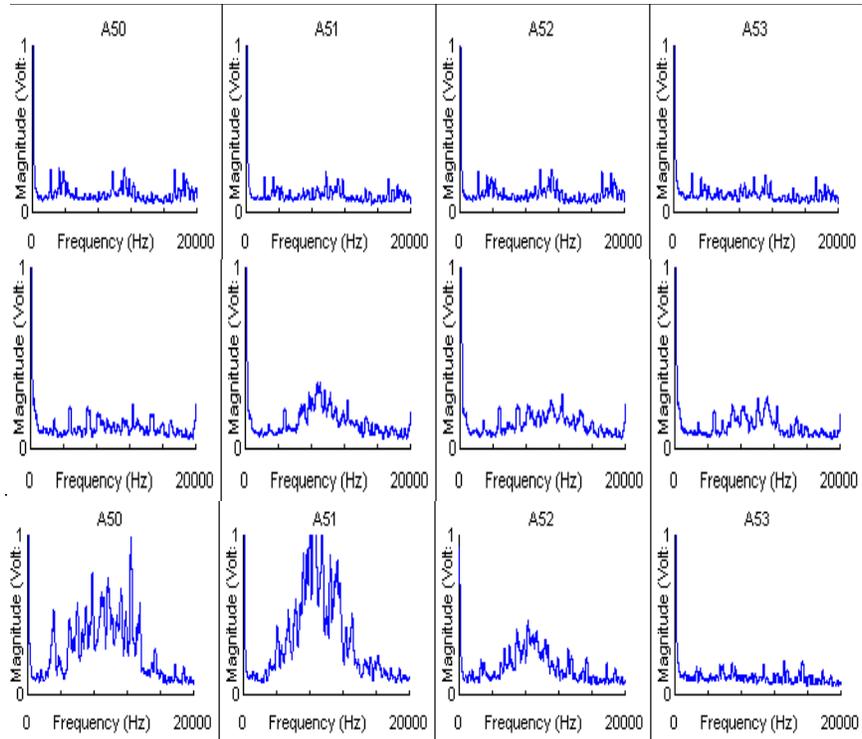
Figure 5.17 Internal Acoustic Sensor Signals at the E/H

Pressurization of the model resumed at 7:00 AM in increments of $0.1P_d$, with increasing dwell time between pressure steps (~30 minutes) required to meet the gage stability criteria. As the pressure was increased to the next planned leak check at $2.5P_d$, liner strain gages in the vicinity of the E/H (LSI-C-K5-12) began registering rapidly increasing strains in excess of 1%. At $2.4P_d$, the acoustic system operator (AO) reported hearing a change in the acoustic output which might indicate that “something had happened.” At approximately 10:00 AM at a pressure of $2.5P_d$ ($10.0 \text{ kg}_f/\text{cm}^2$ or 142.2 psig), the model was isolated for the third planned leak check. After approximately 1-1/2 hours, a fairly stable leak rate of 1.628% mass per day was calculated. The leak rate calculations at 1.5, 2.0, and $2.5P_d$ are plotted in Figure 5.16. Coupled with the acoustic data that continued to confirm some new event had occurred, it became clear that the model was leaking, most likely from a tear in the liner in the vicinity of the E/H. Plots of the output of the four internal acoustic sensors surrounding the E/H at 2.3, 2.4, and $2.5 P_d$ are shown in Figure 5.17.

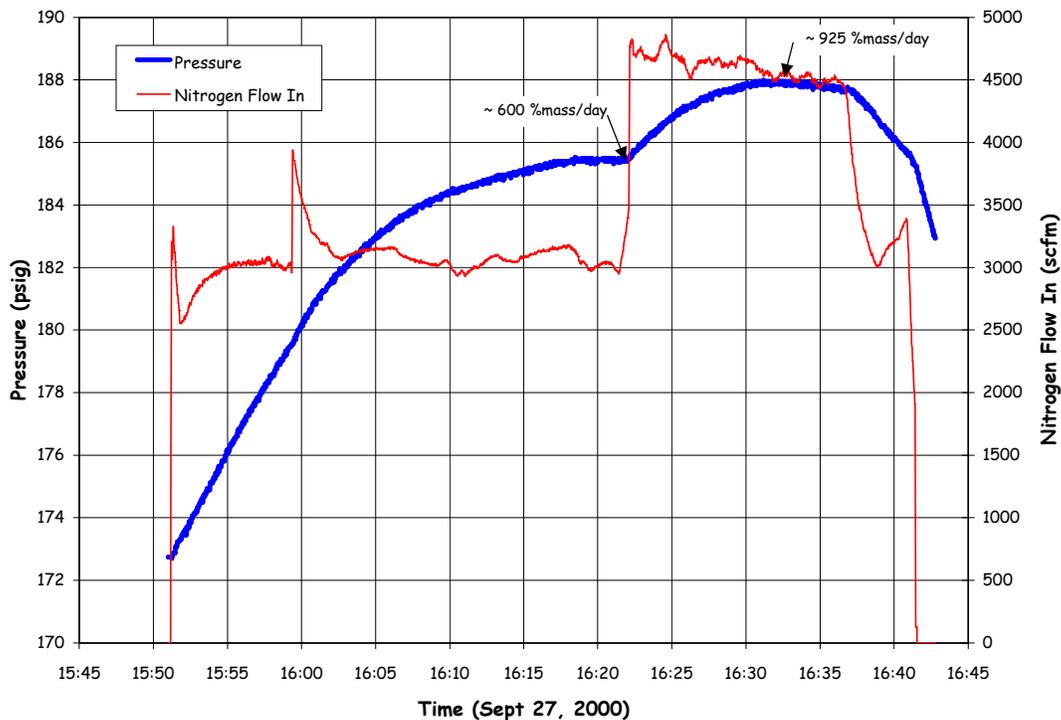
Figure 5.19 LST Pressure and Flow Rates at Maximum Pressure

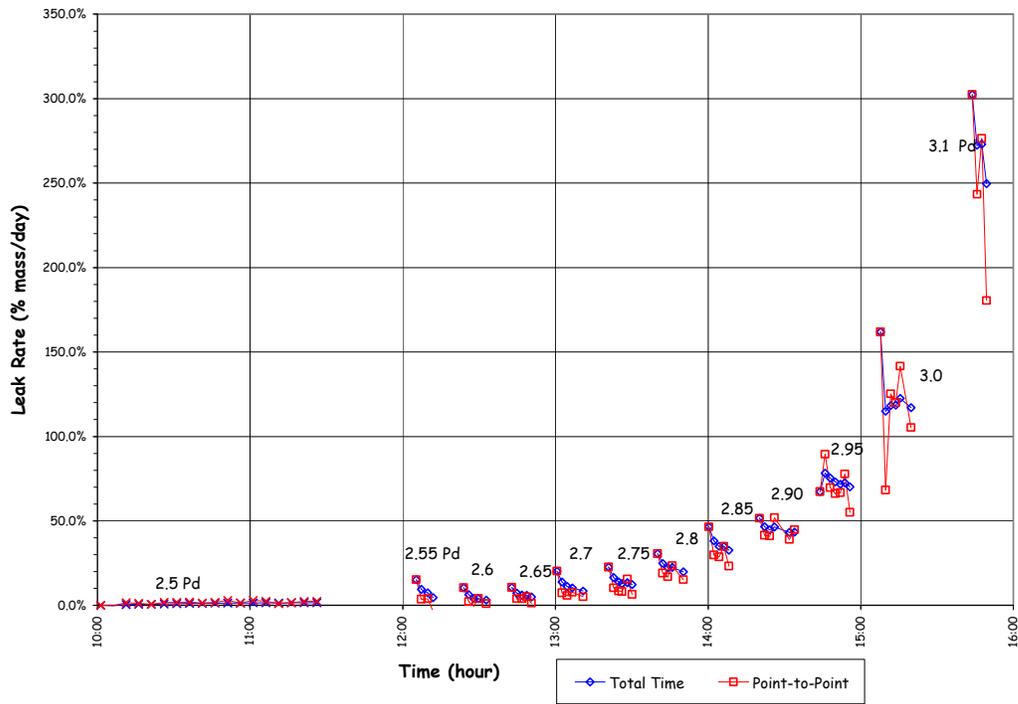
Figure 5-20. LST - Estimated Leak Rates (2.5-3.1 P_d)

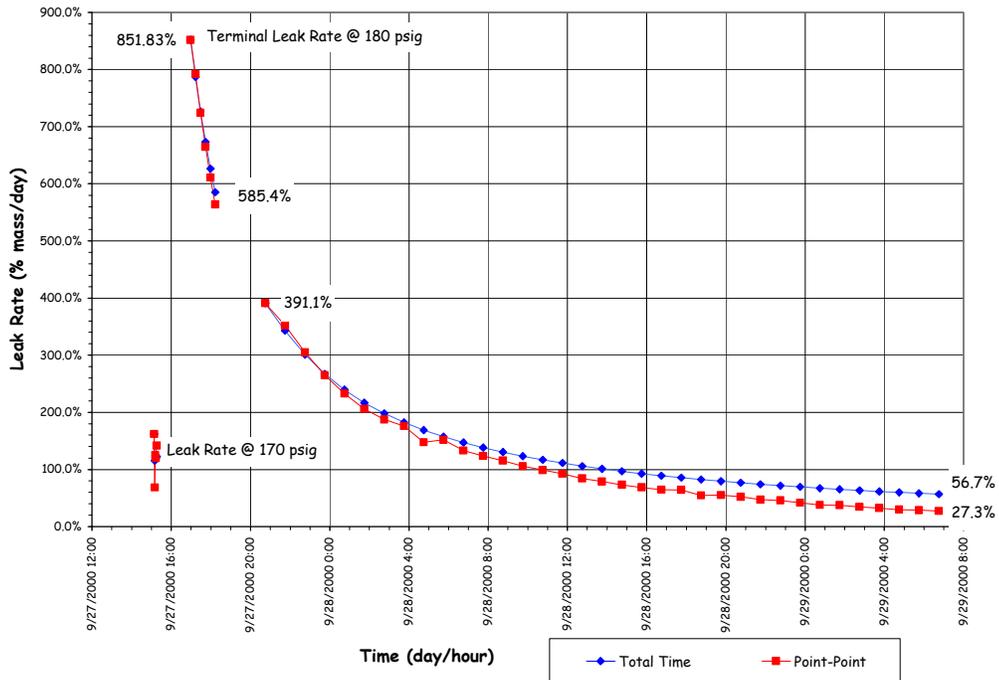
Figure 5.21 LST Estimated Terminal Leak Rates

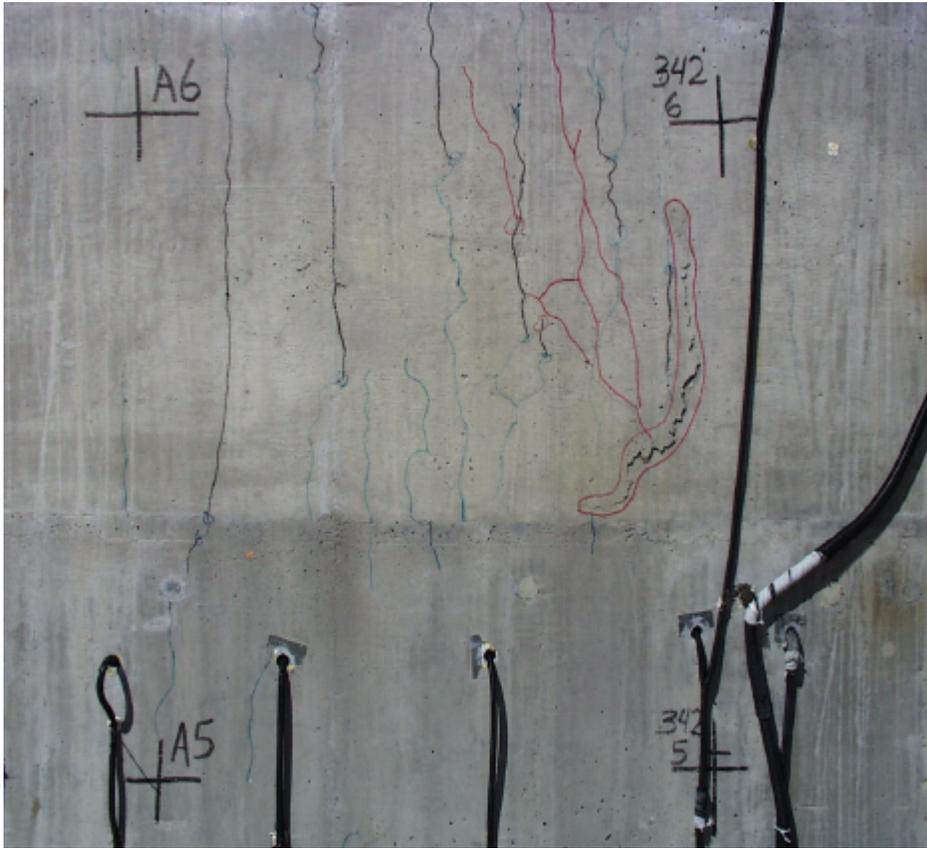
Figure 5.22 Post-LST Cracks at Azimuth 350 degrees, Elev. 4680 to 6200 (Grid 45)

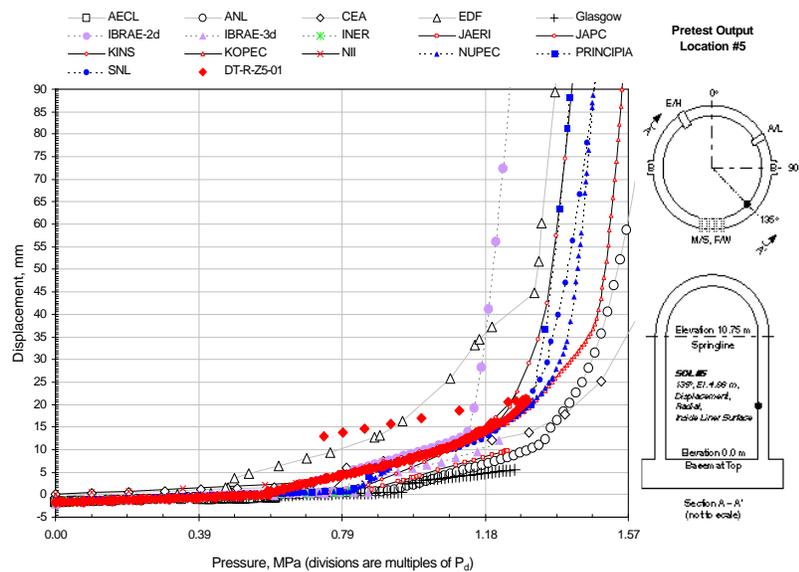
Figure 5.23 LST Radial Displacement at Azimuth 135 degrees, Elev. 4680

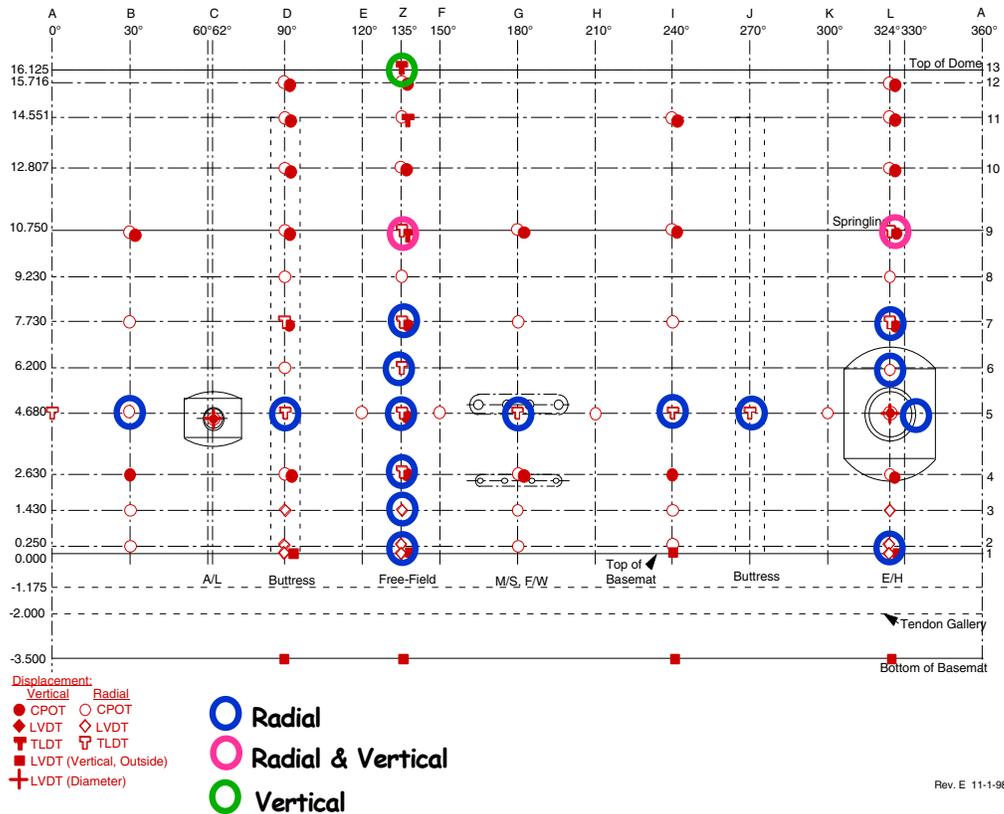
Figure 5.26 SFMT Displacement Transducer Layout
