NUREG/CR-6810
SAND2003-0840P

Overpressurization Test of a 1:4-Scale Prestressed Concrete Containment Vessel Model

Sandia National Laboratories

**U.S. Nuclear Regulatory Commission
Office of Nuclear Regulatory Research
Washington, DC 20555-0001**

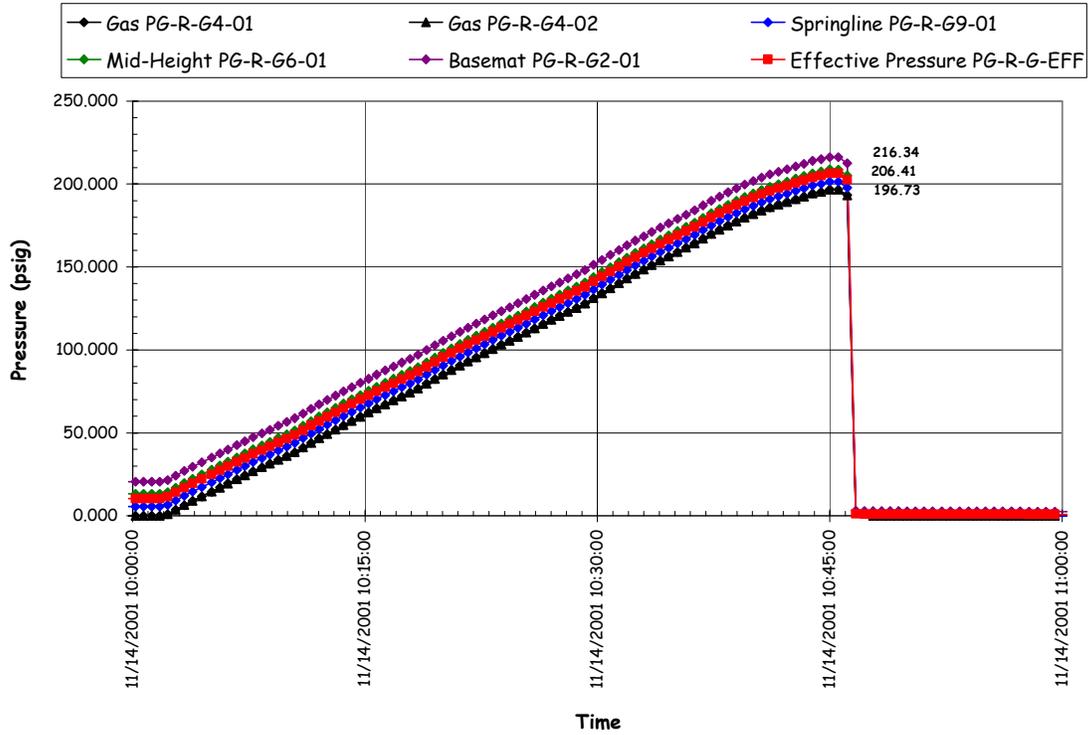
Figure 5.31 SFMT Pressure Time Histories

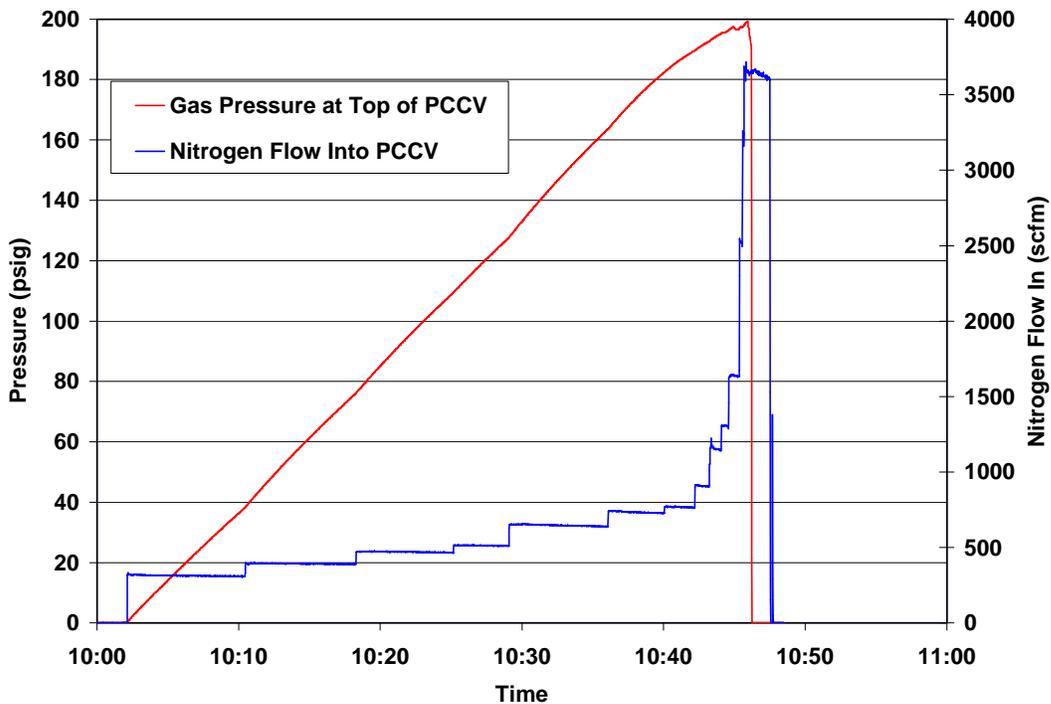
Figure 5.33 SFMT Pressurization System Data

The rate of pressurization decreased and the nitrogen flow rate was increased to maintain the pressurization rate. The gas pressure and flow rates are shown in Figure 5.33. The water surface inside the model, viewed through the internal video camera, was dropping slowly, but it was unclear if this was due to leakage or radial expansion of the vessel.

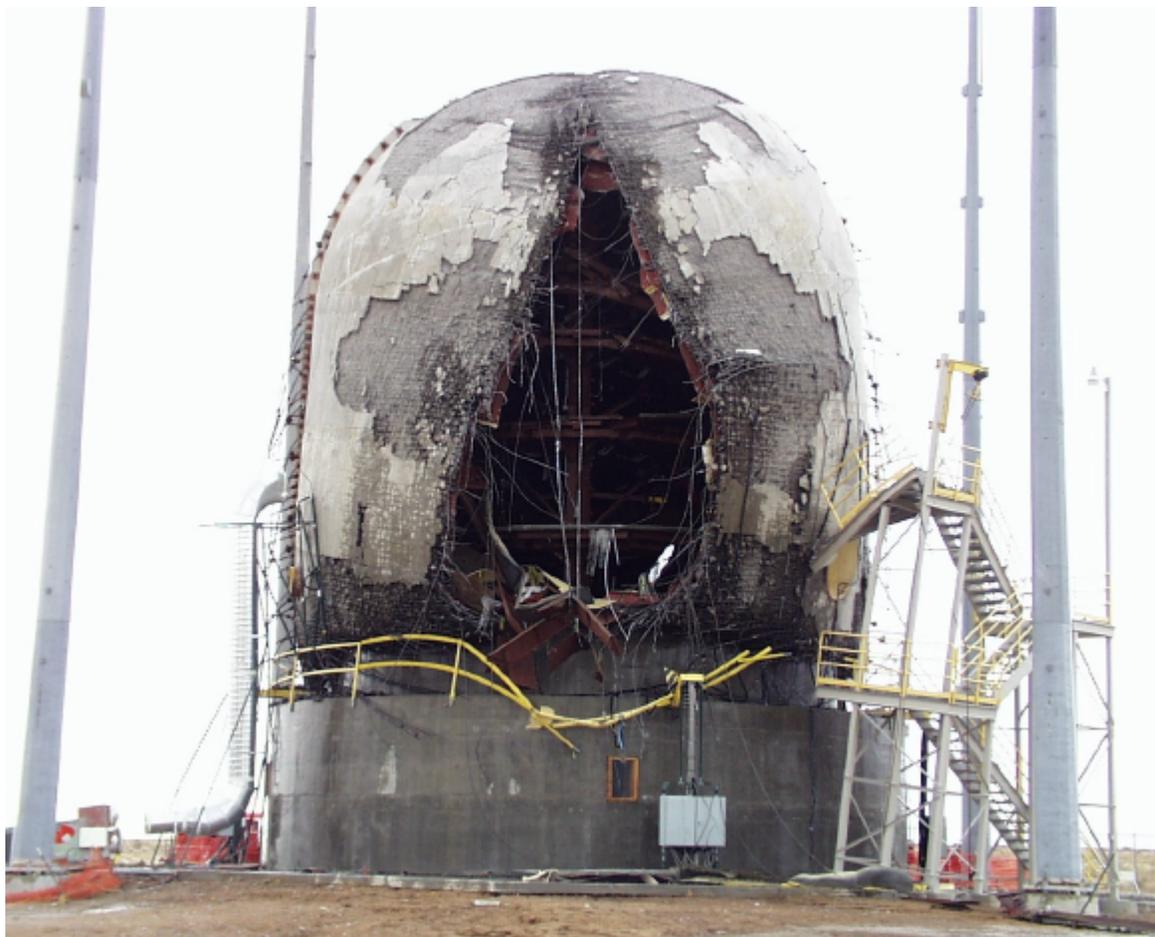
Figure 5.35 PCCV Model after the SFMT

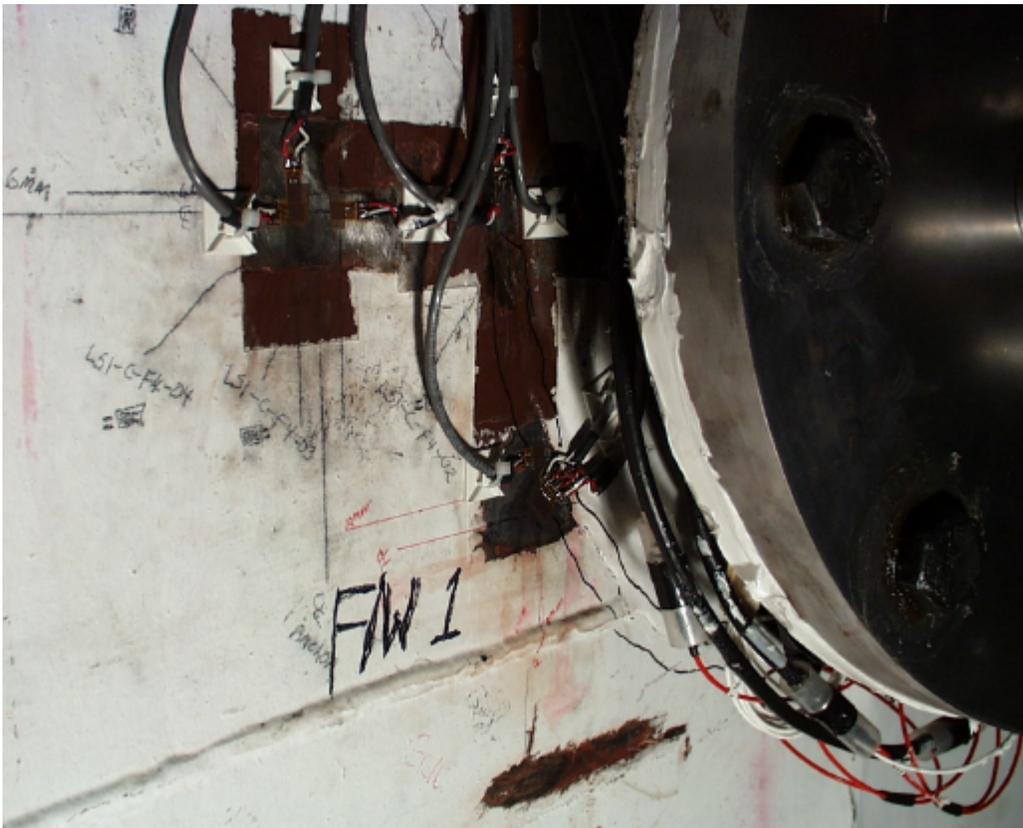
Figure 5.54 Liner Tear (#3) and Strain Gages at F/W Penetration

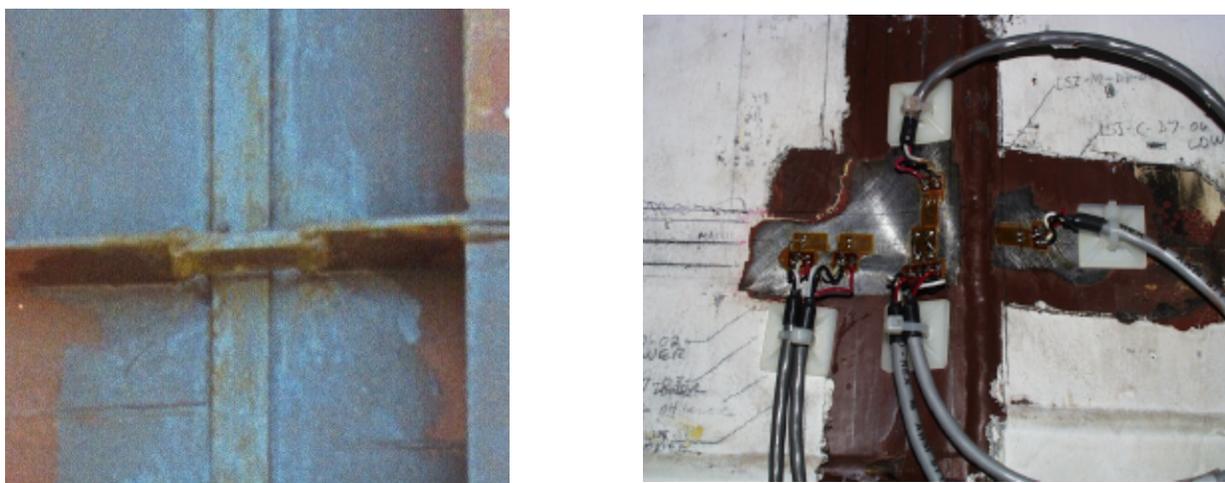
Figure 5.55 Horizontal Stiffener Detail at Vertical Seam Weld (‘Rathole’) near D7

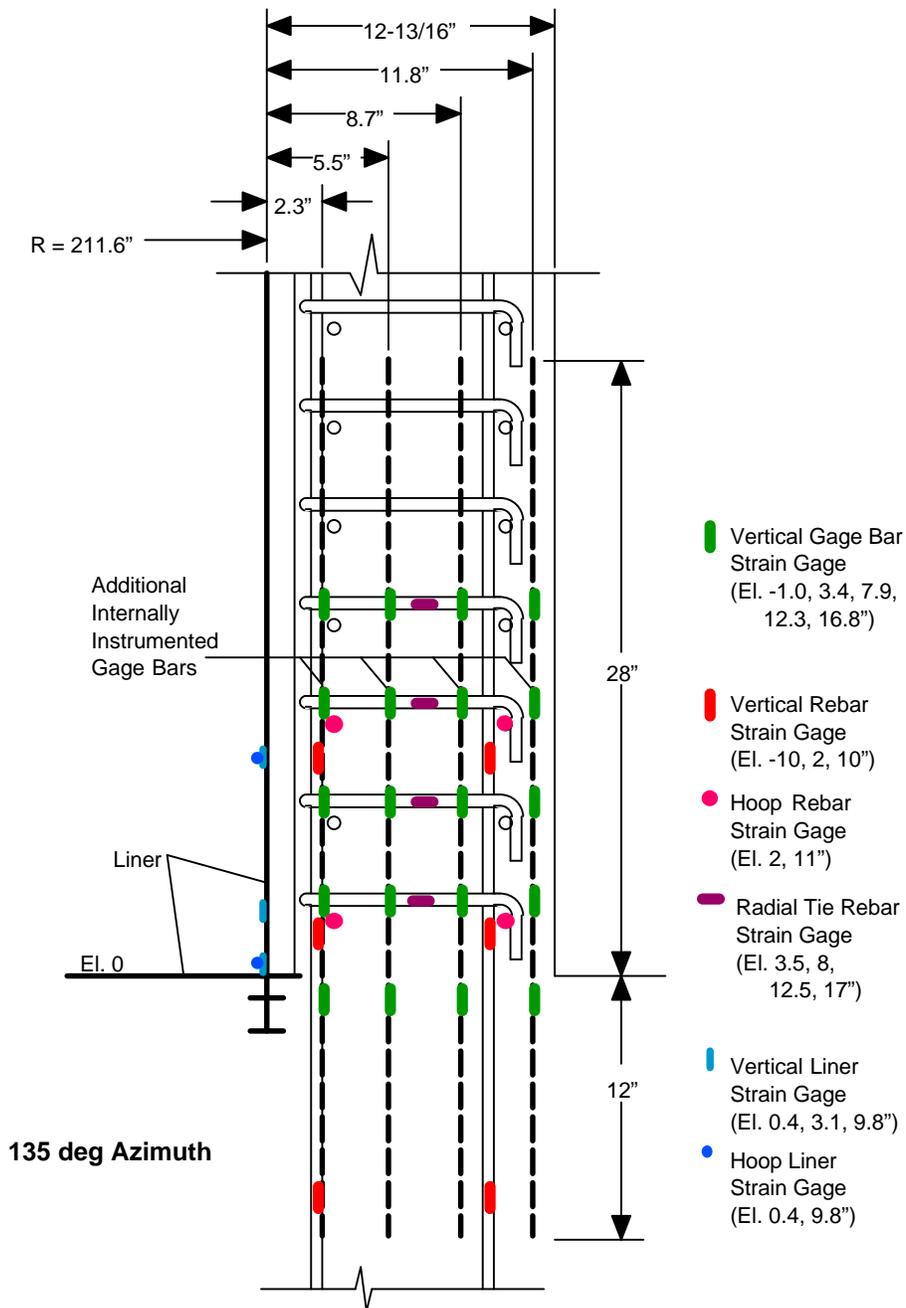
Figure 5.58 Arrangement of Gage Bar Strain Gages at Azimuth 135 degrees

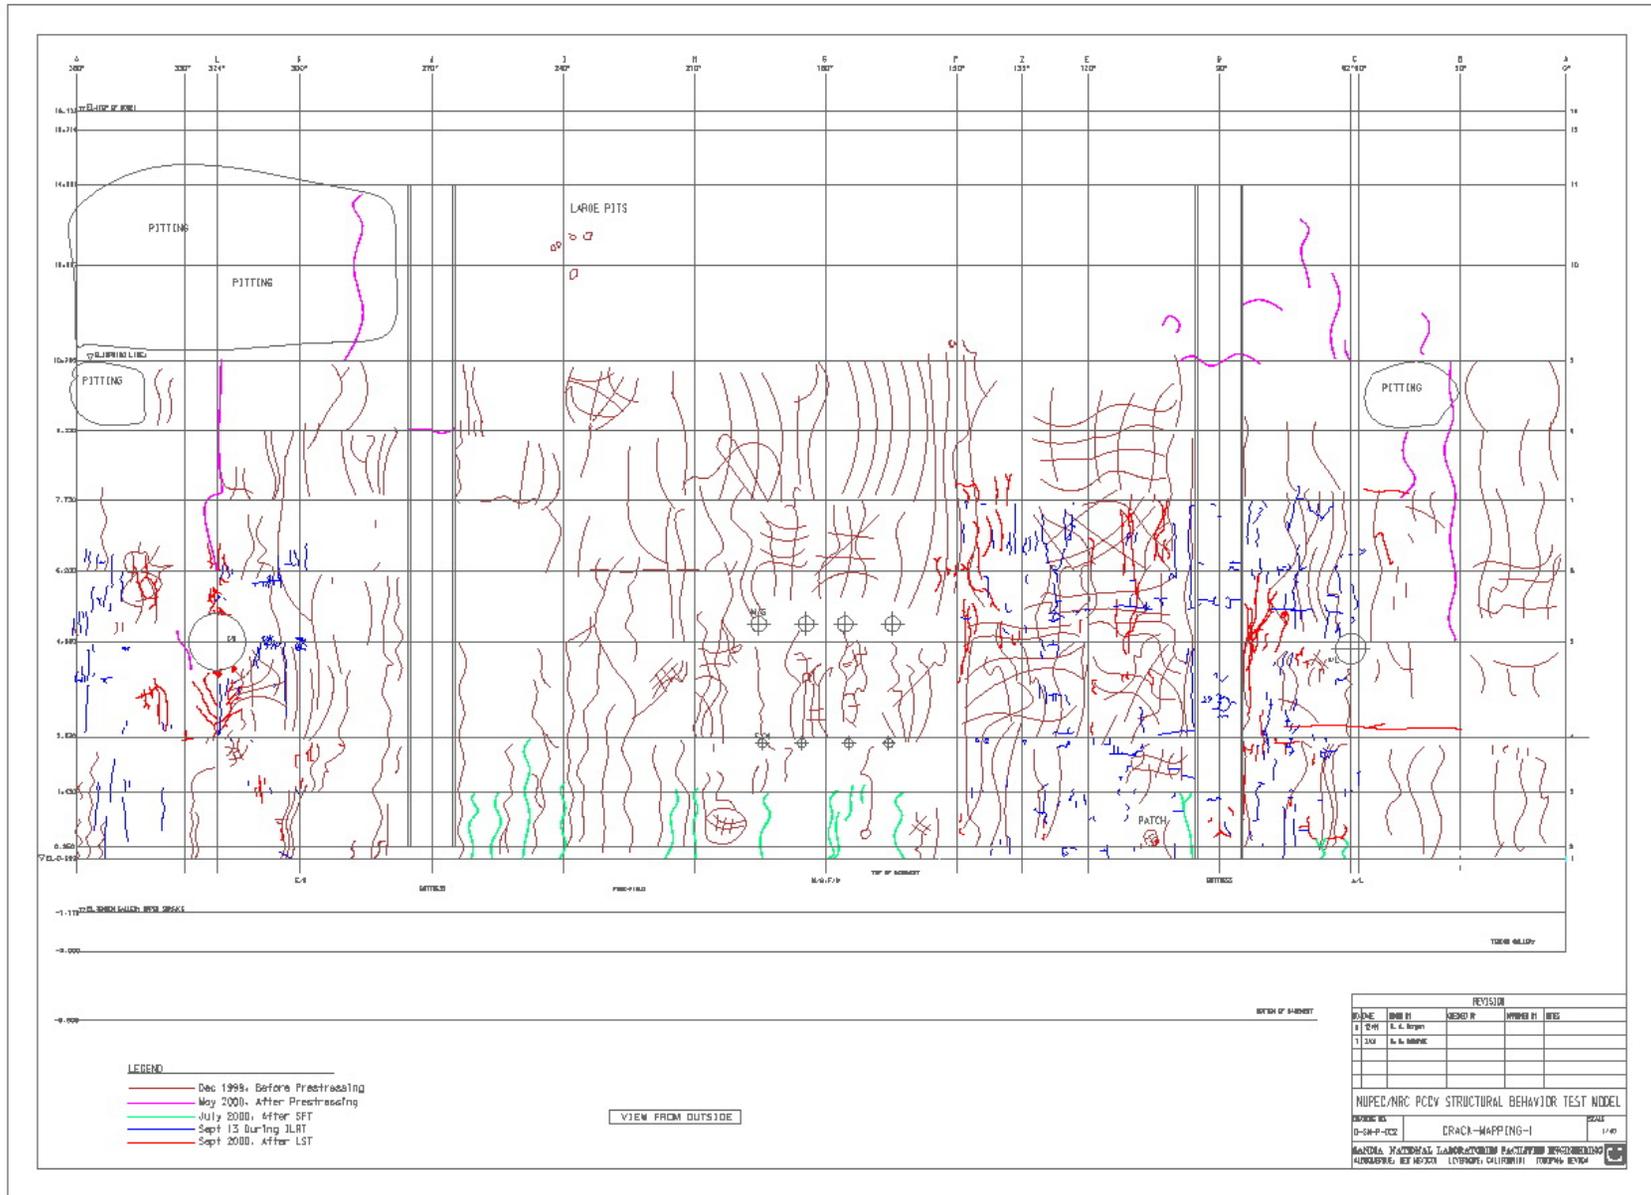
Figure 5.76 Post-LST Concrete Crack Map

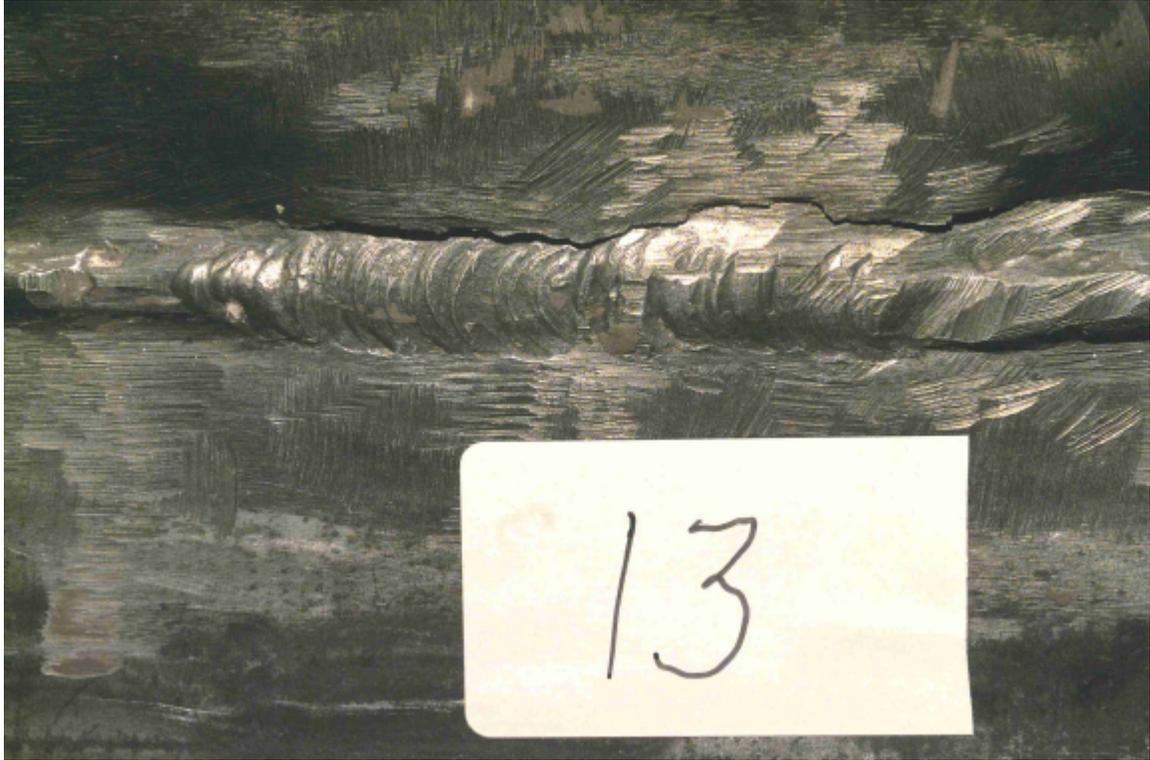
Figure 5.86 Close-Up of Tear #13 after Removal of Paint

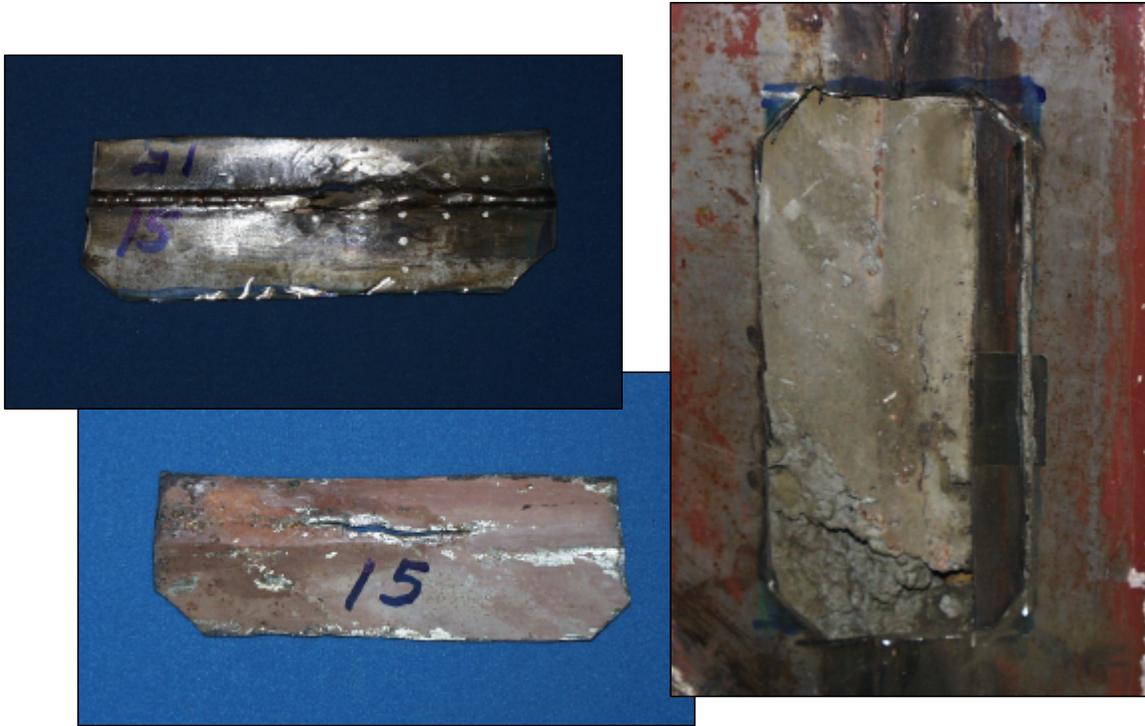
Figure 5.88 Liner Specimen at Tear #15

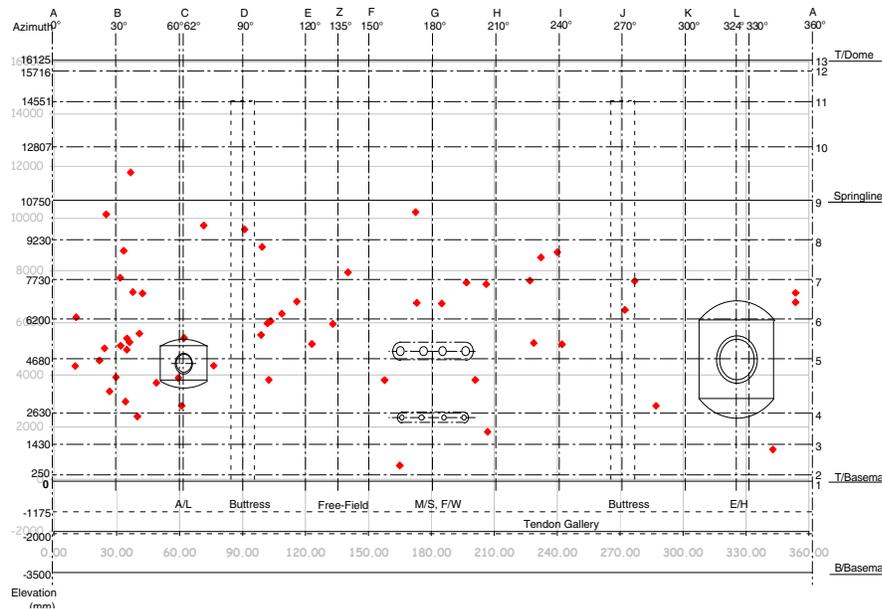
Figure 5.120 SFMT – Wire Break Map

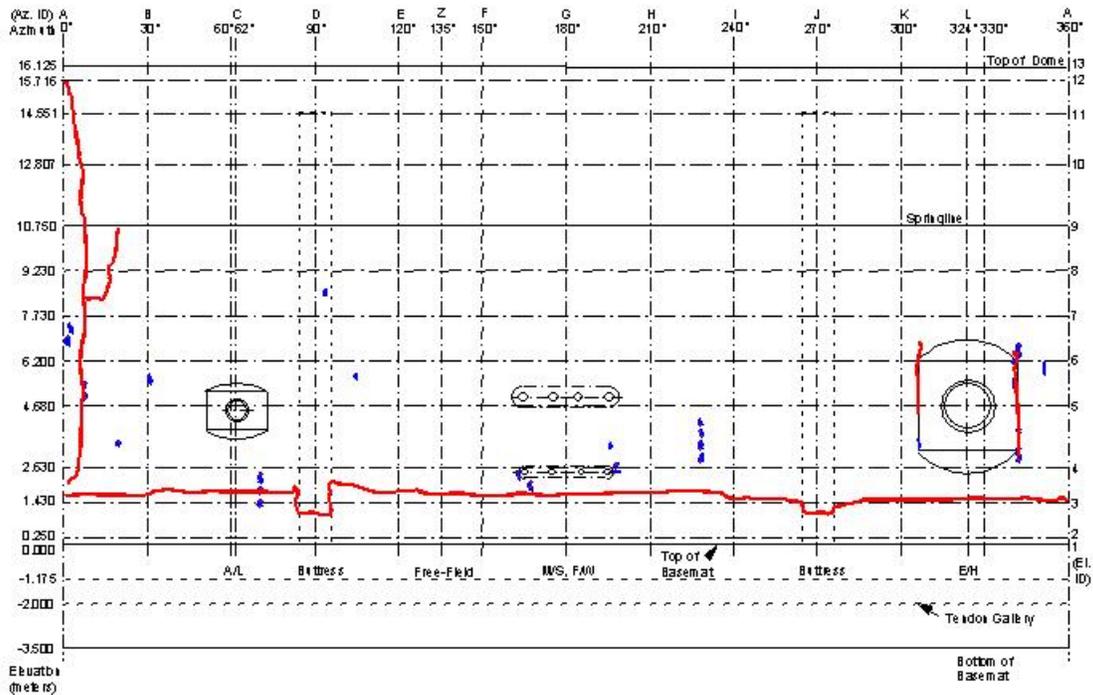
Figure 5.122 SFMT – Rupture Map

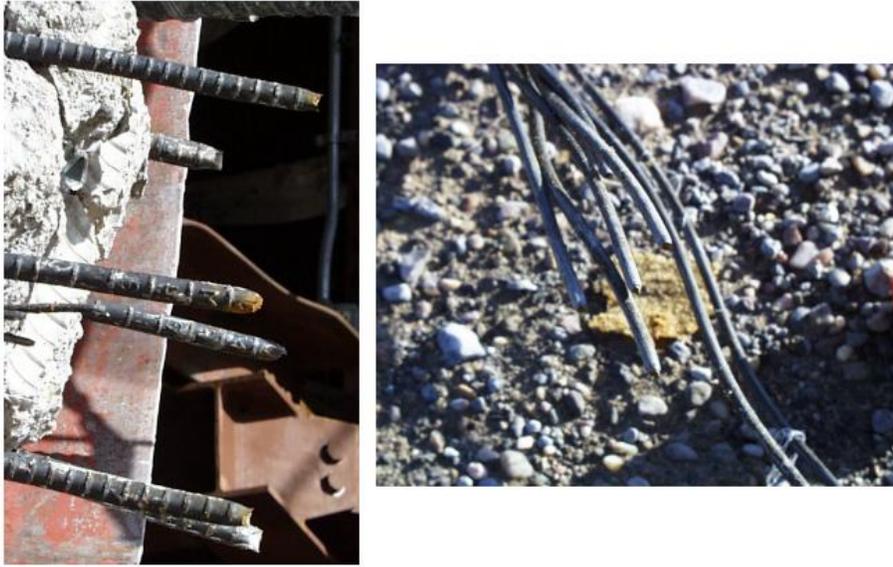
Figure 5.123 SFMT – Rebar and Tendon Strands at the Rupture Line

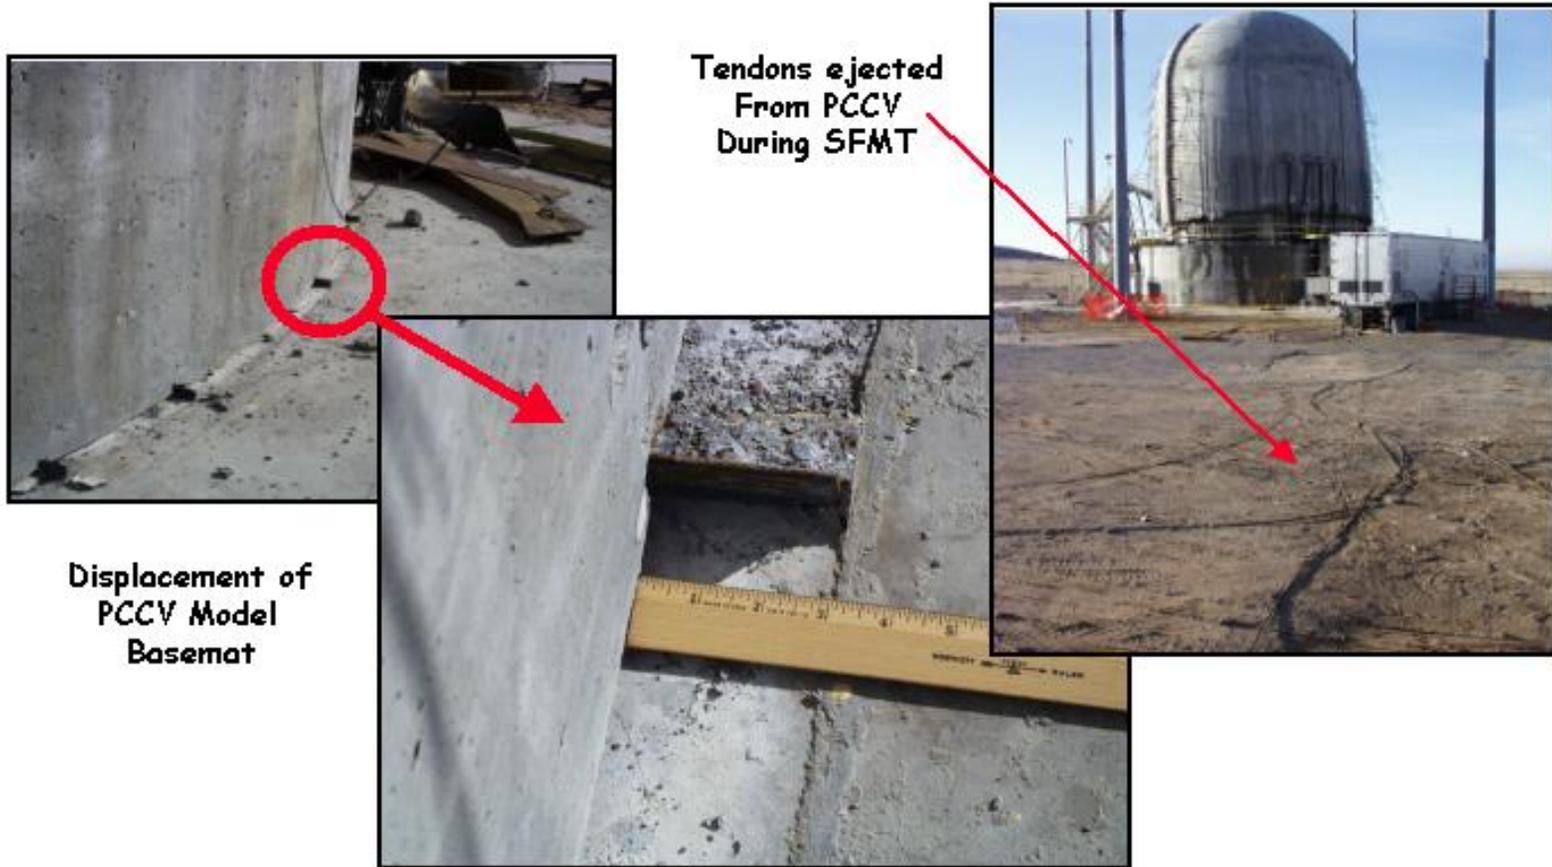
Figure 5.124 SFMT – Model Displacements
