Chemical Waste Landfill Post-Closure Care Permit Renewal

Anita S. Reiser
Sandia National Laboratories

Chemical Waste Landfill (CWL) at Sandia National Laboratories

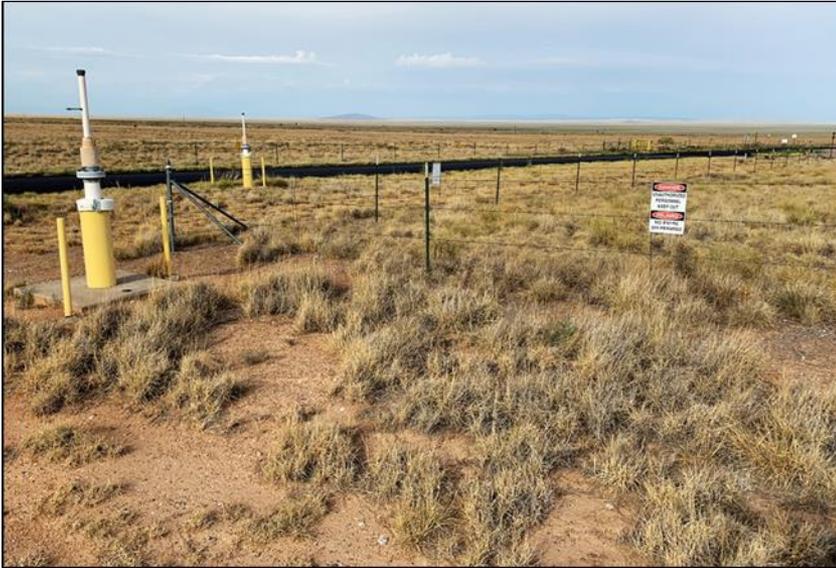
Above on left:

- 2 soil vapor monitoring wells at southeast corner of CWL
- Each well has protective casing (yellow) with passive venting device (white) and posts (yellow) to protect from vehicle damage
- Barrier fence with warning sign
- Cover vegetation (beyond fence) is alive but not green due to lack of summer rains

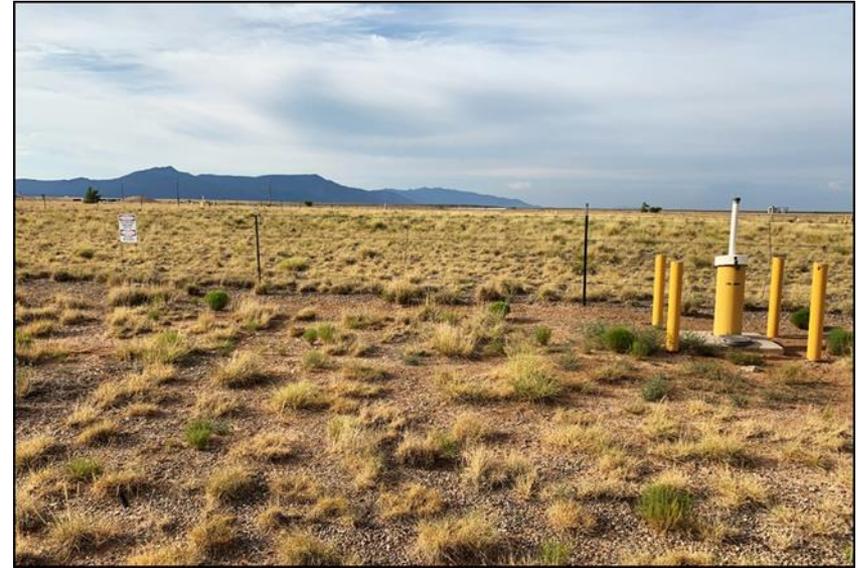
Above on right:

- Groundwater monitoring well on north side of CWL
- Each well has protective casing (yellow) with passive venting device (white) and posts (yellow) to protect from vehicle damage
- Barrier fence with warning sign
- Cover vegetation (beyond fence) is alive but not green due to lack of summer rains
