# Thermal Runaway Thresholds at Cell Level Affected by Chemistry, Capacity and State-of-charge

- Hsin Wang, Lianshan Lin and Mali Balasubramanian
- *Oak Ridge National Laboratory*

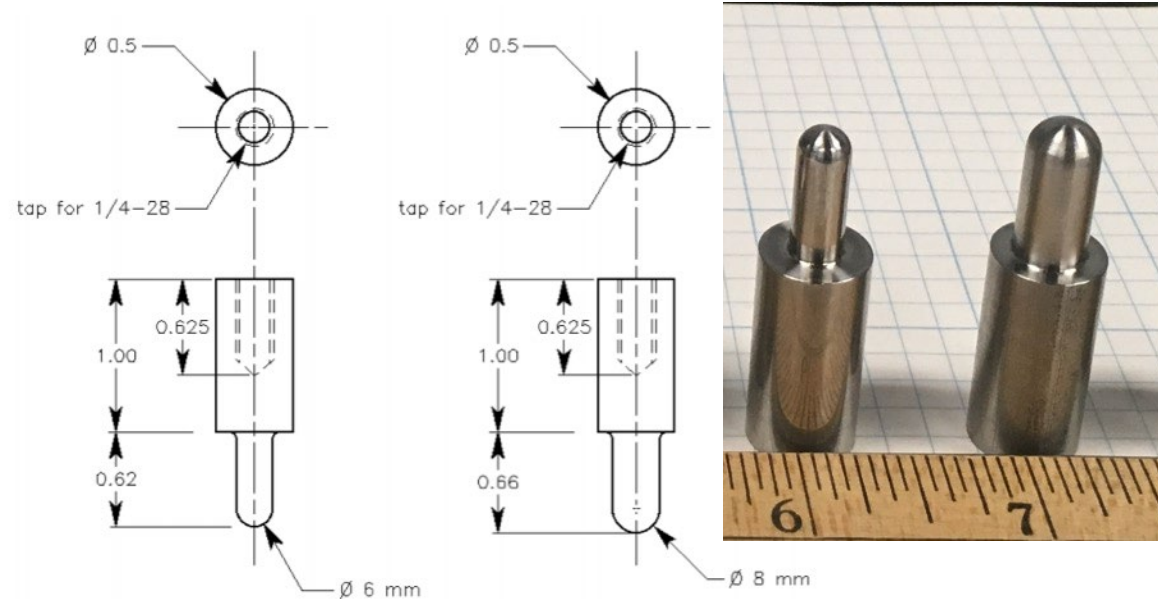
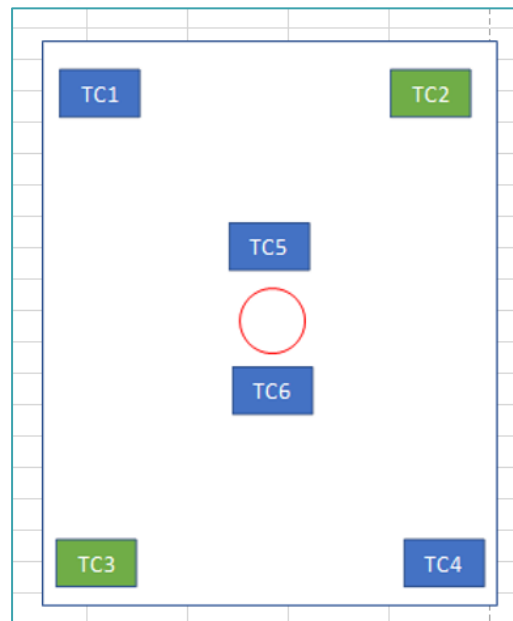
- Cycle cell 3-5 times at C/2 between 3.0-4.2V to determine SOC and discharge to test SOC
- Hydraulic or servo-motor driven load frame
- 6 mm punch (most sensitive, small contact)
- 0.05 inch per minute compressive loading
- 25 mV  $V_{oc}$  drop
- Hold the punch after short circuit
- Temperature measurement:
  - 5 mm from the indenter
  - At cell corners when possible

Punches for Battery Testing		
ELC-2019.03.001	Scale: 1.5:1	
Dimensions: inches (unless otherwise specified)	Material: stainless steel	
Make four (4) pieces of each		
Edgar Lara-Curzio	ORNL	March 2019

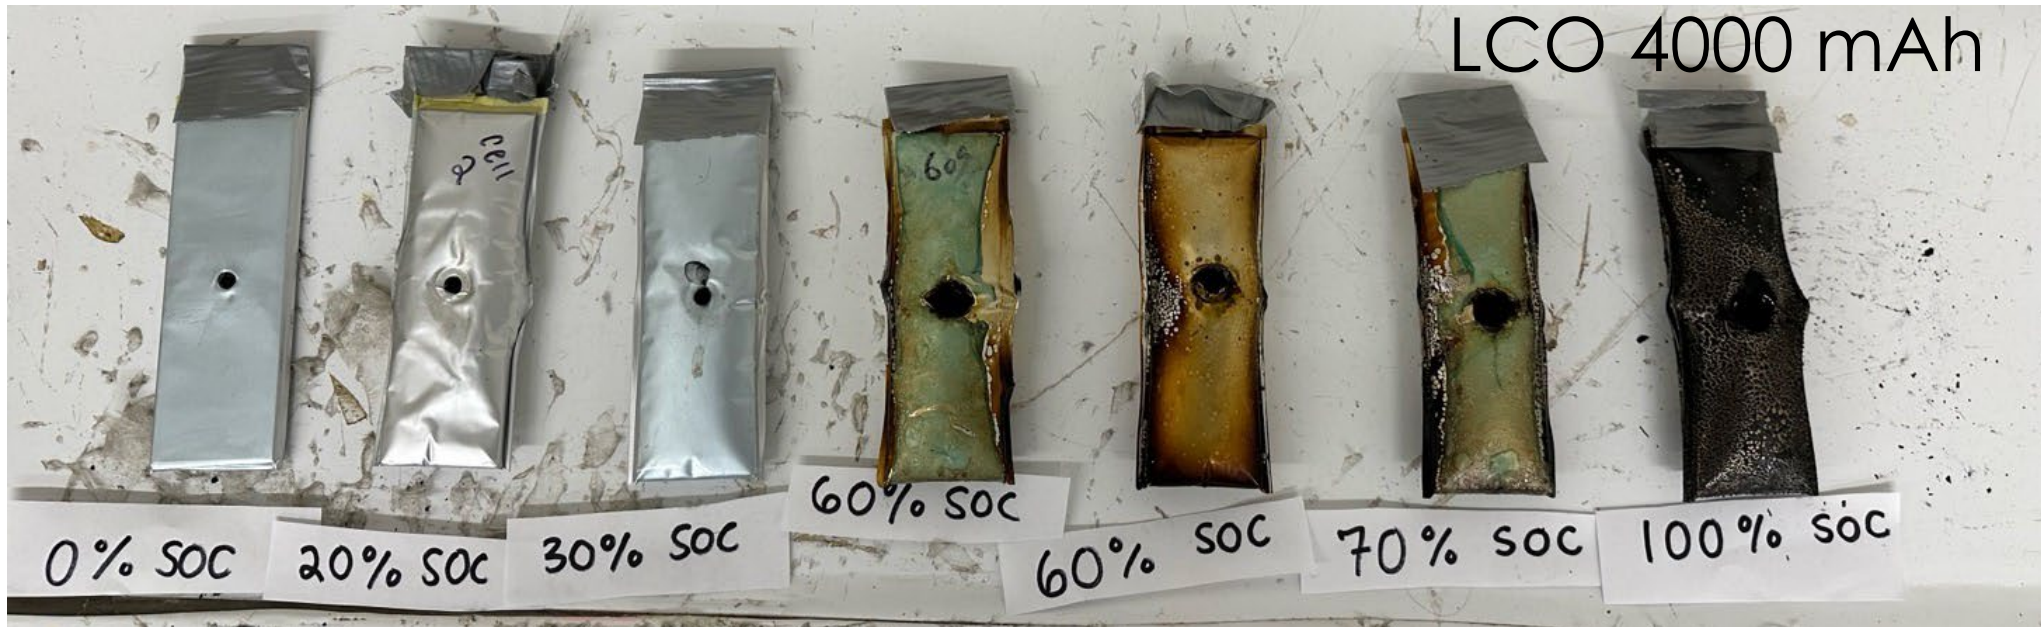
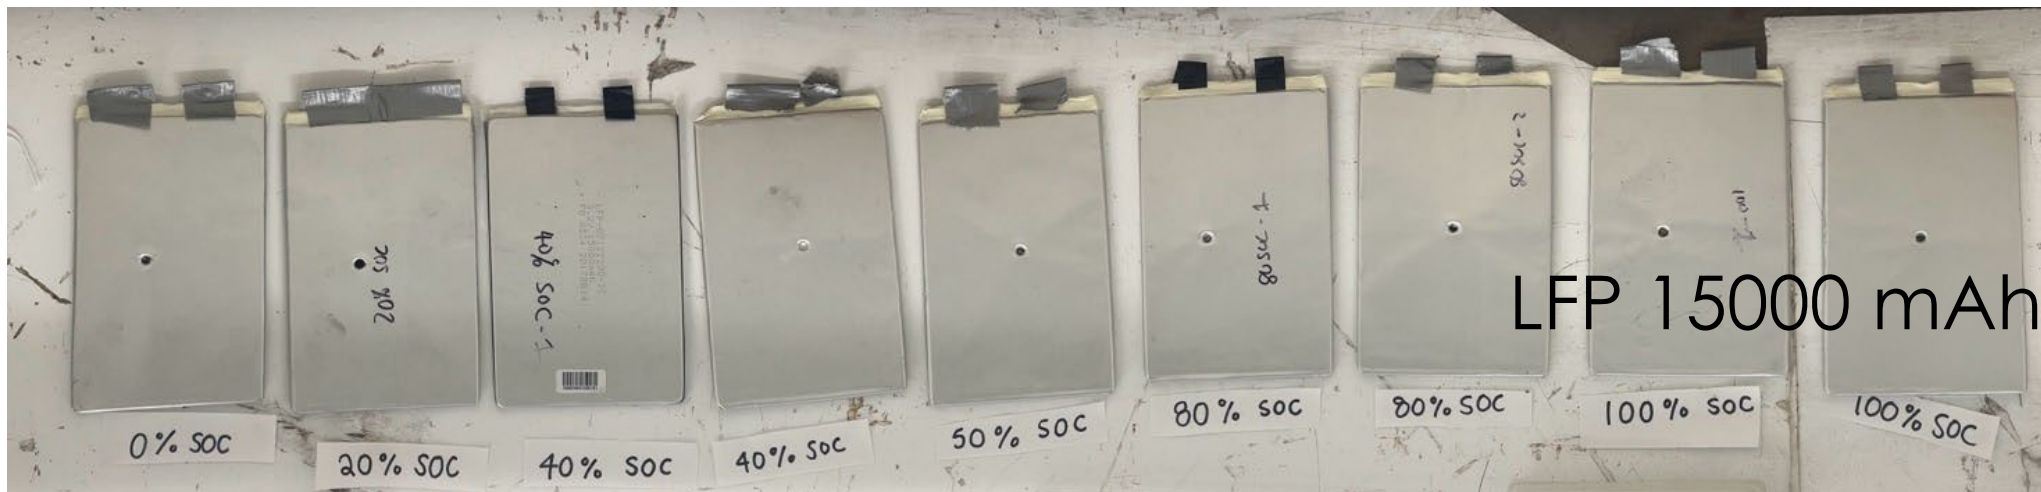
Post Indentation Test

Thermal runaway threshold is related to chemistry, capacity, and SOC

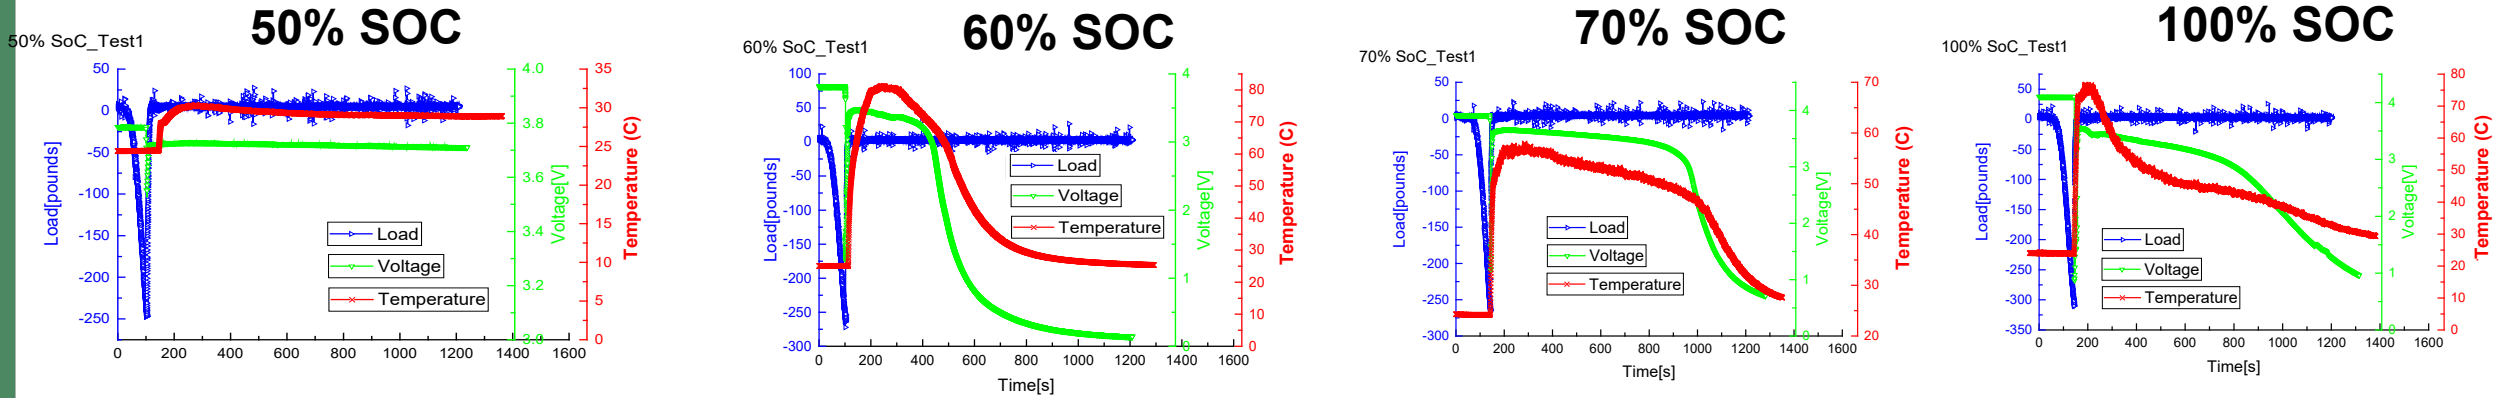
## Characteristic Responses from 500 mAh Li-ion Cells as Function of SOC

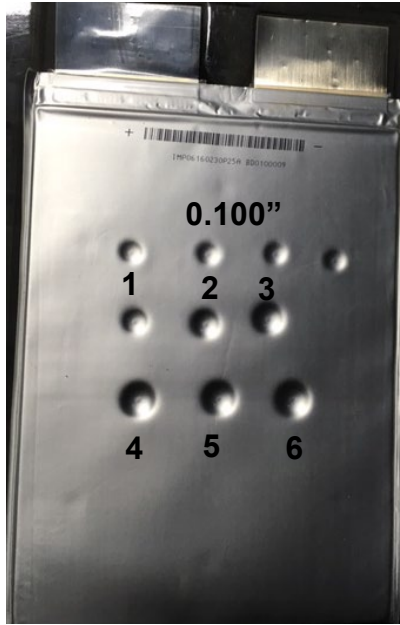
Cell#1: IMP0160230P25A BD100009  
Step 1: 0.100 inch was repeated 4 times!

Test Steps	Displacement(in)	mm	Short
1	0.1	2.54	No
2	0.125	3.175	No
3	0.15	3.81	No
4	0.175	4.445	No
5	0.2	5.08	No
6	0.21	5.334	No

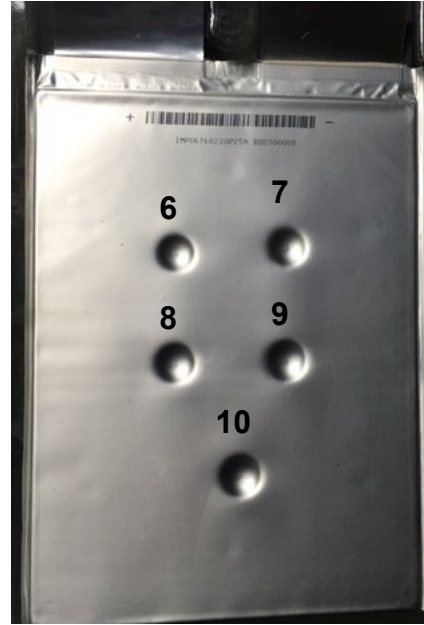
Cell#2: IMP0160230P25A BD100008

Test Steps	Displacement(in)	mm	Short
6	0.21	5.334	No
7	0.22	5.588	No
8	0.23	5.842	No
9	0.24	6.096	No
10	0.245	6.223	No

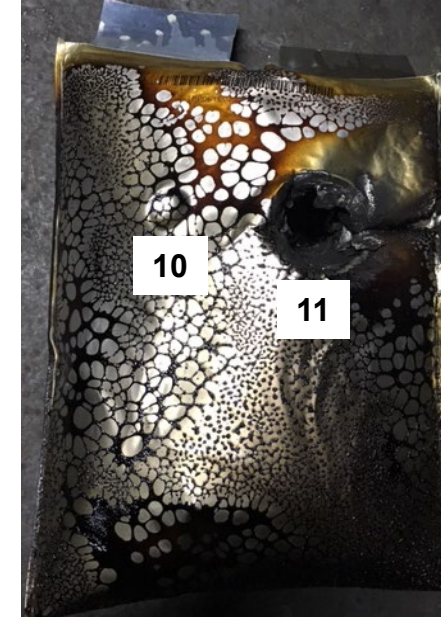
Cell#3: IMP0160230P25A BD100006

Test Steps	Displacement(in)	mm	Short
10	0.245	6.223	No
11	0.250	6.350	Yes

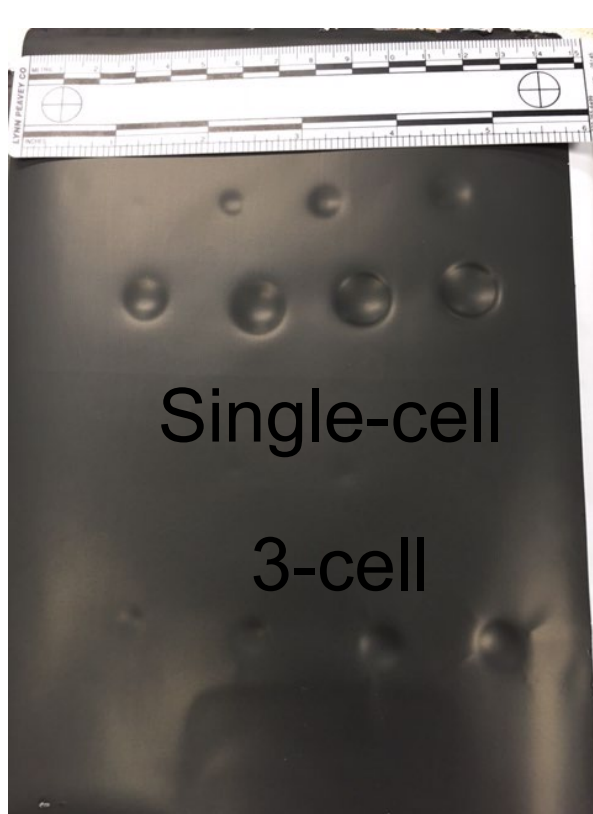
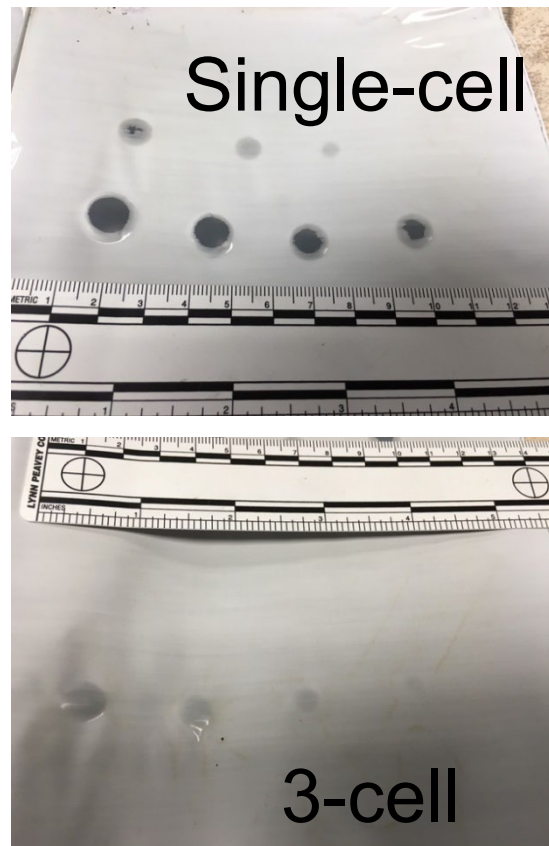
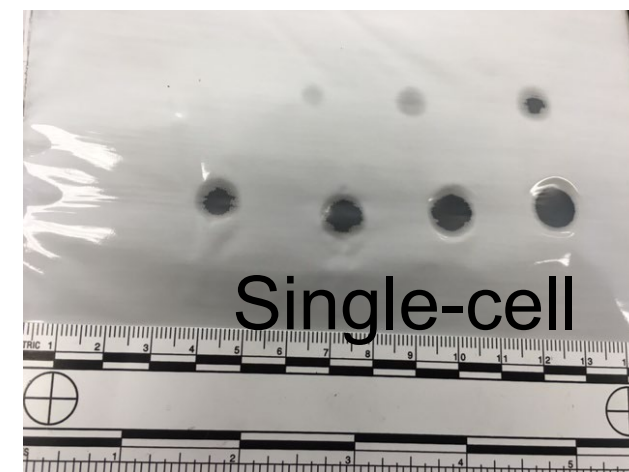
# Post-mortem Pictures of Separators: 0.025" - 0.200"

Eight single cell indentations and eight 3-cell indentations

- >80% deformation under compression with no short circuit (1" diameter ball)
- 1/3 of deformation in 3-cell stack (large impact absorption capacity in pouch cell)

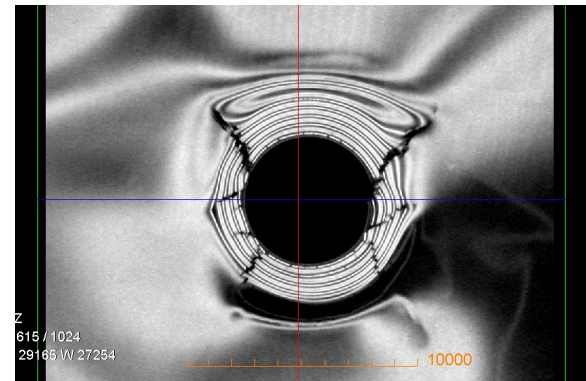
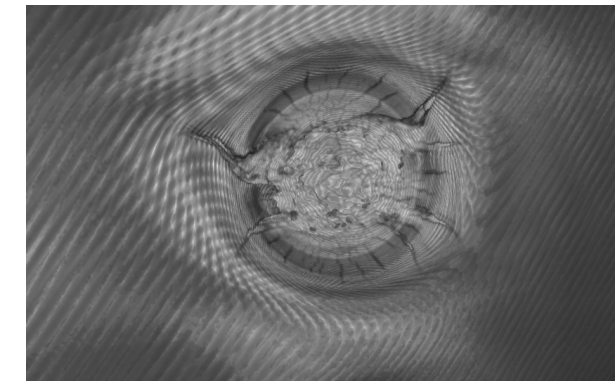
Short Circuit Induced on a Chevy Volt Cell Discharged to 2.80 V

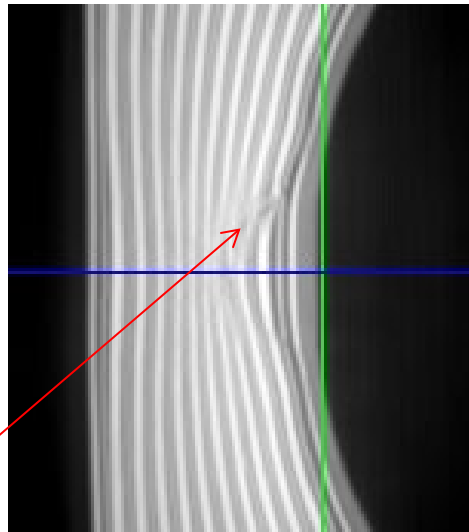
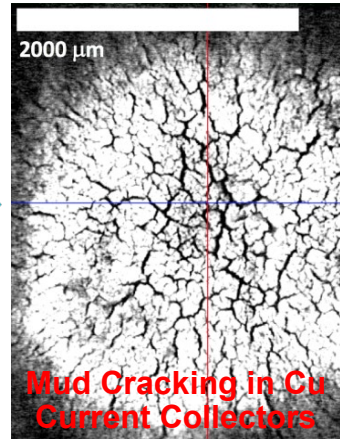
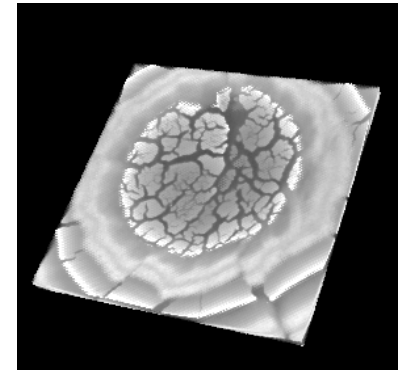
1/2 inch Indenter

Through Layer Failure

Copper fragmentation

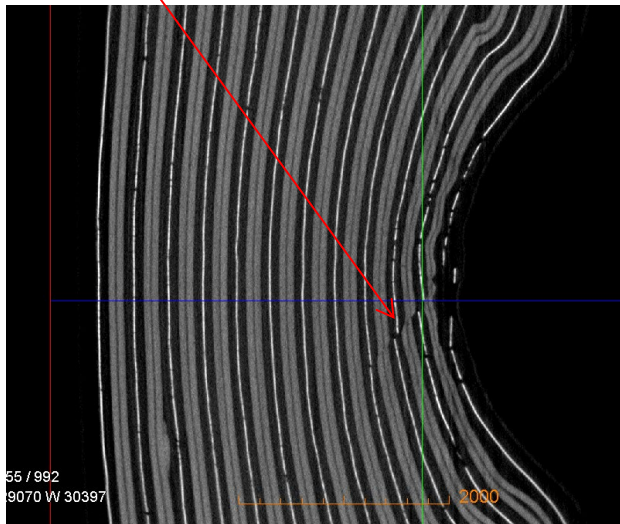
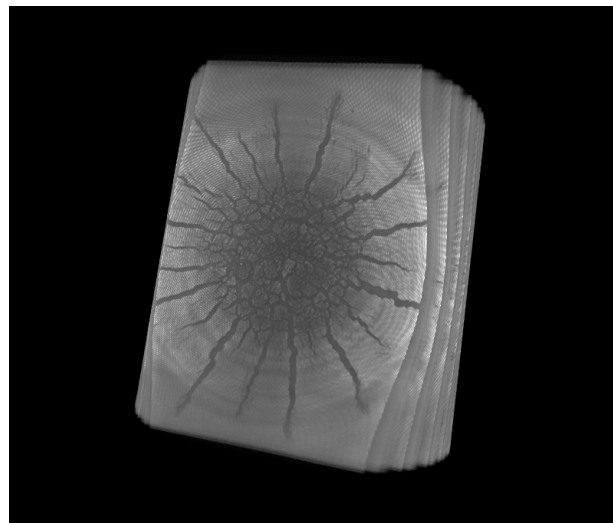
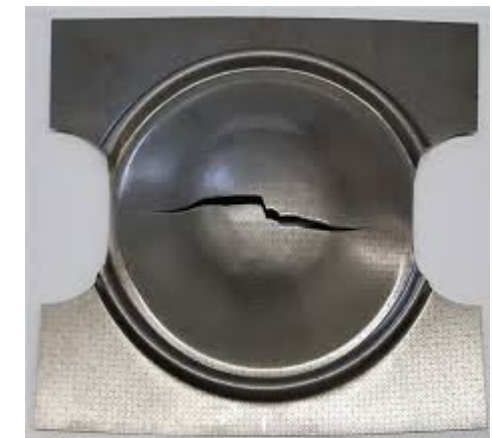
1/4 inch Indenter

- Separator Failure
- Anode Failure
- Cathode Failure
