Fire Testing a Lithium Ion Battery Energy Storage System

Presented by:
Andrew Blum, P.E., CFEI, CVFI
Senior Fire Protection Engineer
Fisher Engineering, Inc.

- Project History
- Energy Storage System Fire Tests
 - External Fire Exposure Test
 - Internal Fault Test
- Summary of Tests
- Acknowledgements

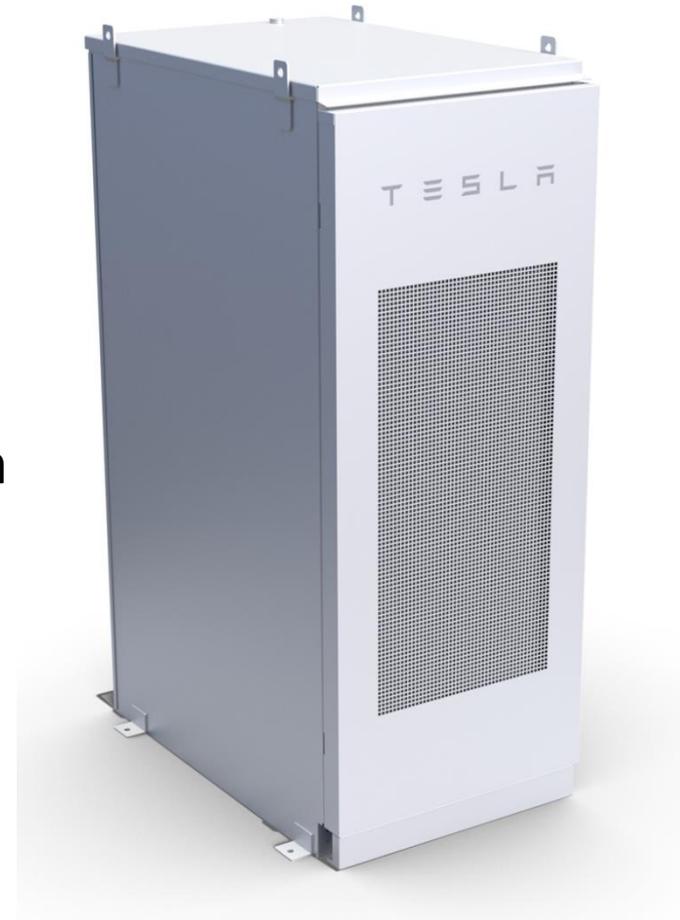
ESS Tested

- Two ESS – Tesla PowerPack
- ESS is a 100 kWh unit designed for commercial installation
- ESS is modular, can be expanded to include multiple 100 kWh units to increase capacity
- Outdoor installations typically placed on a concrete pad
- Can be remote from the building or abutting
