Recommended Practices for the Safe Design and Operation of Flywheels

Donald Bender

Overview

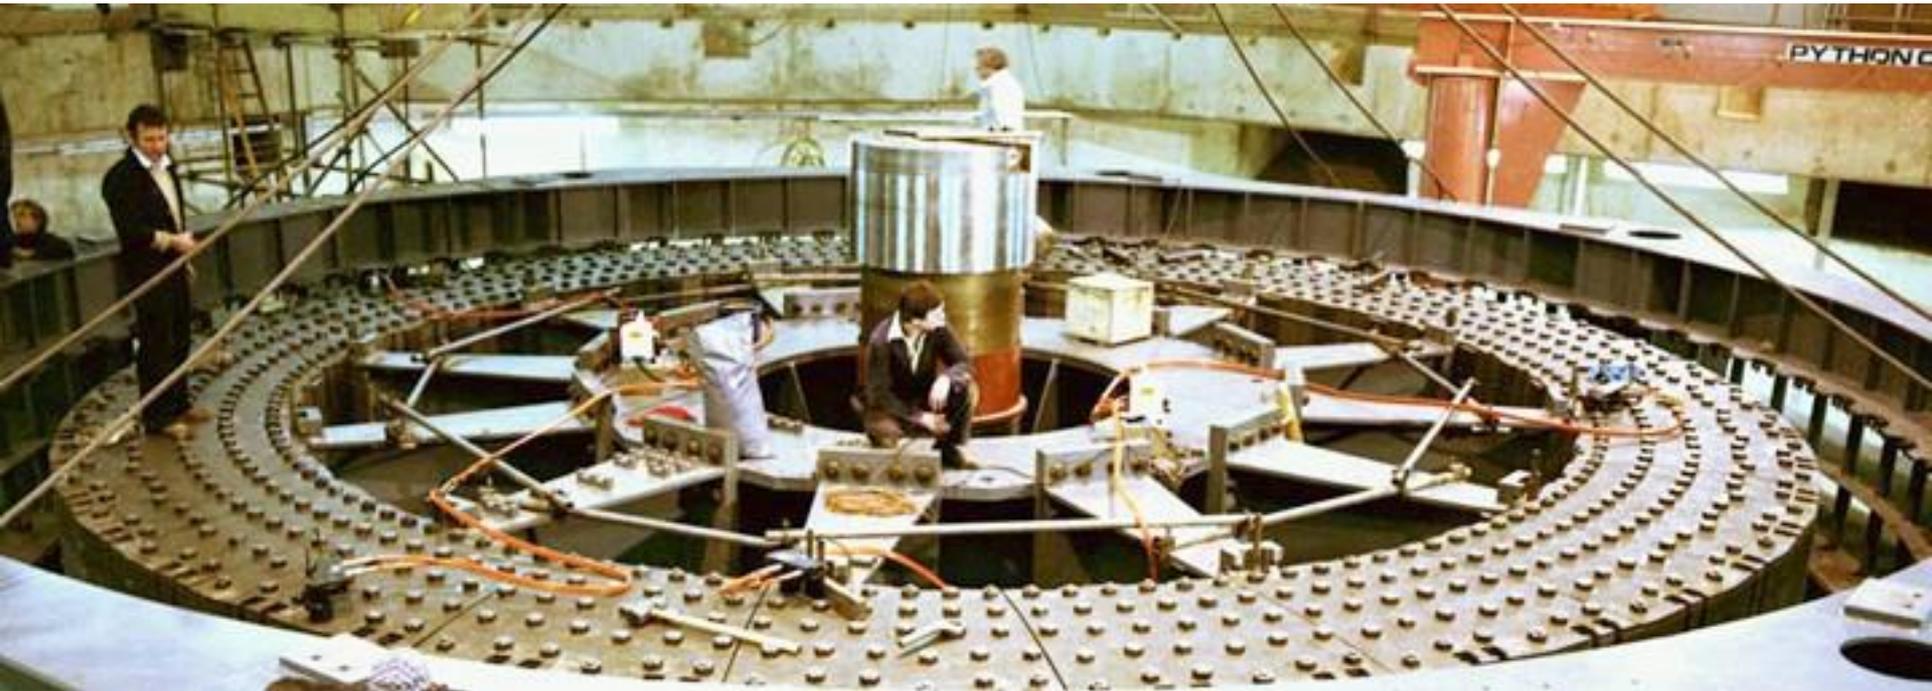
Pulsed Power

- Powering the Joint European Torus
 - 400 MW, 700 kWh, about 10 pulses daily since 1981
 - 775 tons, 100 m/s tip speed

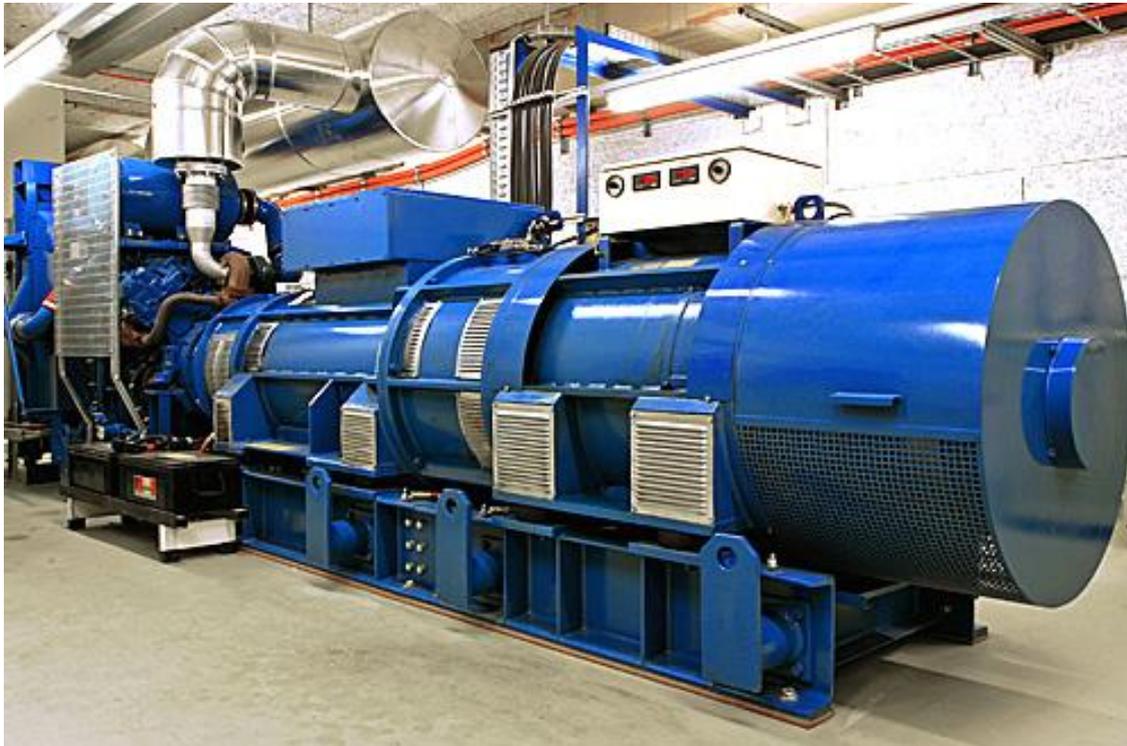
Rotary UPS

- Commercial and industrial installations world-wide
 - 5% of UPS market (35% of market >2MW) – Source: Hitec

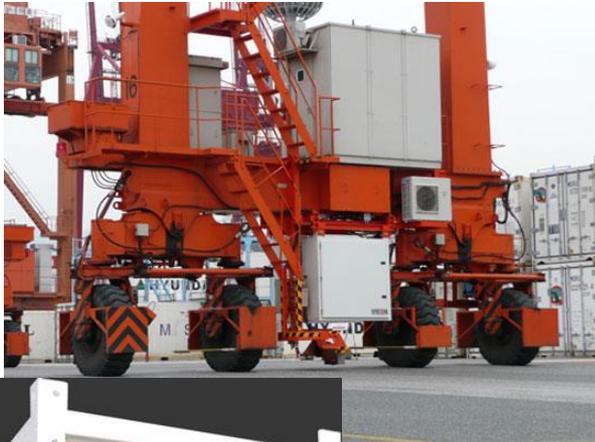
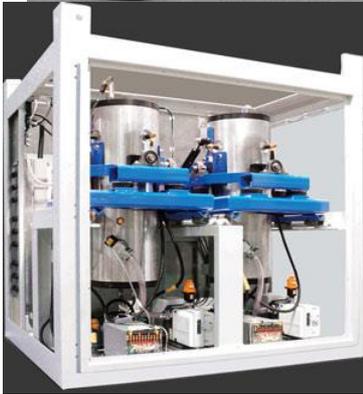
- RTG's (Rubber Tire Gantry)
 - Diesel-electric power
 - Flywheel energy recovery
 - Reduces port emissions

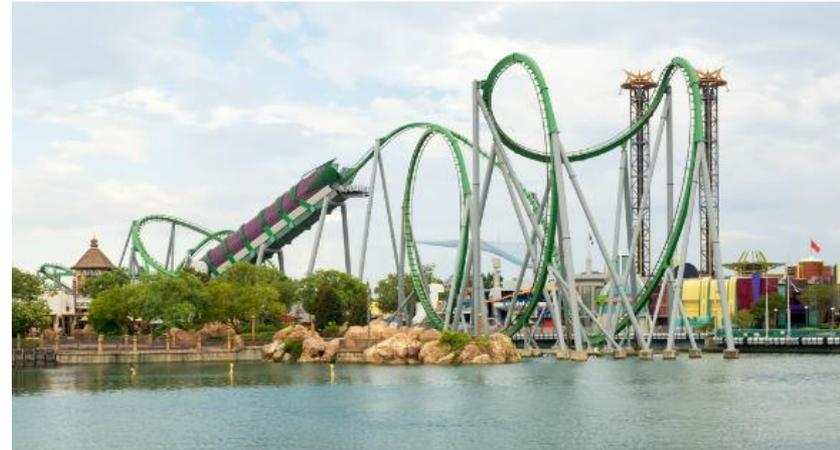
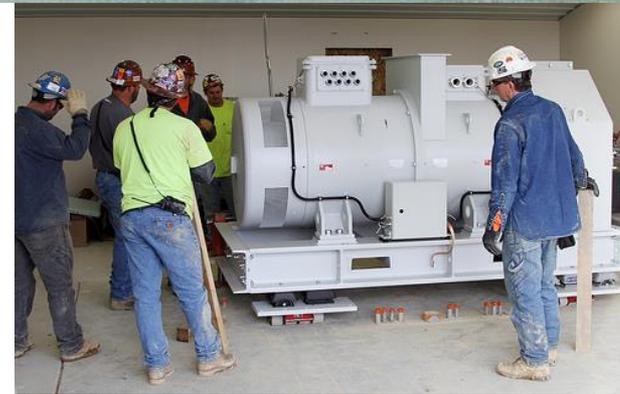
- Roller coaster launch
 - 8 MW for 2s repeated every 90s
 - Continuous charge at 200 kW
 - Avoids disruptive load to grid

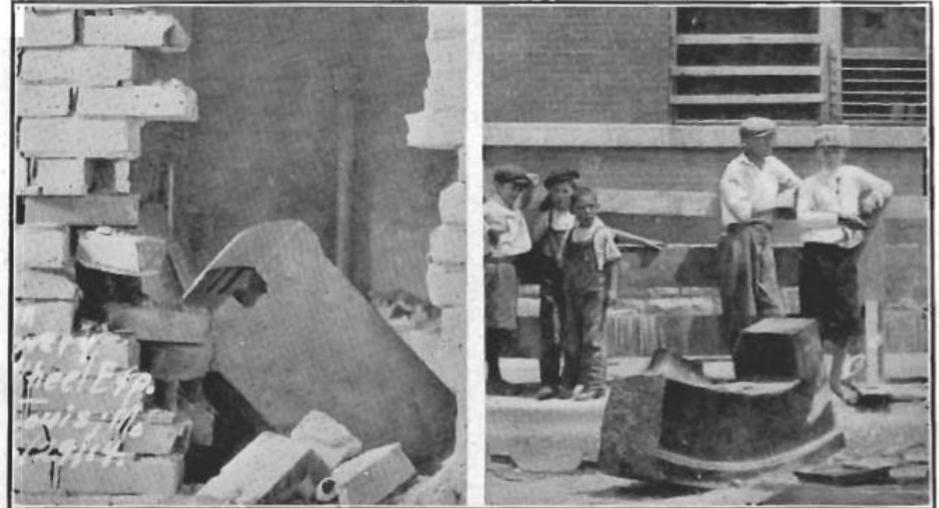
FLY-WHEEL EXPLOSION UNION BREWING CO., ST. LOUIS, MO., 40,000-
POUND WHEEL ON ICE MACHINE RUNNING NORMALLY AT ONLY
50 R.P.M. MACHINE RACED AND BURST WHEEL BY CEN-
TRIFUGAL FORCE, HURLING 8,000-POUND CHUNKS
GREAT DISTANCES. RIM SECTION WAS 13"x16",
TO BREAK WHICH REQUIRED 4,000,000
POUNDS. LOSS \$13,423. WHEEL INSURED.

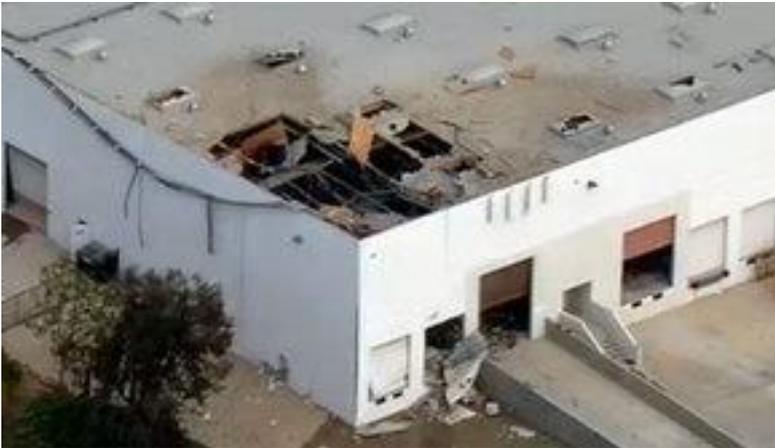
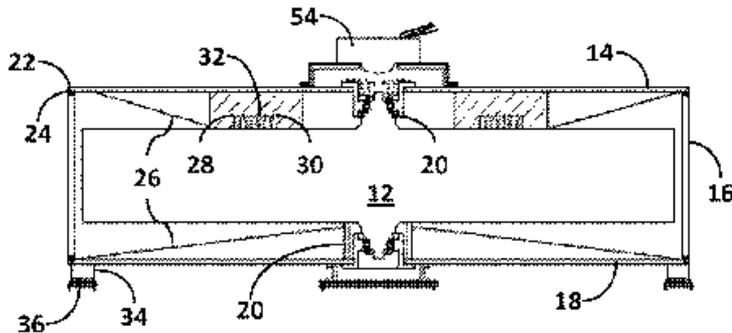
FIG. 2

- Burn-in at developer site
 - Intended for customer delivery
 - Less than 24 hours operation
 - Solid steel disk, 11,700 lb
 - 570 m/s surface speed
 - 120 kWh stored energy
 - Thin-wall vacuum enclosure
 - Below grade cell, uncovered

- Failure
 - Essentially no design margin
 - Prompt failure, no warning
 - Earth surrounding the cell redirected part of blast axially
 - Ejecta travelled up to ¼ mile
 - No fatalities, 5 injured

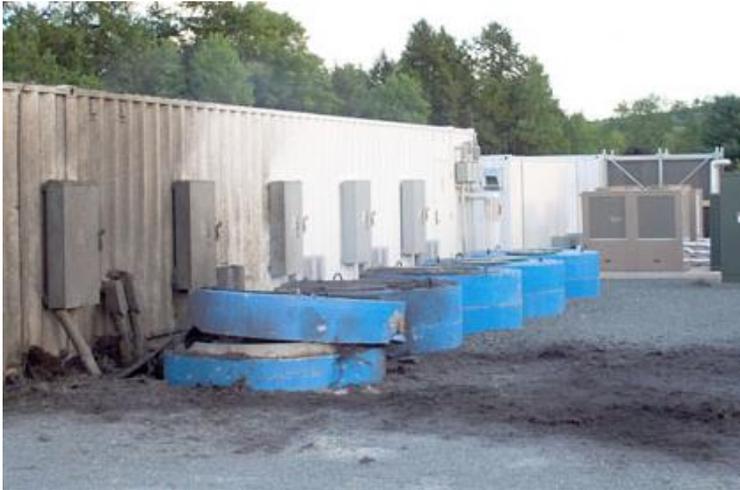
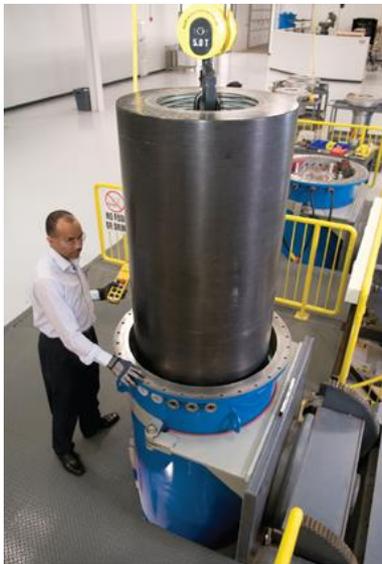
Loose rotor event

- Grid connected site
 - Normal operation
 - Composite rotor, 2000 lb
 - 33 kWh stored energy
 - Thin-wall vacuum vessel
 - Below grade, concrete “vault”
- Component failure
 - Dropped composite rim
 - Destroyed vac. vessel and vault
 - Ejected carbon composite dust
 - No projectiles escaped vault
 - Rotor intact
 - Root cause: Manufacturing defect. Two components from the same lot failed same way.
