# SANDIA REPORT

SAND88-2154 • UC-94cb

## Exploratory Battery Technology Development and Testing Report for 1987

Nicholas J. Magnani, Ronald B. Diegle, Jeffrey W. Braithwaite,  
Donald M. Bush, Paul C. Butler, James M. Freese,  
Kenneth R. Grothaus, Kevin D. Murphy

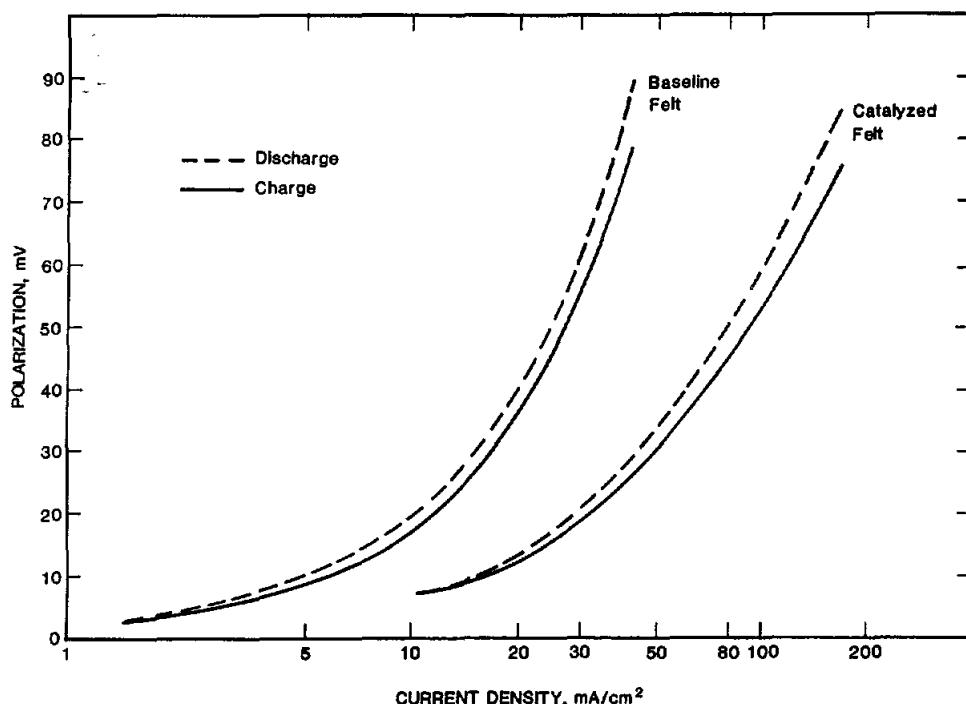
**Figure 2-1. Bromine Electrode Polarization (Baseline Felt Versus Catalyzed Felt)**

**Activated-Felt Electrode.** The baseline felt material has a specific surface area of about 0.5 m<sup>2</sup>/g, and the catalyzed felt has a surface area of about 1 m<sup>2</sup>/g (both determined by BET analysis). Carbon felt can be made with significantly higher surface area by modifying the carbonization conditions, producing an activated

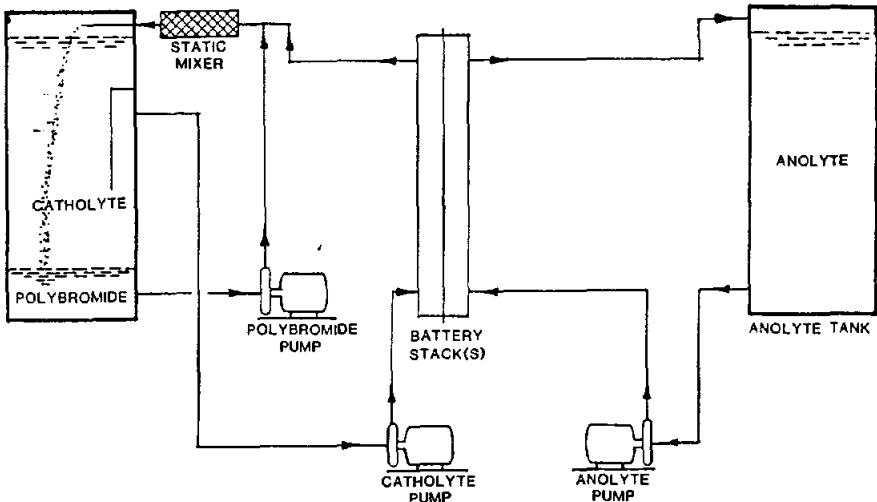
(a) Former System Configuration, with Three Recirculation Loops

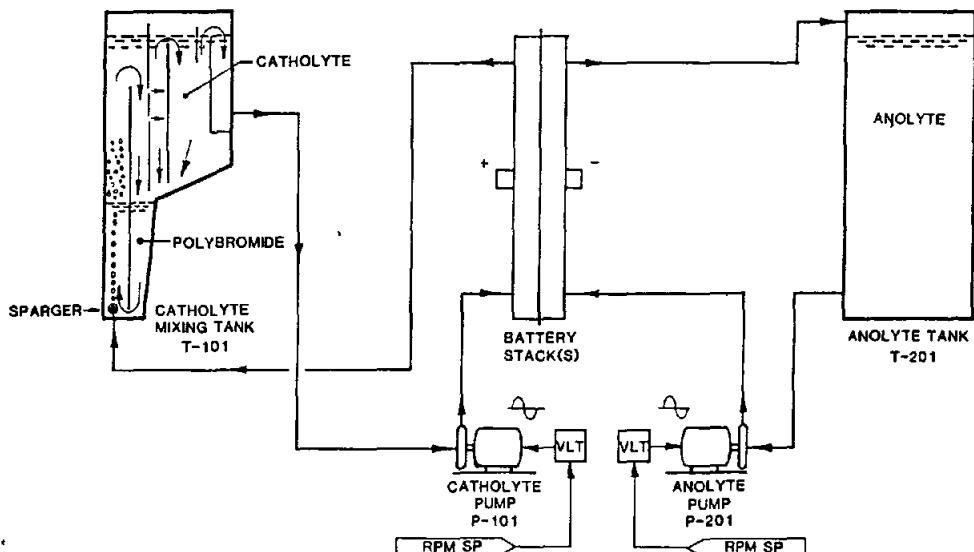
(b) Two-Loop System Configuration, with Catholyte/Polybromide Mixing/Settling Tank

- A flow frame with  $1500 \text{ cm}^2$  of active area was designed, and prototypes were fabricated and tested. This frame will replace the  $872\text{-cm}^2$  flow frame. The new design improves system reliability by reducing clogging in the flow channels, frame cracking from misalignment during assembly, electrolyte leakage, high pumping pressure requirements, and poor cell-to-cell flow uniformity.
- A two-loop flow system was designed and tested. This new flow system will also improve system reliability significantly, since it eliminates the third polybromide loop. Mixing and separation of the catholyte and polybromide fluids now

takes place in the catholyte tank. The two-loop system no longer requires a polybromide pump, which was extremely unreliable because of the high viscosity and corrosivity of the polybromide.

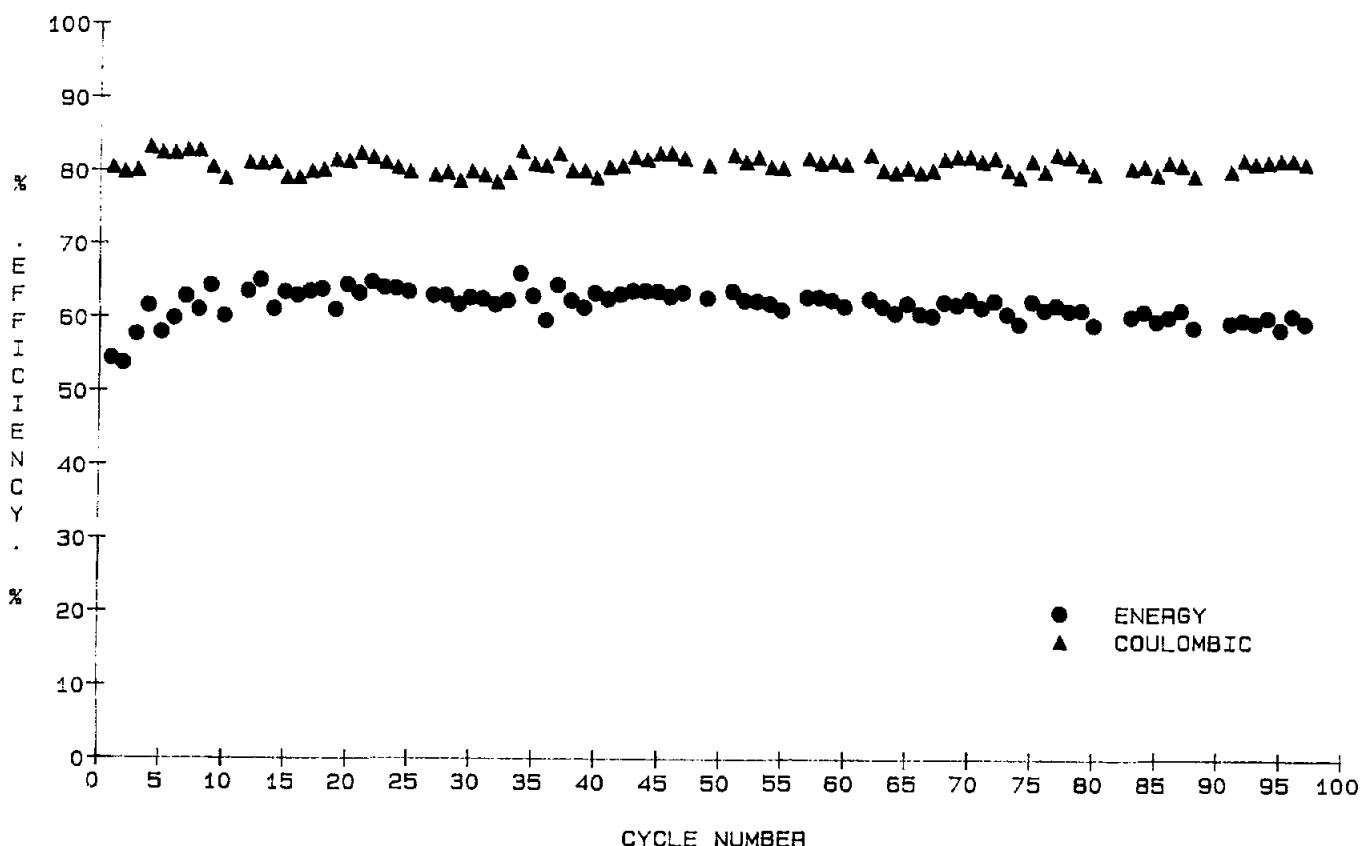
Figure 2-8. Cycle Efficiencies of the JCI Zinc/Bromine Load Management Battery

Cycling was initiated at the Load Management Facility in August of 1987. A total of 97 C/3 rate discharge cycles were completed by the end of 1987 (Figure 2-8). Initial energy efficiencies were as high as 65% and averaged 64%, about 4% higher than originally anticipated for the design and materials used. Coulombic

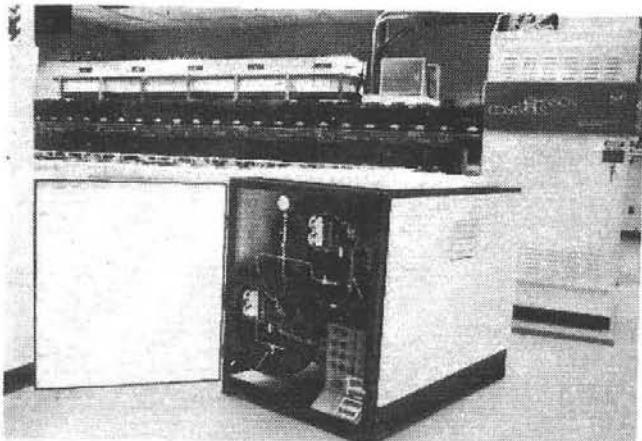
Figure 2-9. Terrestrial 7-kWh Nickel/Hydrogen Battery. Side panel is open.

transfer, which represents an improvement in thermal management. The cap on each cell contains a porous, hydrophobic plug that allows the hydrogen gas to move freely in or out of the cell case while retaining the electrolyte. Tests

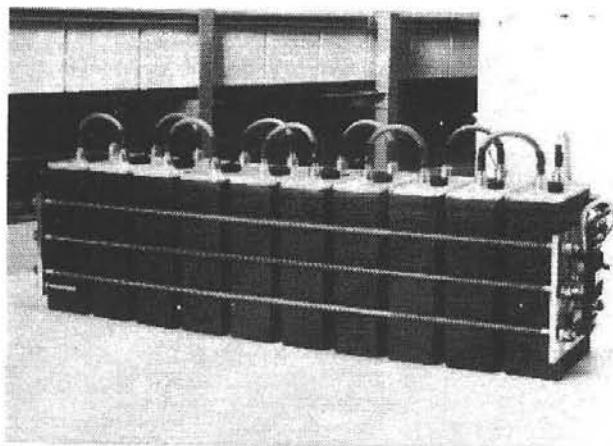
Figure 2-10. A 12-V 150-Ah Nickel/Hydrogen Battery Module

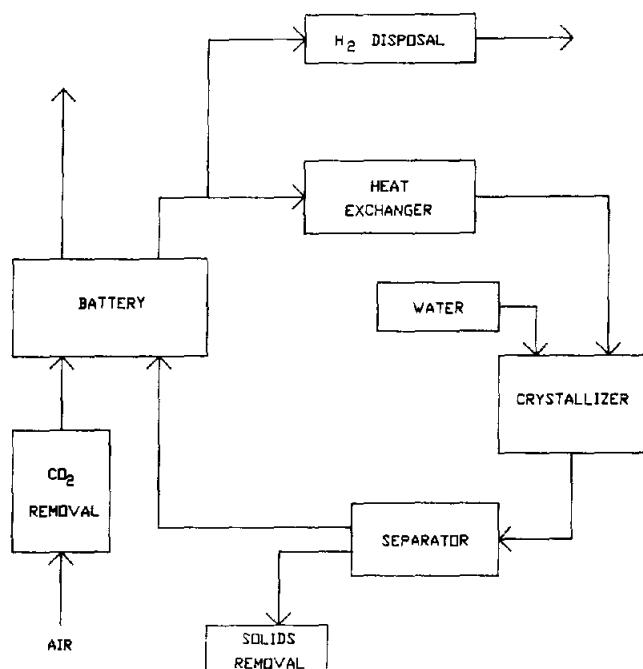
Figure 2-13. Alkaline Aluminum/Air Battery System

The air is treated to reduce its carbon dioxide content. Hydrogen is generated by a parasitic corrosion reaction between aluminum and water, and safe disposal of this gas is necessary. A heat exchanger may be required to maintain the optimum temperature of the electrolyte in the battery during operation. A crystallizer and separator unit precipitates the hydrargillite (thereby regenerating sodium or potassium hydroxide in the electrolyte), and the solid product is then removed.

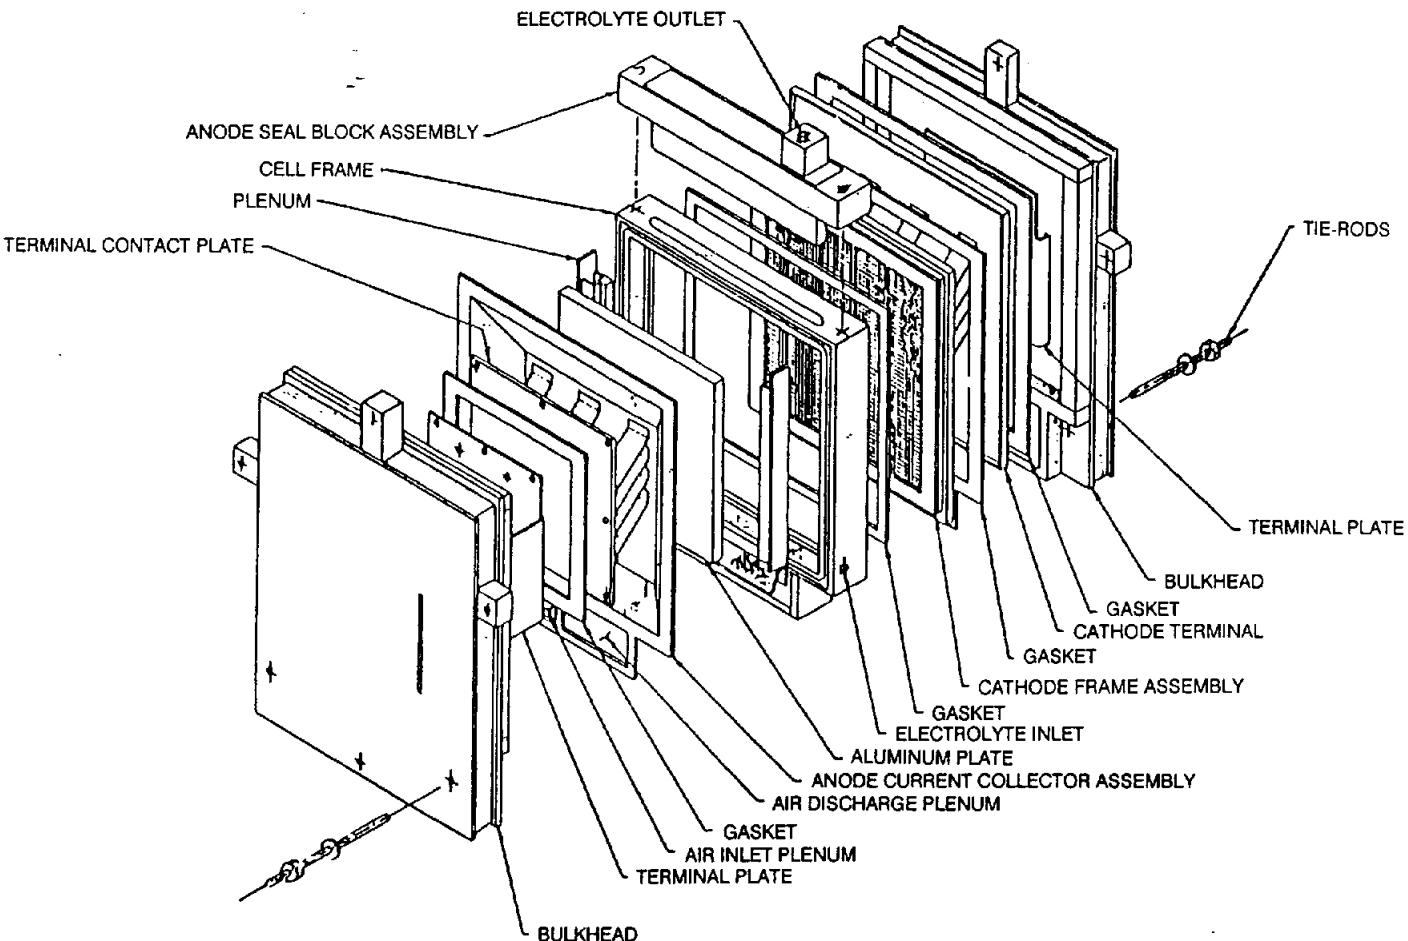
**Figure 2-14. Components of the B-300 Battery**

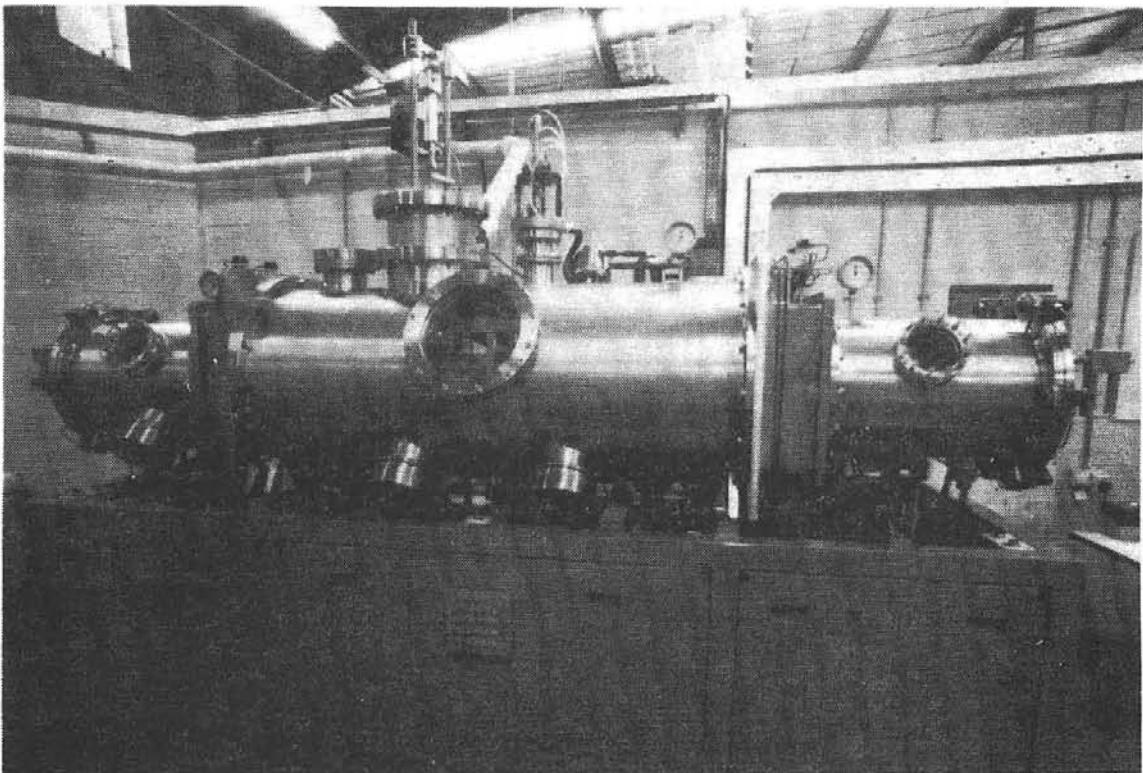
Figure 3-2. Automatic Sodium-Filling Machine

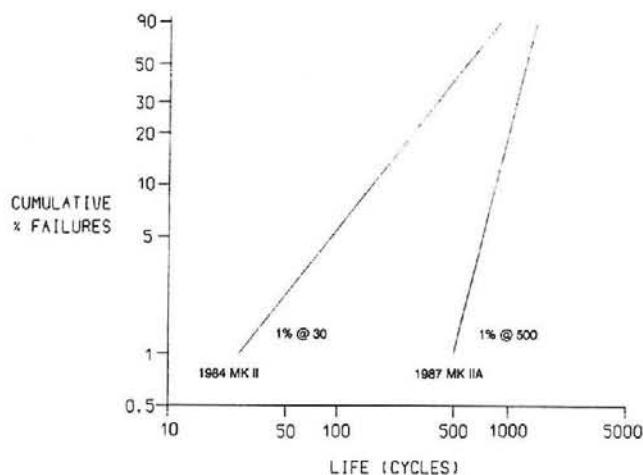
Figure 3-3. Reliability Improvement of PB Cells (1984 to 1987)

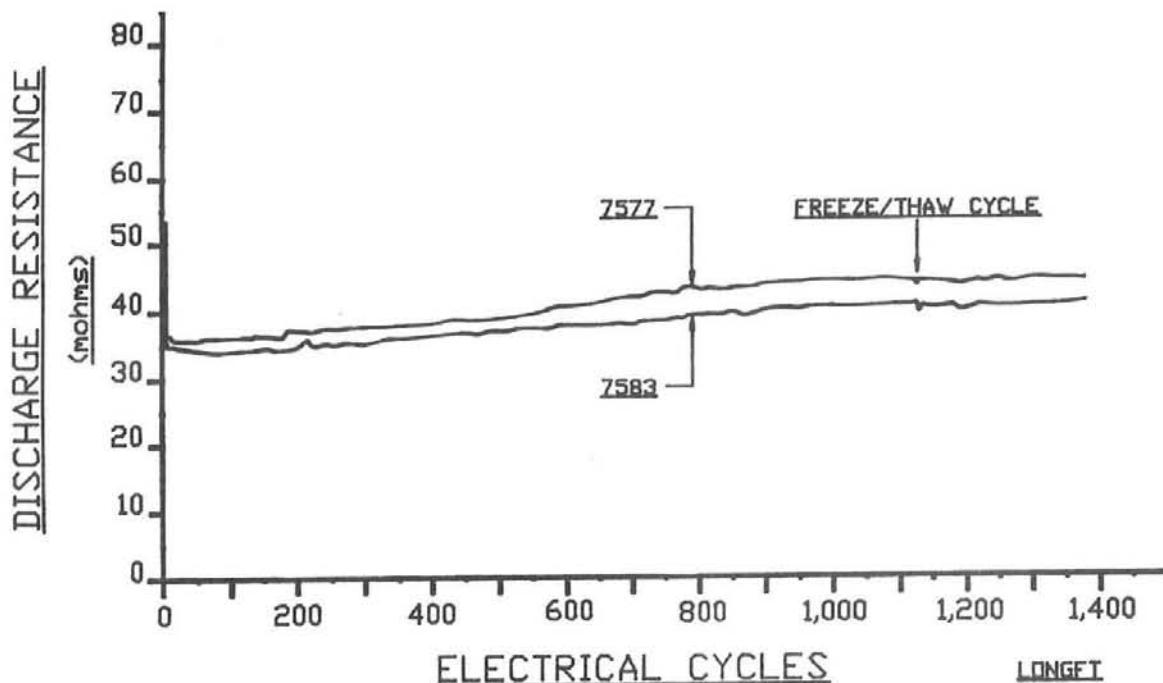
Figure 3-4. Freeze/Thaw of Long-Lived PB Cells

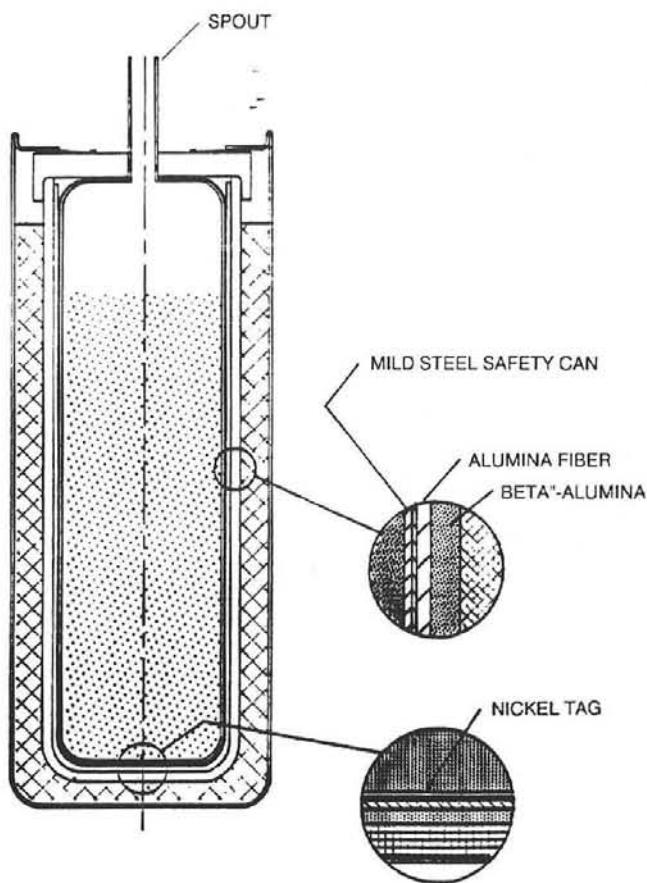
Figure 3-5. Composite XPB Cell Design

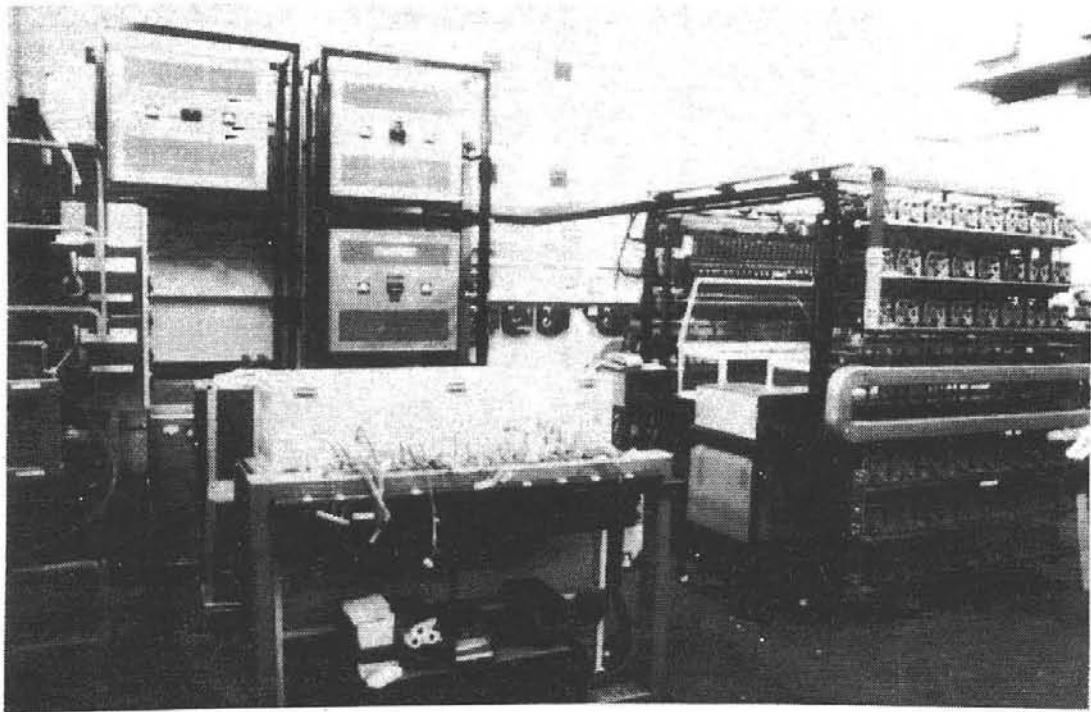
Figure 3-6. XPB Test Rig

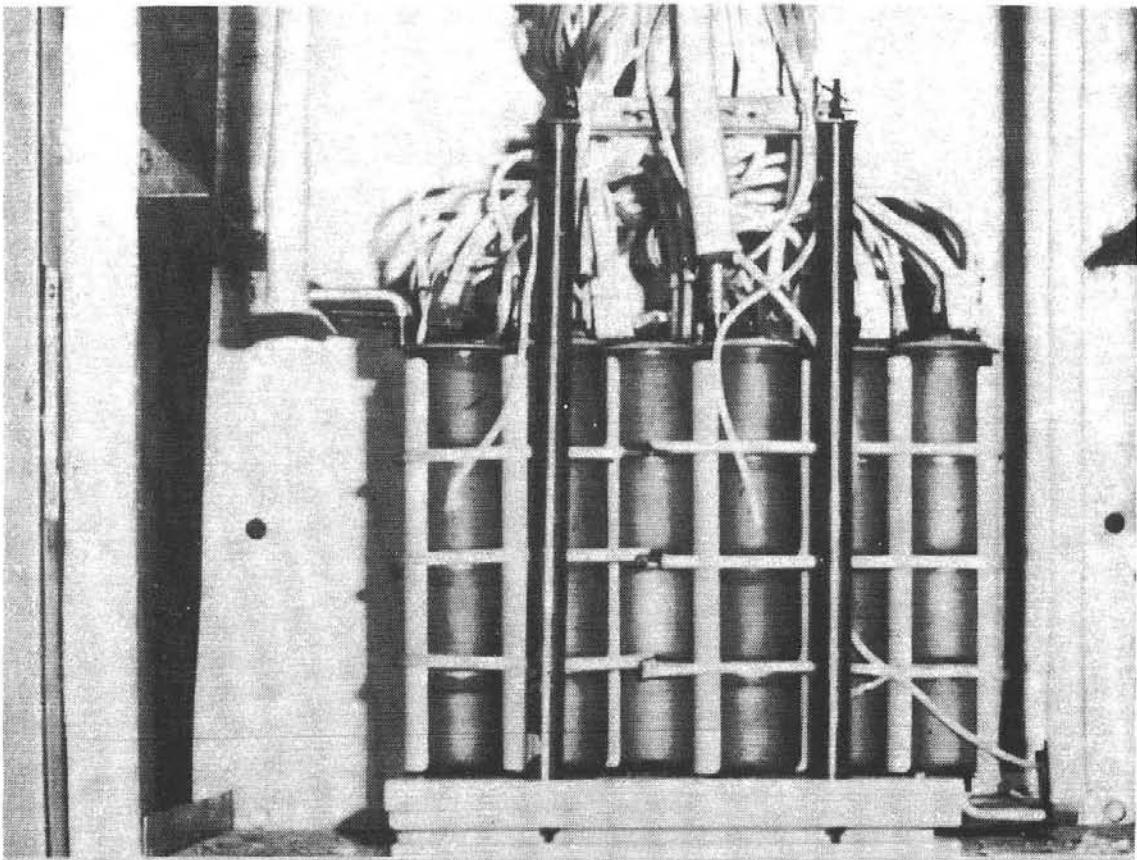
Figure 3-9. 120-PB-Cell Battery After Test

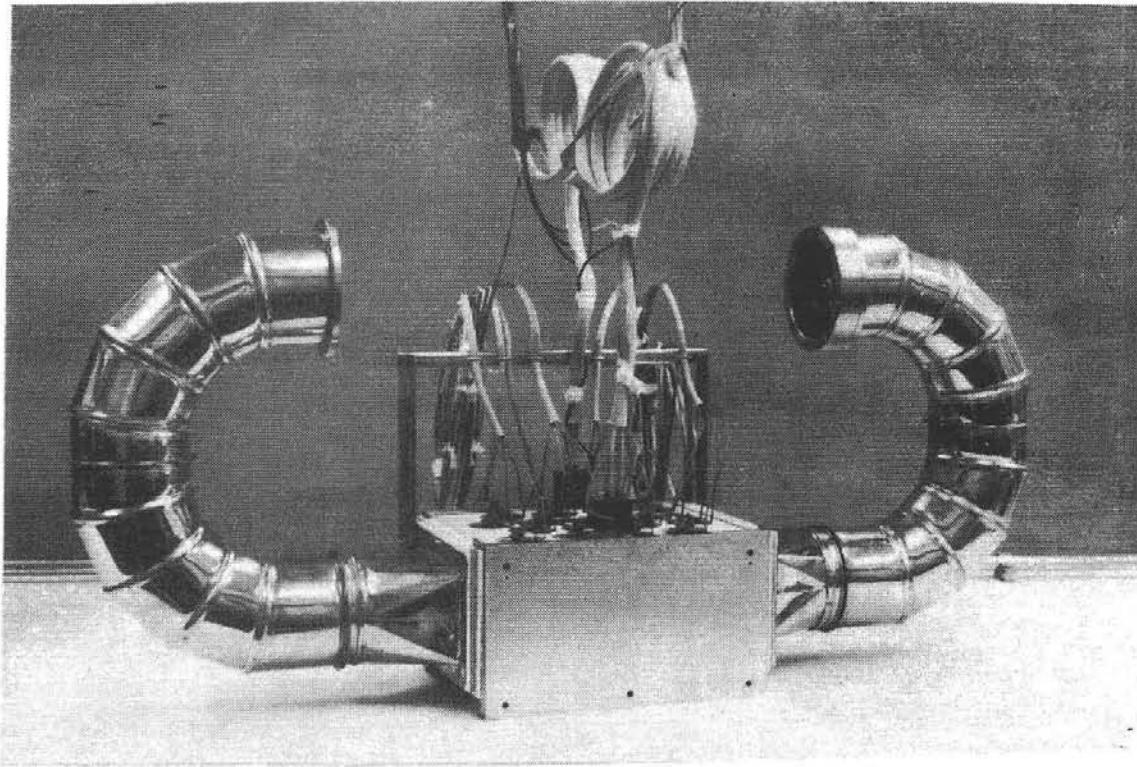
Figure 3-10. 16-Cell XPB Module with Air-Over Facilities

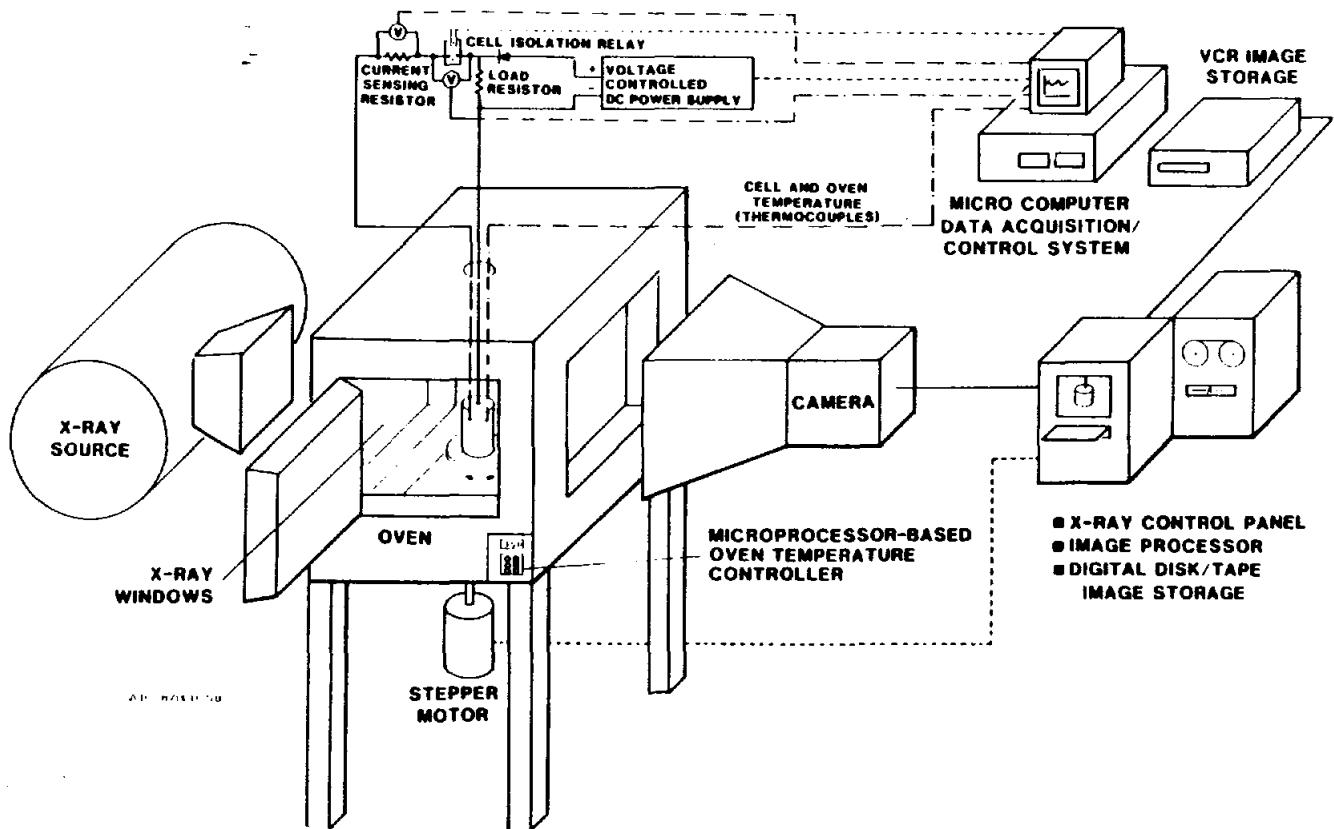
**Figure 3-12. Freeze/Thaw Data Acquisition and Control Device**

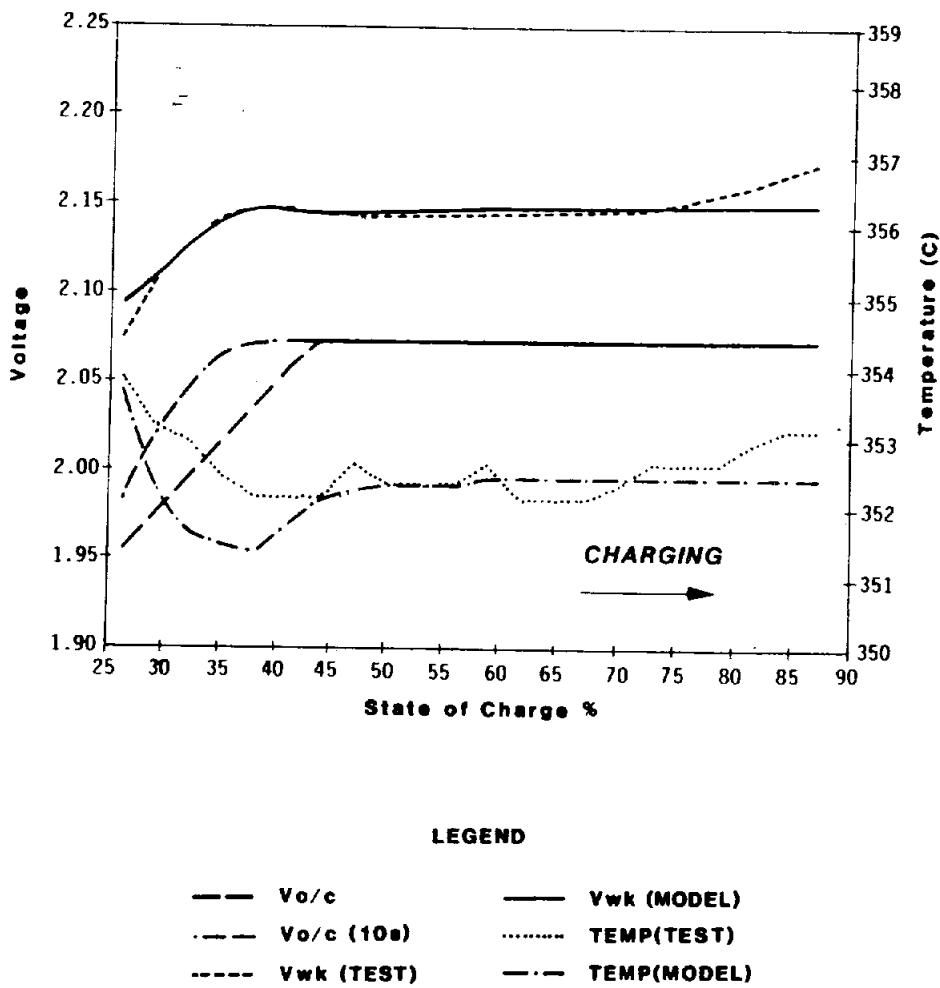
Figure 3-13. Cell Performance Model Versus Test Data for XPB Cell 8032

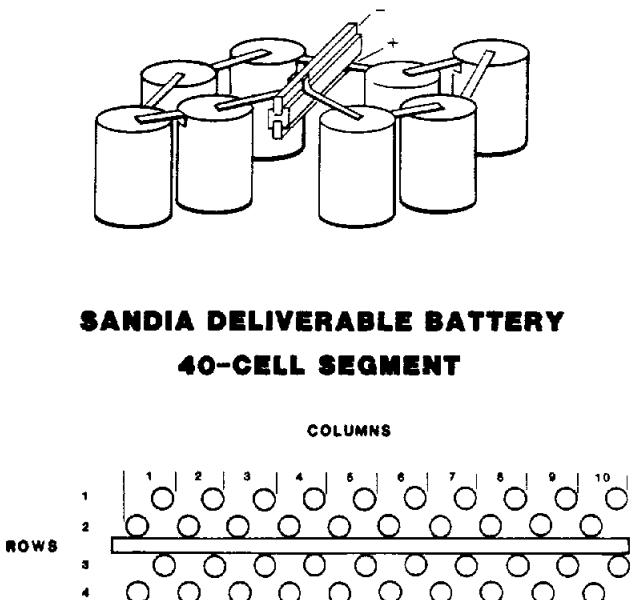
Figure 3-14. Baseline Design of SNL-Deliverable Battery

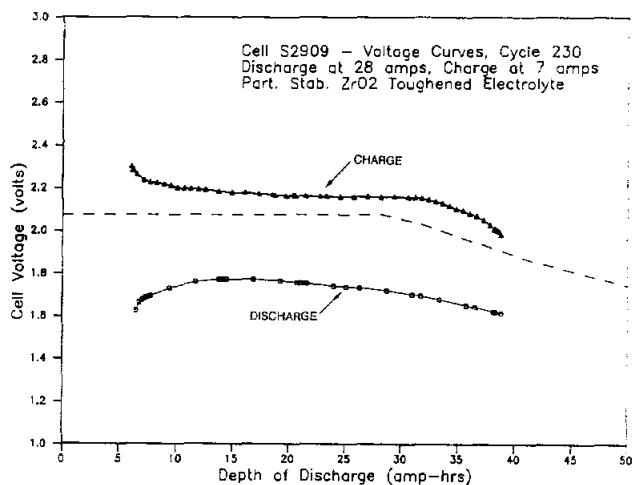
Figure 3-15. Typical Cell Voltage

The electrical performance of the cells was in relatively good agreement with data obtained at FACC during their work on this cell. A typical plot of voltage as a function of depth of discharge during both charge and discharge is shown in Figure 3-15. Some slump in voltage at the beginning of discharge was observed in most cells as a result of the high current level and the very high rechargeability. Typical plots of cycle average cell resistance and capacity for one of the cells are shown as functions of cycle number in Figures 3-16 and 3-17, respectively. This cell contained a Zeta-process electrolyte and at the end of the year had accumulated over 1000 cycles. The step change in cell resistance at cycle 760 shown in Figure 3-16 is an artifact of reducing the charging current from 7 to 5 A without reducing the charge voltage cutoff limit.

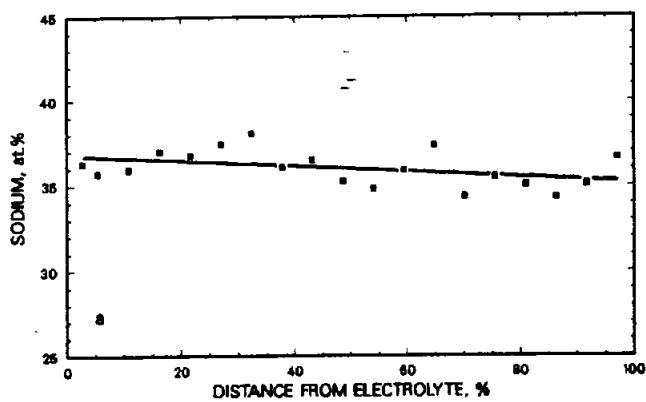
(a) Cell 7824: Discharged to 1.76 V and Slowly Cooled

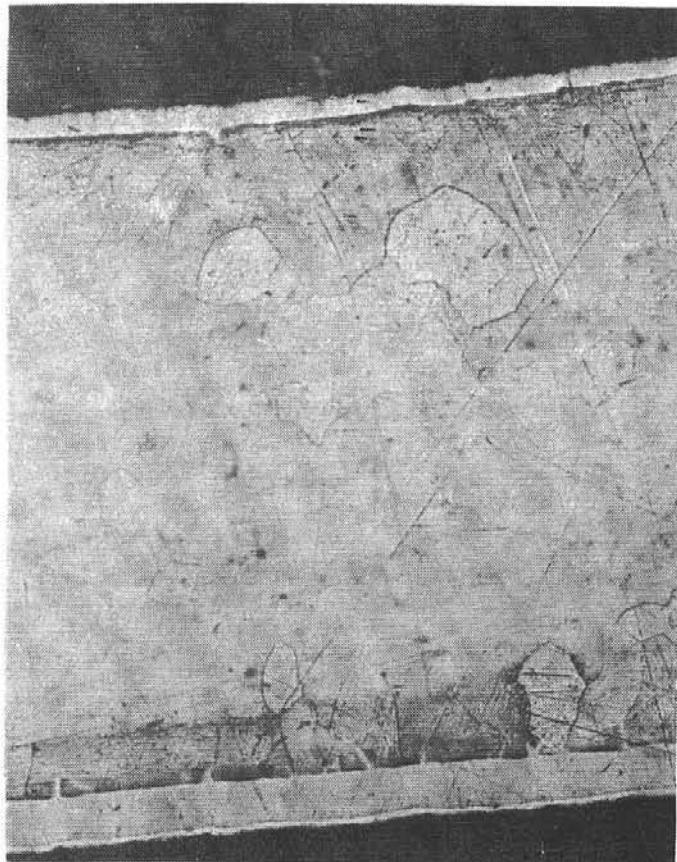
Figure 3-19. Corrosion of the Chromized Layer (Top) at the Base Section of Case for Cell 7521 (Etched)

Figure 3-19 illustrates the condition of the ferrochromium layer at the base of cell 7521 after 520 cycles. The thickness of this layer, which was about five times greater than the high-chromium layer, was reduced in half for the entire base section of the cell case. Corrosion was significantly less along the walls of the cell case. The high chromium layer was still present, although reduced in thickness. The coating on the top cap of this cell also fared well and showed only minor scale formation.

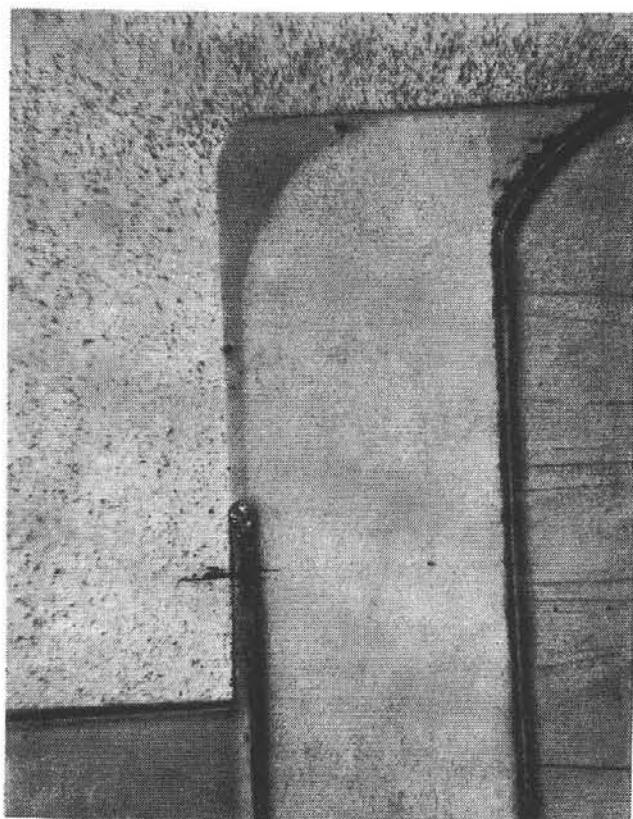
Figure 3-20. Typical Glass Seal Between the Insulator Cap (Top and Left) and the Electrolyte (Center)

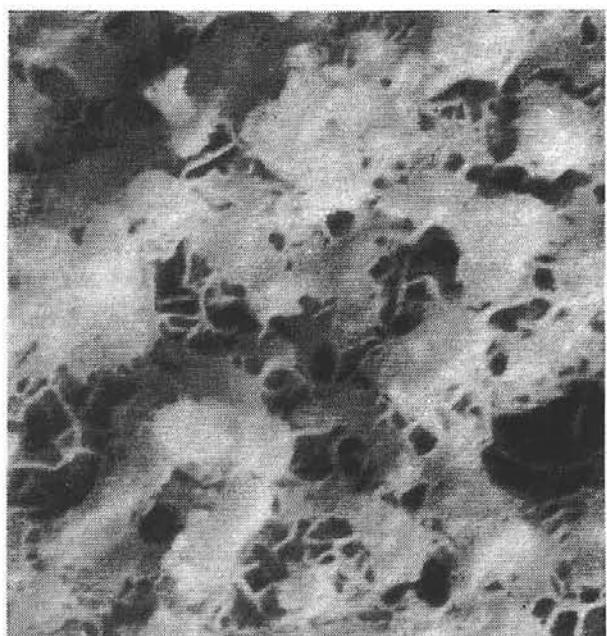
Figure 3-21. A Fibrous Network of Beta"-Alumina Found on the Interior Surface of the Electrolyte from Cell 7826

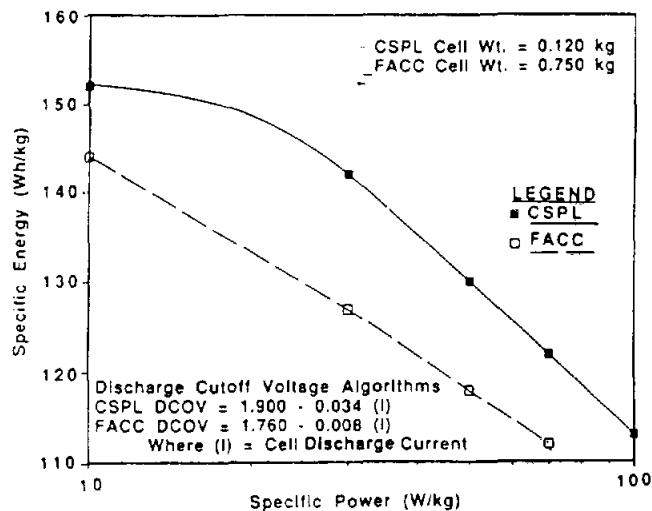
Figure 4-1. Ragone Plot for CSPL and FACC Sodium/Sulfur Cells Tested at the ADL

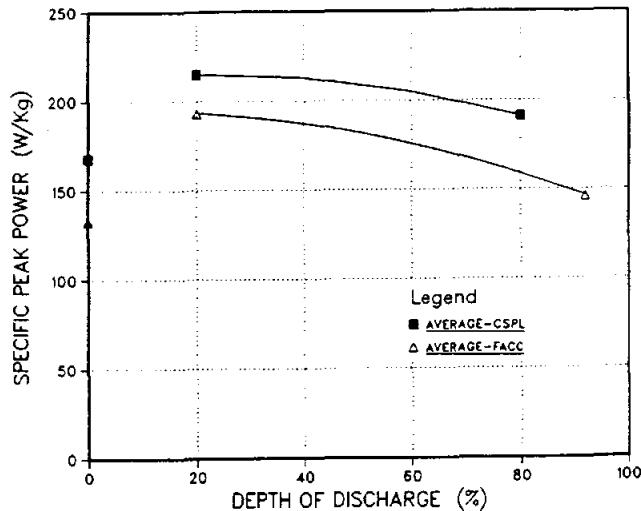
Figure 4-2. Specific Peak Power Versus Depth of Discharge for CSPL and FACC Sodium/Sulfur Cells Tested at the ADL

**Peak Power.** The peak-power capability of the CSPL cells was found to be about 19% greater than that of the FACC cells. A plot of peak power versus DOD for each technology is given in Figure 4-2. The specific peak power for both systems was derived from cell data acquired during an SAE J227aD/IETV-1 discharge. The

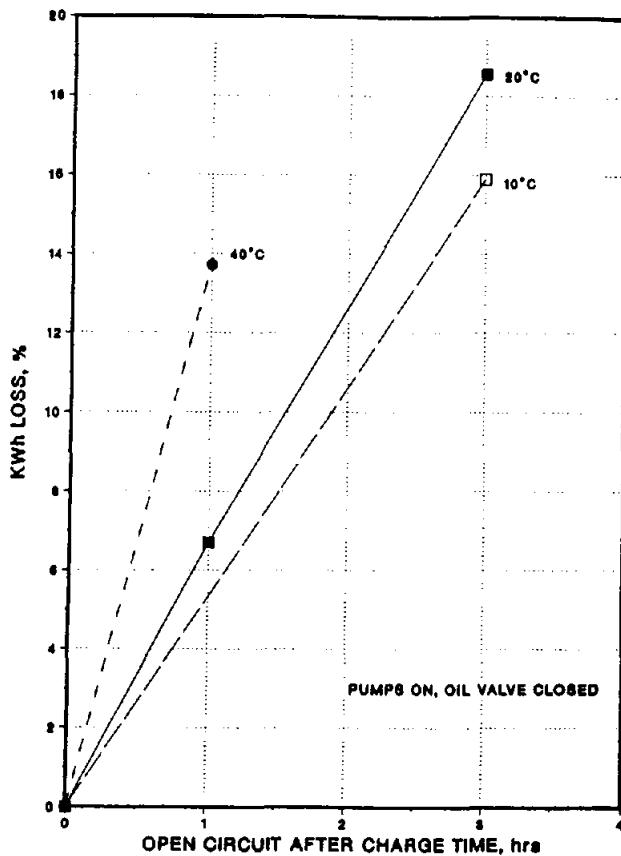
**Figure 4-3. Exxon 30-kWh Zinc/Bromine Battery Energy Loss as a Function of Stand Time After Charge**

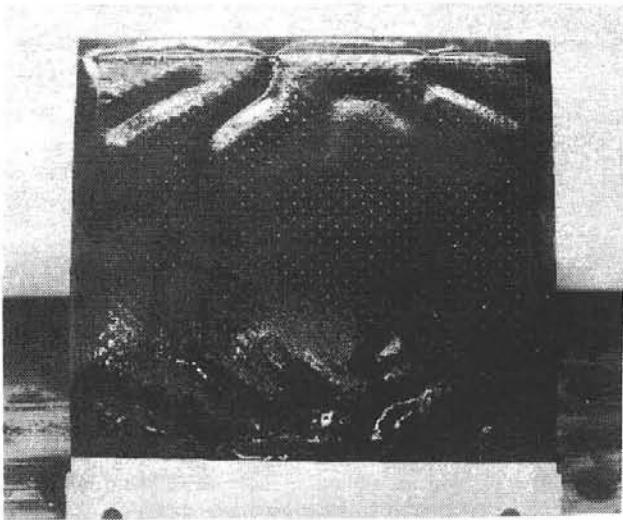
Figure 4-4. Zinc Electrode from Exxon Zinc/Bromine Battery 301 after 2030 cycles

As is seen in the figures, the warpage was confined to the top and bottom of each electrode

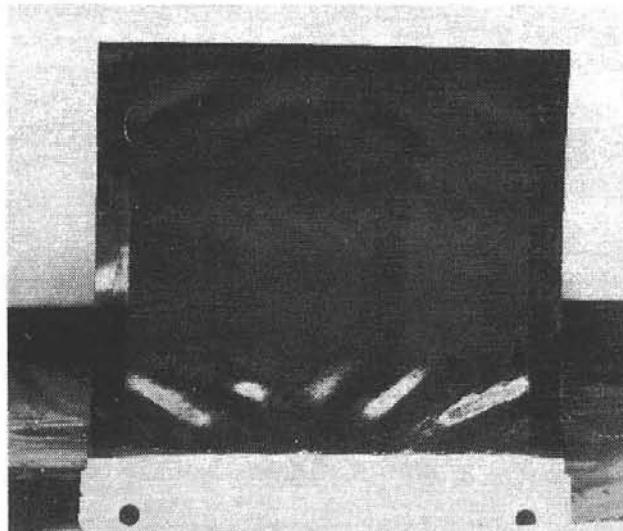
Figure 4-5. Bromine Electrode from Exxon Zinc/Bromine Battery 301 after 2030 cycles

The main reason that this battery operated for over 2000 cycles was that the pattern of electrode warpage permitted uniform electrolyte distribution in the cell stack. Thus, the warpage did not cause significant nonuniform current distribution. These results have been shared with

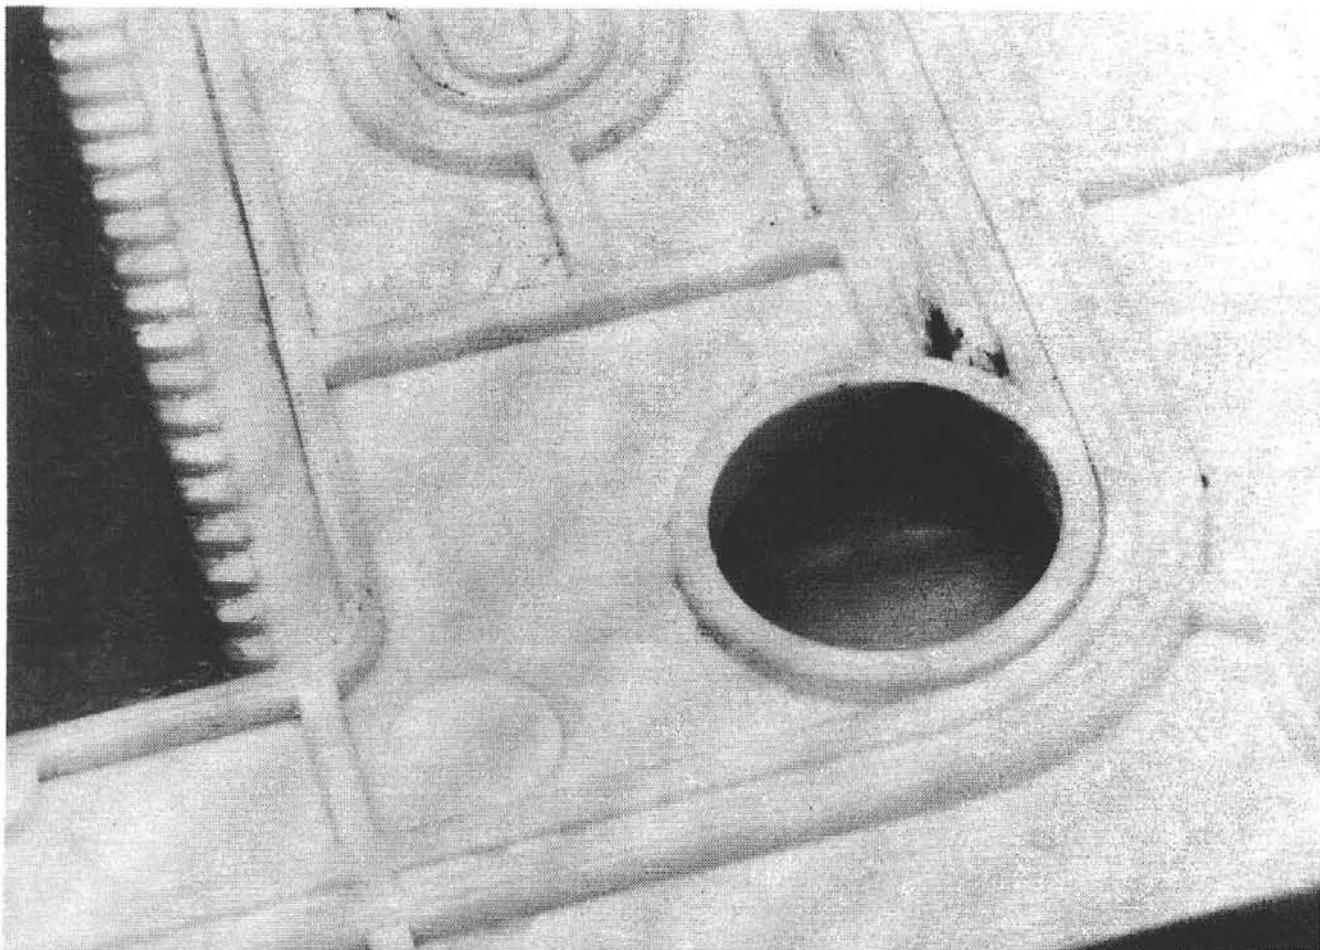
Figure 4-6. Blocked Flow Channels From ERC Zinc/Bromine Battery 430

On 22 January 1987, the cell stack was disassembled with the help of ERC personnel. The cause of the poor performance and electrolyte crossover was found to be blocked electrolyte flow channels to all zinc electrodes. The blockage led to poor electrolyte flow uniformity, localized high current densities, and high pressure gradients across the separators. The particles causing the obstruction were pipe thread bits and small pieces of teflon tape, which can be seen in Figure 4-6. When the stack was assembled, one or more of the threaded

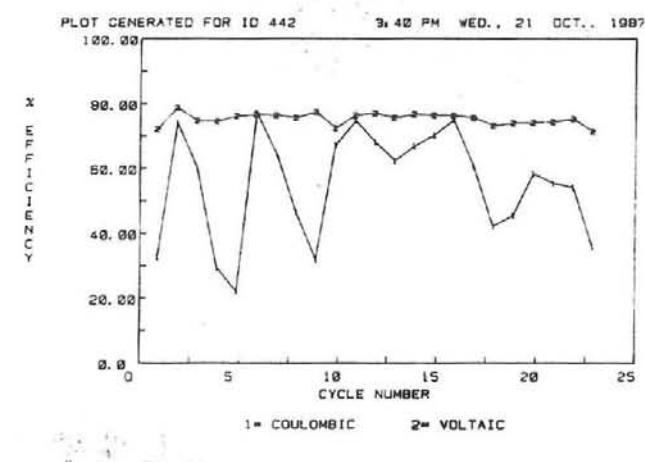
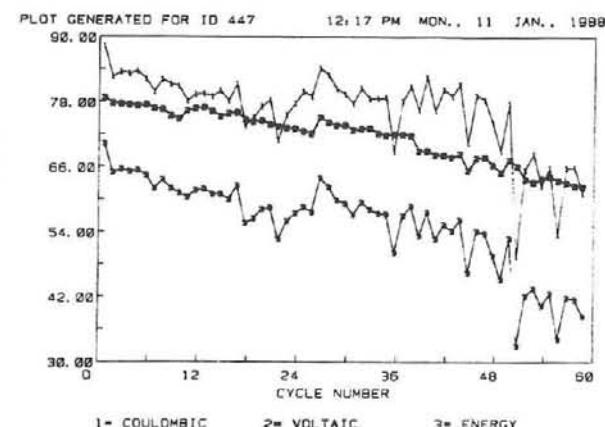
Figure 4-7. Cycle Data for ERC Zinc/Bromine Battery 442 at SNL

Voltaic efficiency declined steadily during the tests. Coulombic efficiency dropped significantly during the last ten cycles. There was no noticeable effect on efficiency when zinc loading on charge was increased from

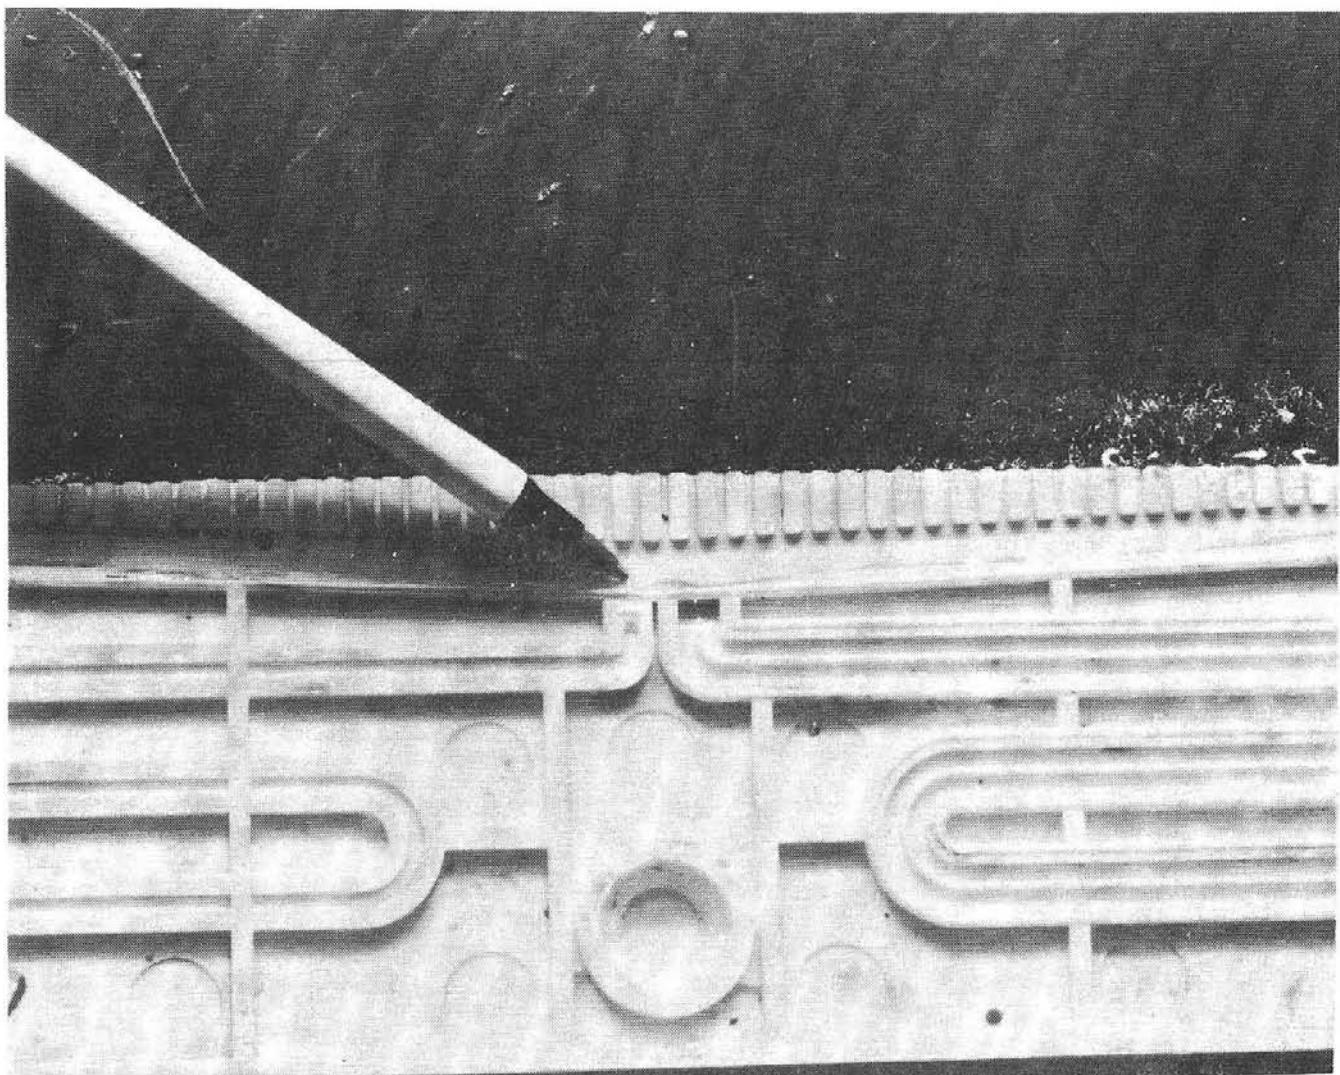
Figure 4-9. Positive End-Electrode Flow Frame From ERC Zinc/Bromine Battery 447. Note crack in flow channel (at tip of pen).

All of the flow channels were open and clear of obstructions. The only damage inside the stack was a hairline crack in the flow channel of the positive end electrode, which is shown in Figure 4-9. The crack allowed electrolyte to enter the normally dry positive current-collector chamber. The titanium current collector was coated with a resistive film of electrolyte over about 50% of its area. This led to high current densities on the remaining active area and subsequently poor electrode performance.
