# SANDIA REPORT

SAND88-2154 • UC-94cb

## Exploratory Battery Technology Development and Testing Report for 1987

Nicholas J. Magnani, Ronald B. Diegle, Jeffrey W. Braithwaite,  
Donald M. Bush, Paul C. Butler, James M. Freese,  
Kenneth R. Grothaus, Kevin D. Murphy

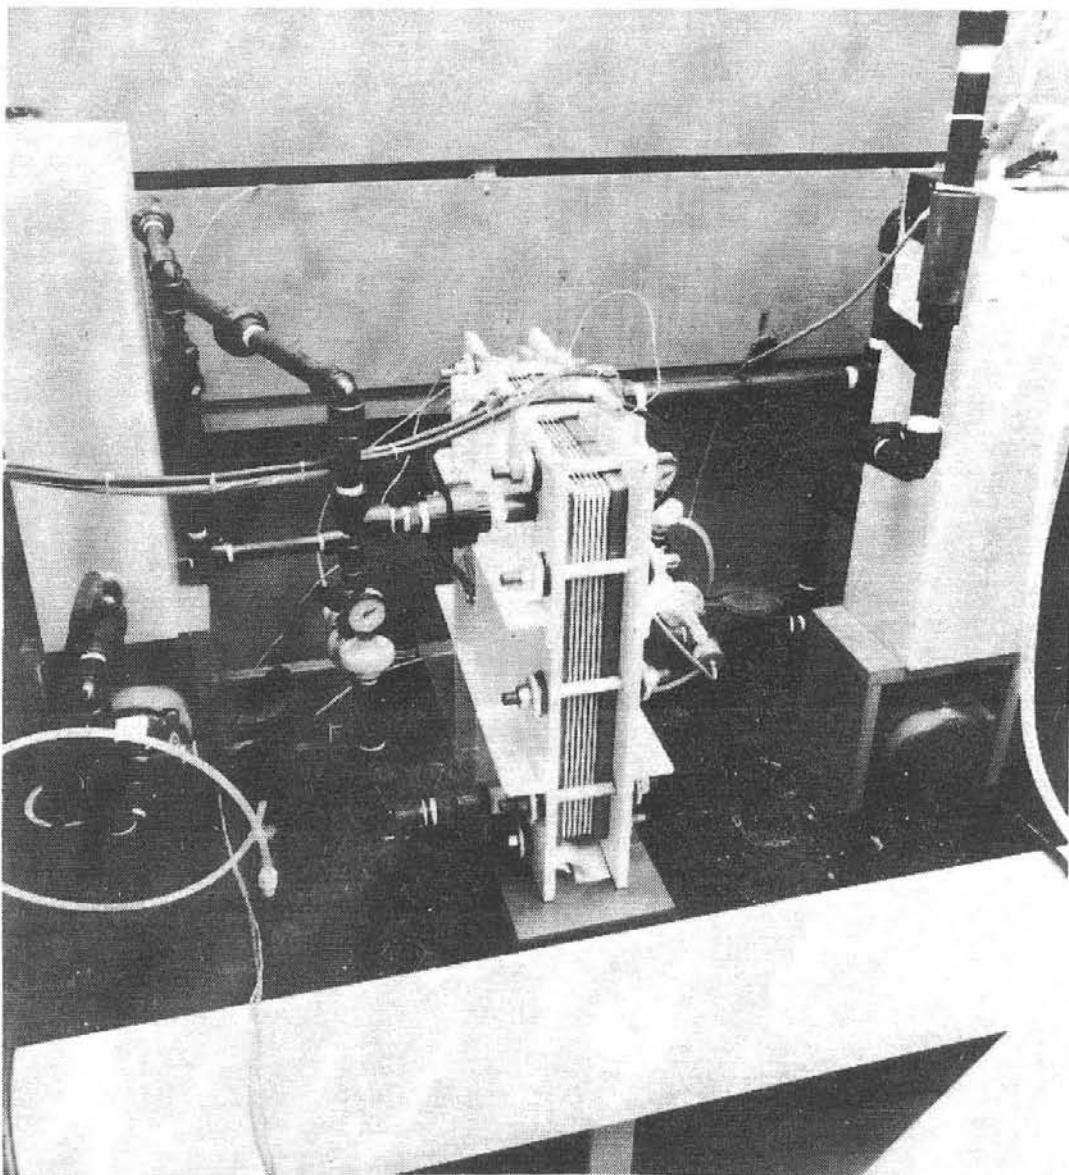
Figure 4-10. ERC Zinc/Bromine Battery 448 at SNL

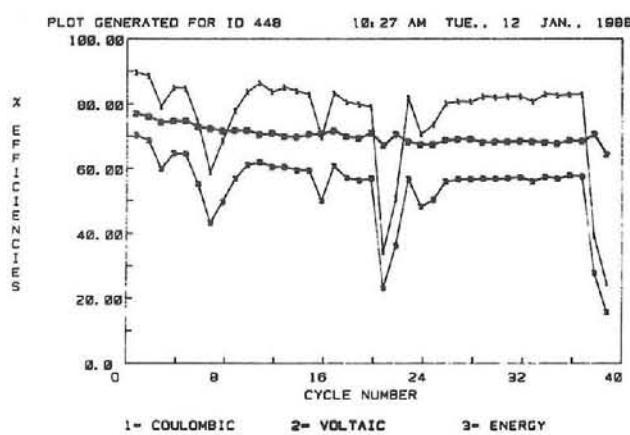
Figure 4-11. Efficiency Performance of ERC Zinc/Bromine Battery 448 at SNL

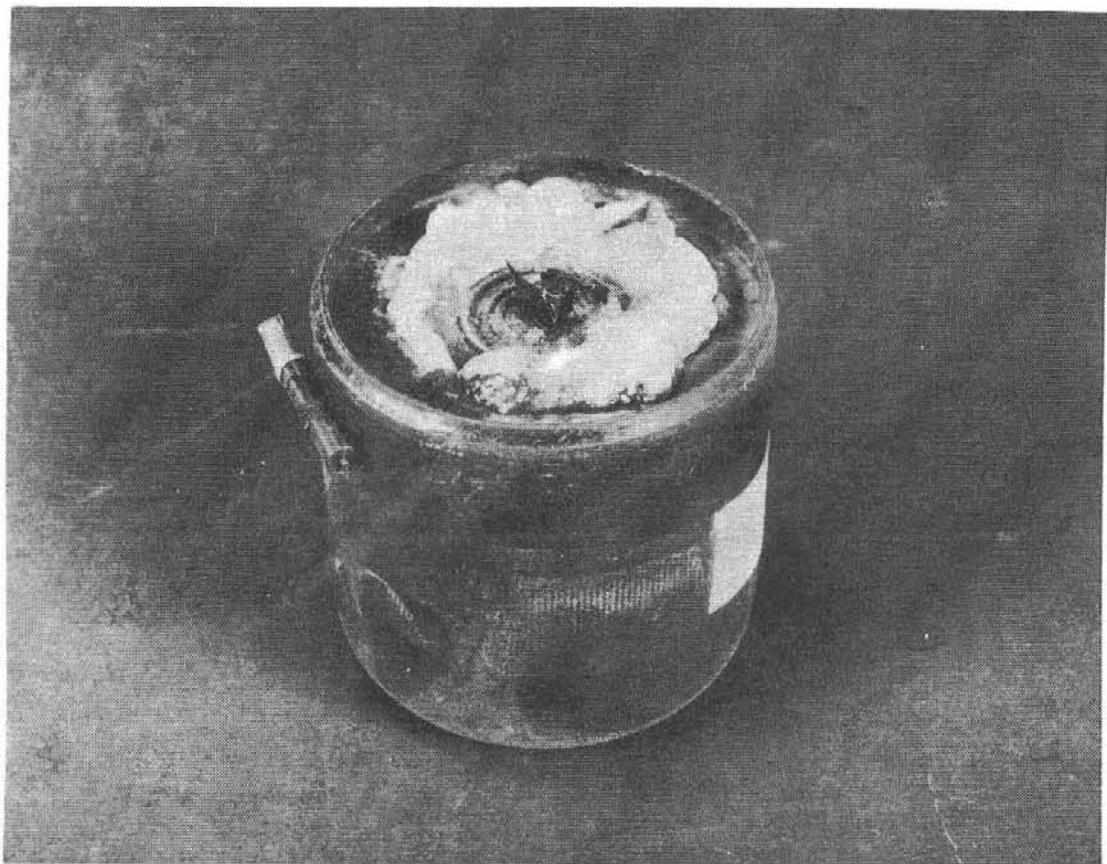
Figure 4-12. Sodium/Sulfur Cell with Sulfur Seal Failure

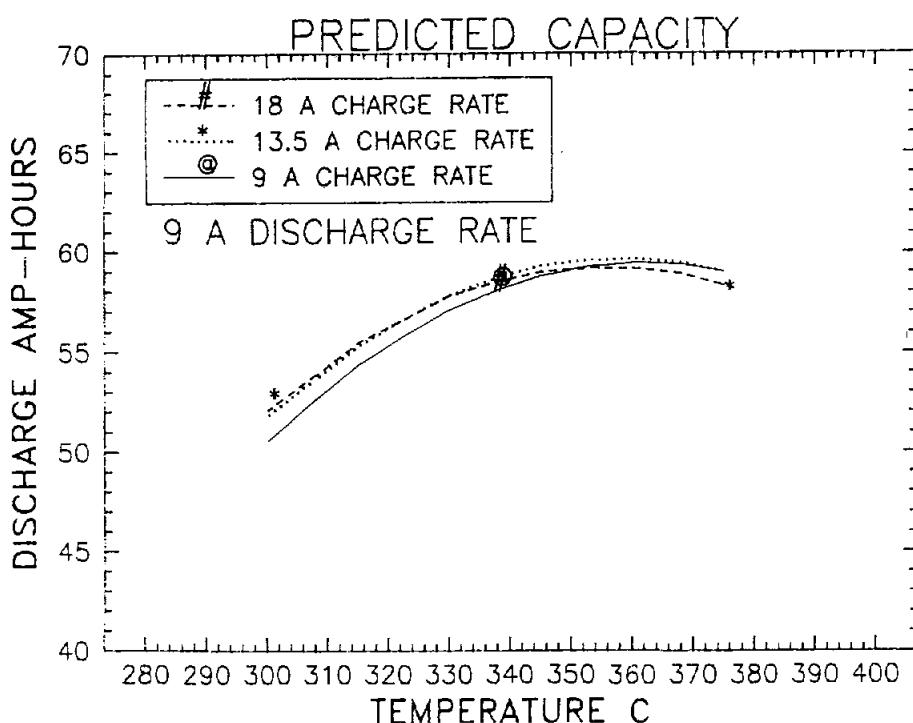
Figure 4-13. Predicted and Actual Capacity of FACC Sodium/Sulfur Cell 410 versus Temperature and Charge Rate

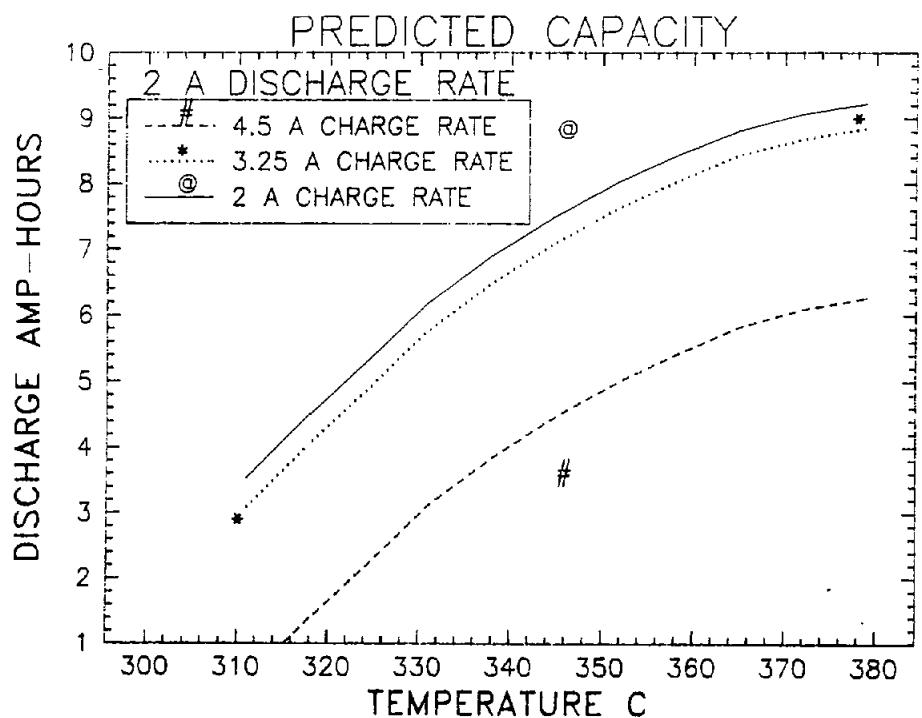
**Figure 4-15. Predicted and Actual Capacity of CSPL Sodium/Sulfur Cell 438 versus Temperature and Charge Rate**

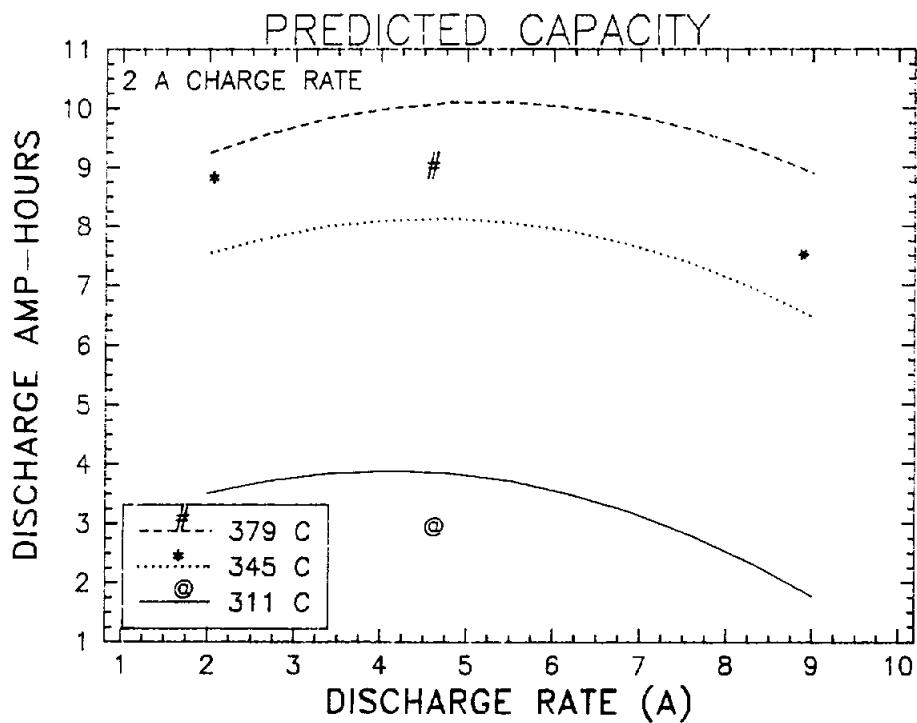
**Figure 4-16. Predicted and Actual Capacity of CSPL Sodium/Sulfur Cell 438 versus Discharge Rate and Temperature**

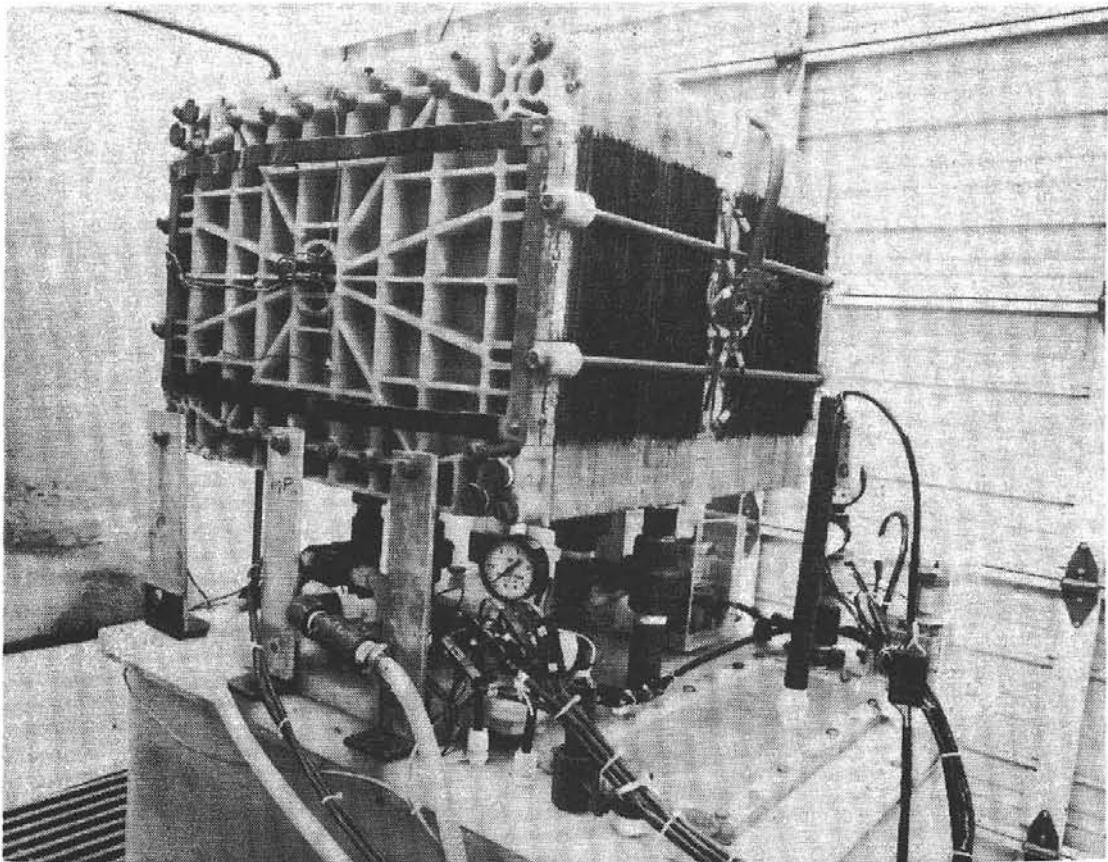
Figure 4-22. Exxon PV-20 Zinc/Bromine Battery

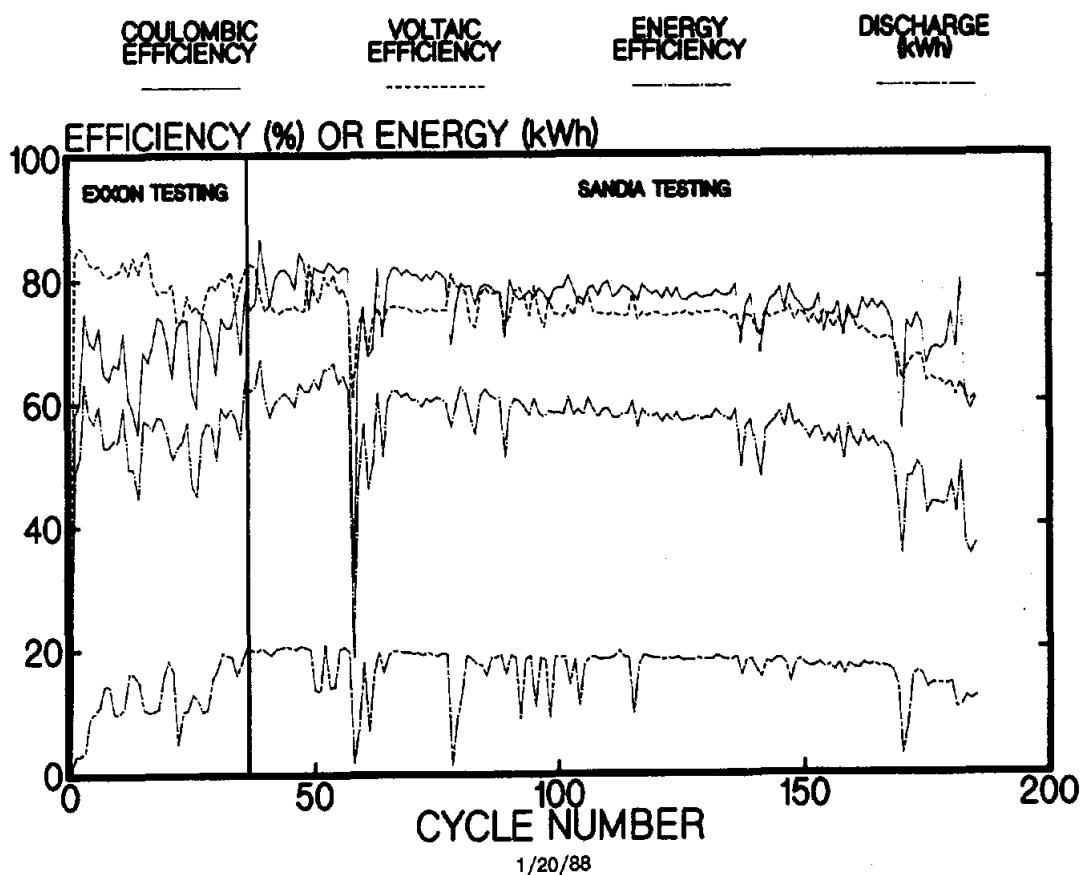
**Figure 4-23. Efficiencies and Energy Output versus Cycle Number for the Exxon PV-20 Zinc/Bromine Battery**

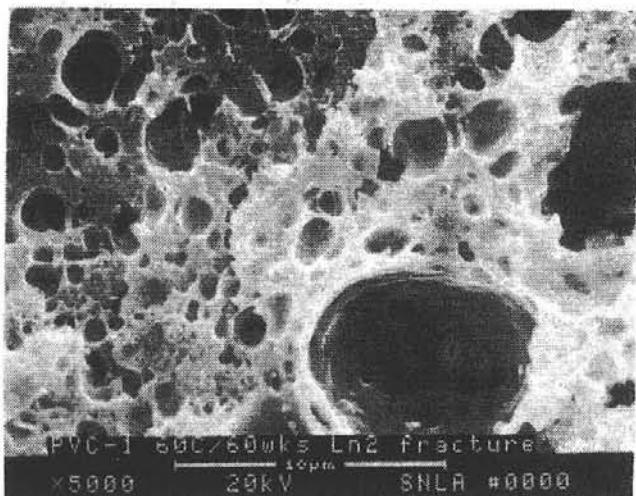
Figure 5-1. Scanning Electron Photomicrograph of the Fracture Surface of PVC-1 After Aging

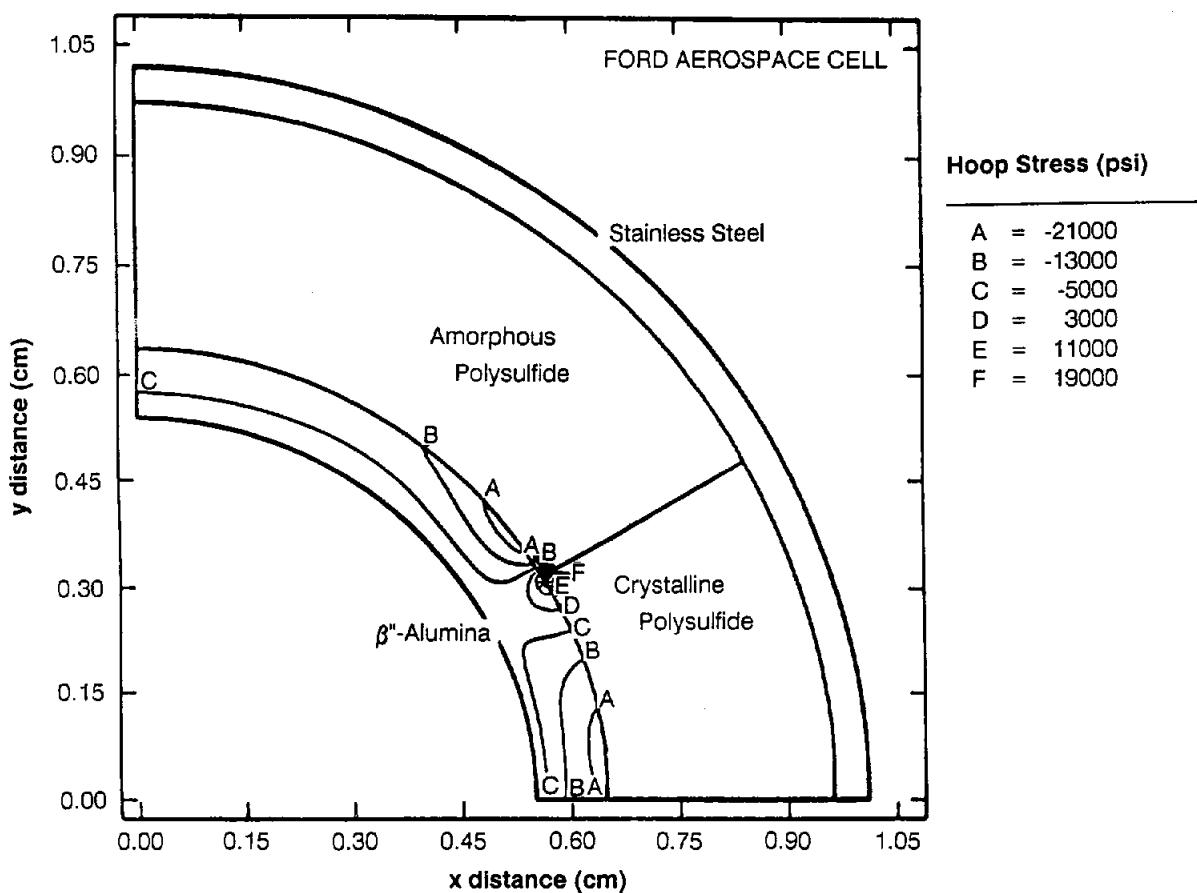
Figure 5-6. Stress Contours Calculated for an FACC Cell Design Containing Amorphous and Crystalline Polysulfide Phases When Cell Is Cooled to 25°C

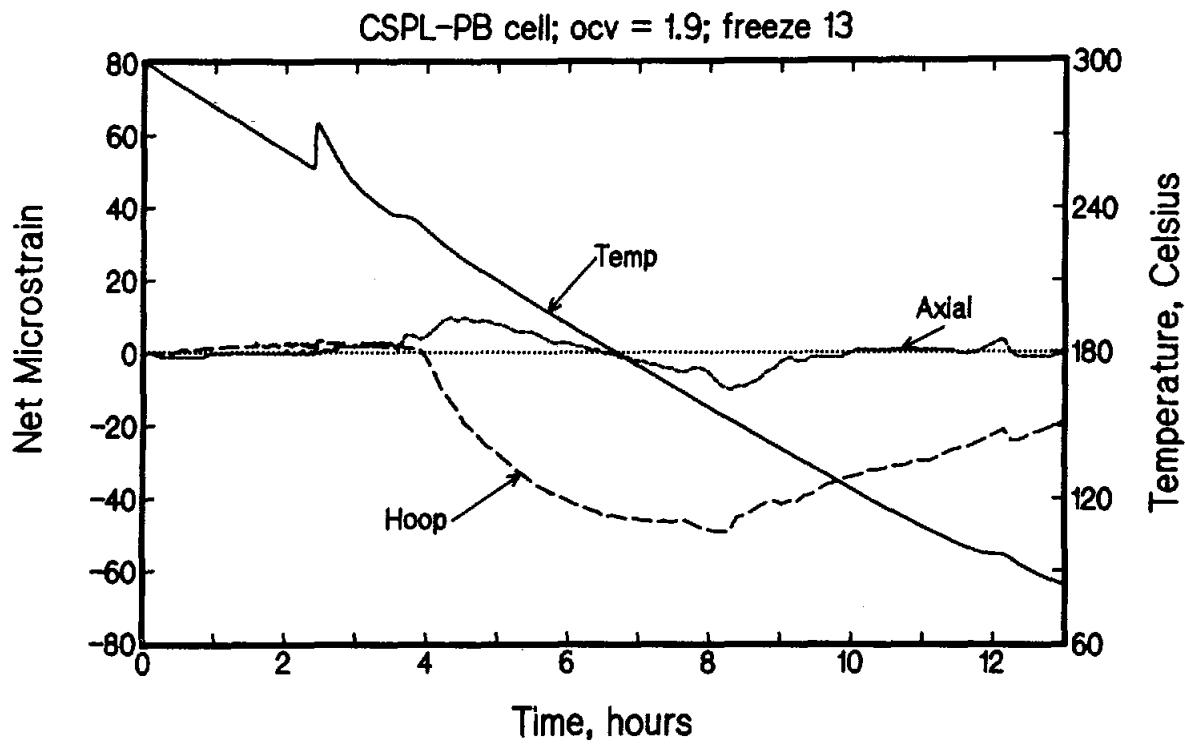
Figure 5-7. Average Mechanical Strain Measured During the Freezing of a Discharged CSPL-PB cell. OCV = 1.9 V.

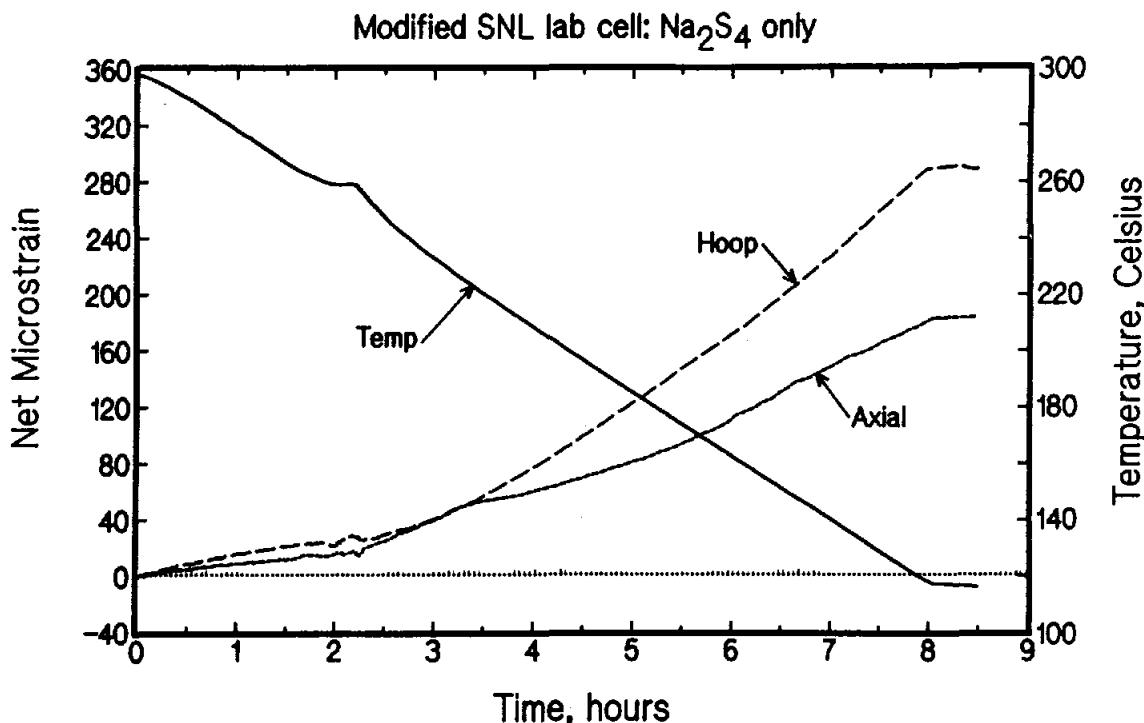
Figure 5-8. Average Mechanical Strain Measured During the Freezing of a Modified SNL Lab Cell. This cell was fabricated without any sodium and a positive electrode containing only  $\text{Na}_2\text{S}_4$ .

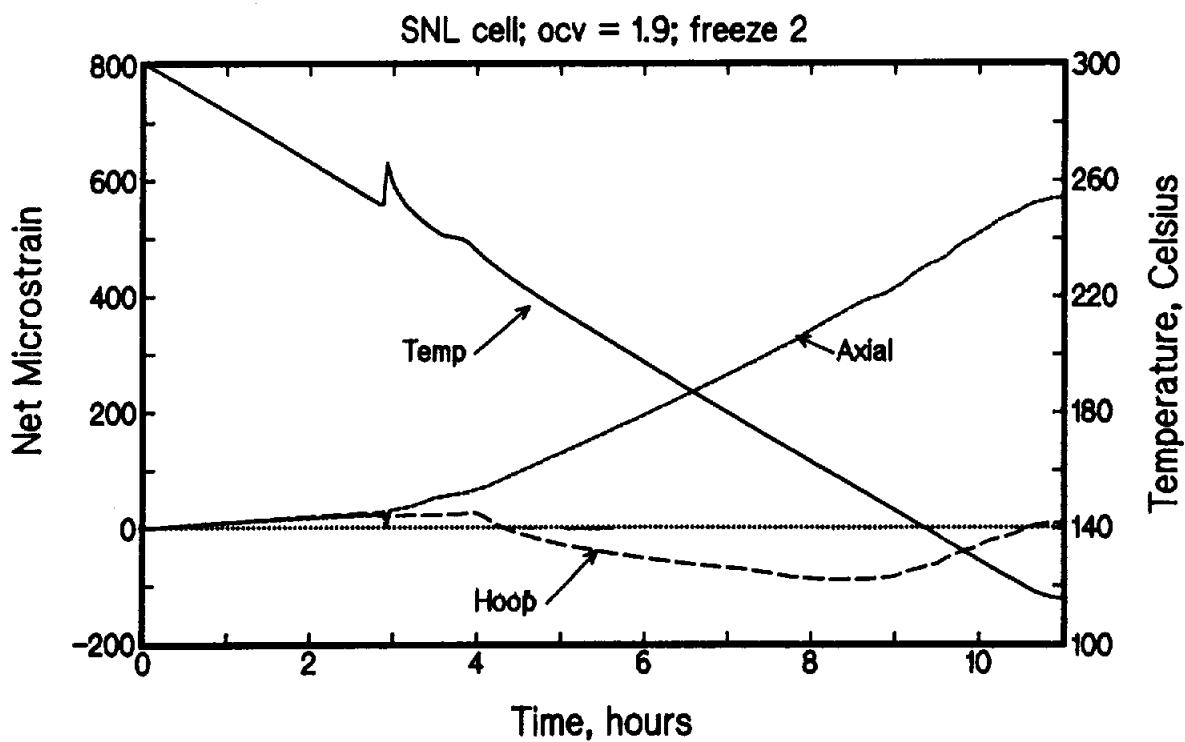
Figure 5-9. Average Mechanical Strain Measured During the Freezing of a Discharged SNL Lab Cell. OCV = 1.9 V.

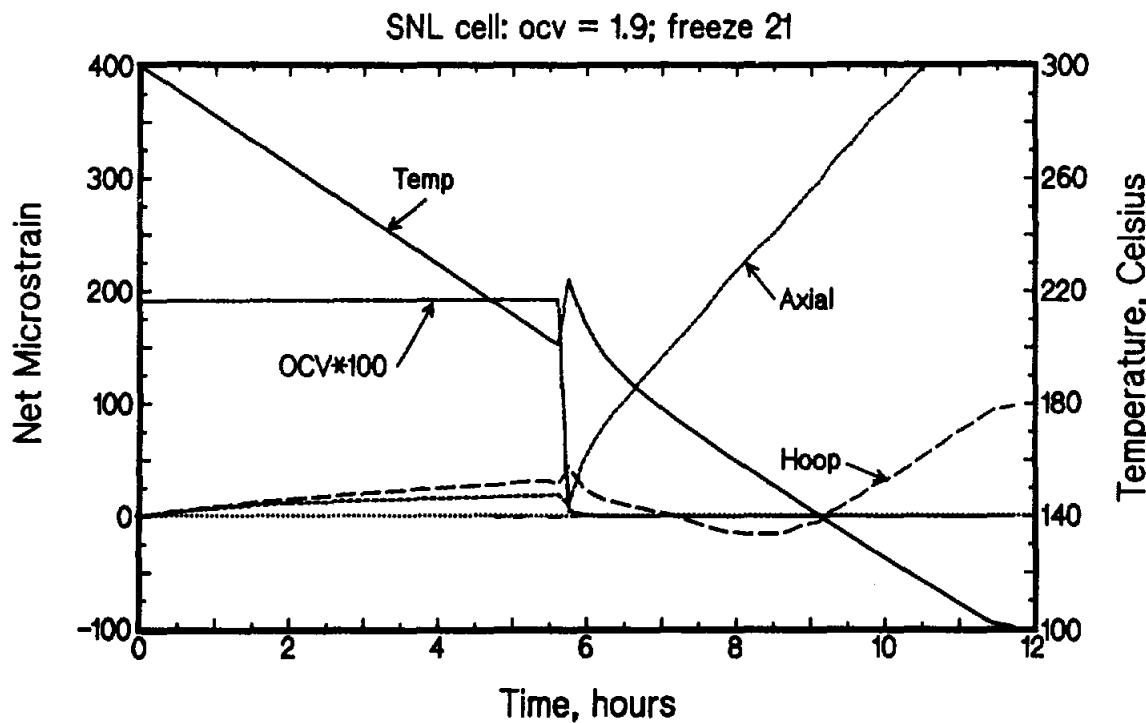
Figure 5-10. Average Mechanical Strain Measured During the Freezing of a Discharged SNL Lab Cell. Electrolyte failure was coincident with the freezing isotherm. OCV = 1.9 V.

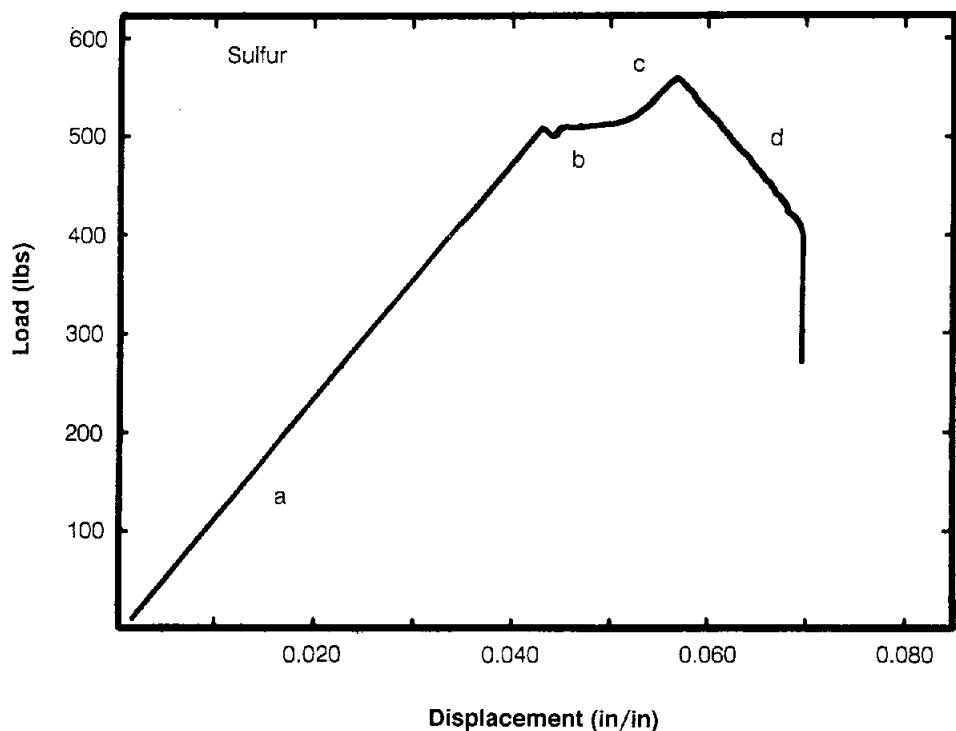
Figure 5-11. Results From the Compressive Load-Displacement Testing of Pure Sulfur

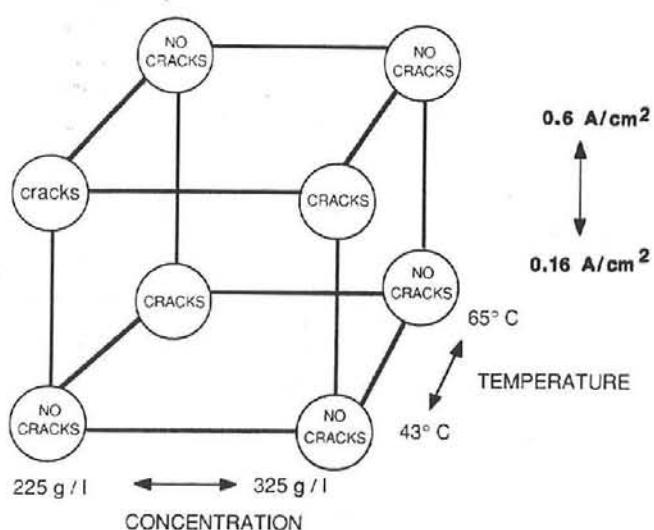
**Figure 5-12.** Schematic Diagram of the Factorial Study Performed to Determine the Influence of Plating Conditions on Cracking of the Chromium Deposit

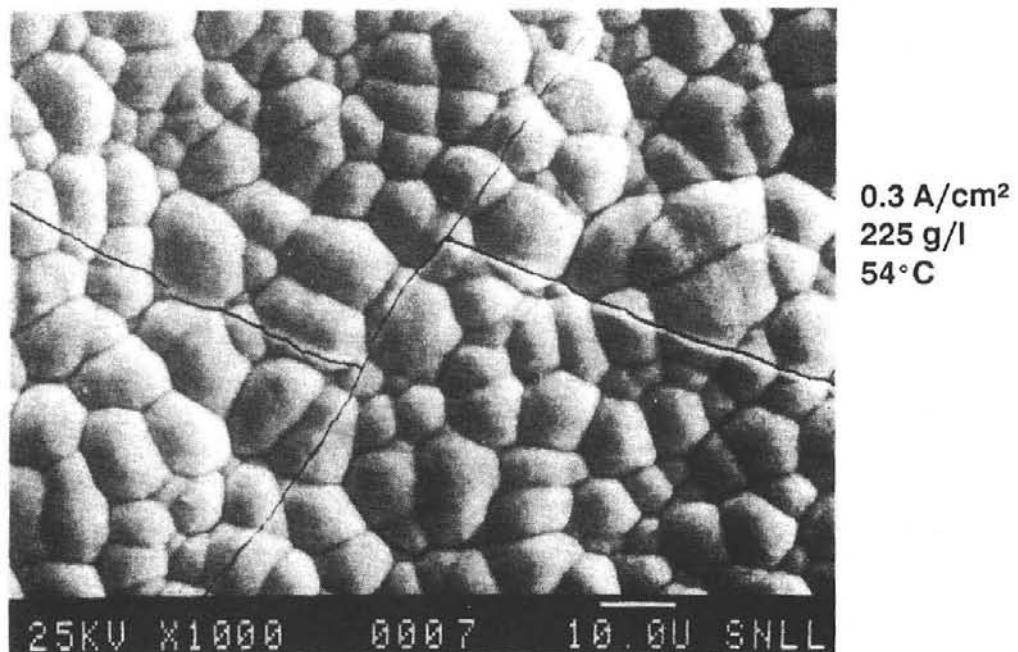
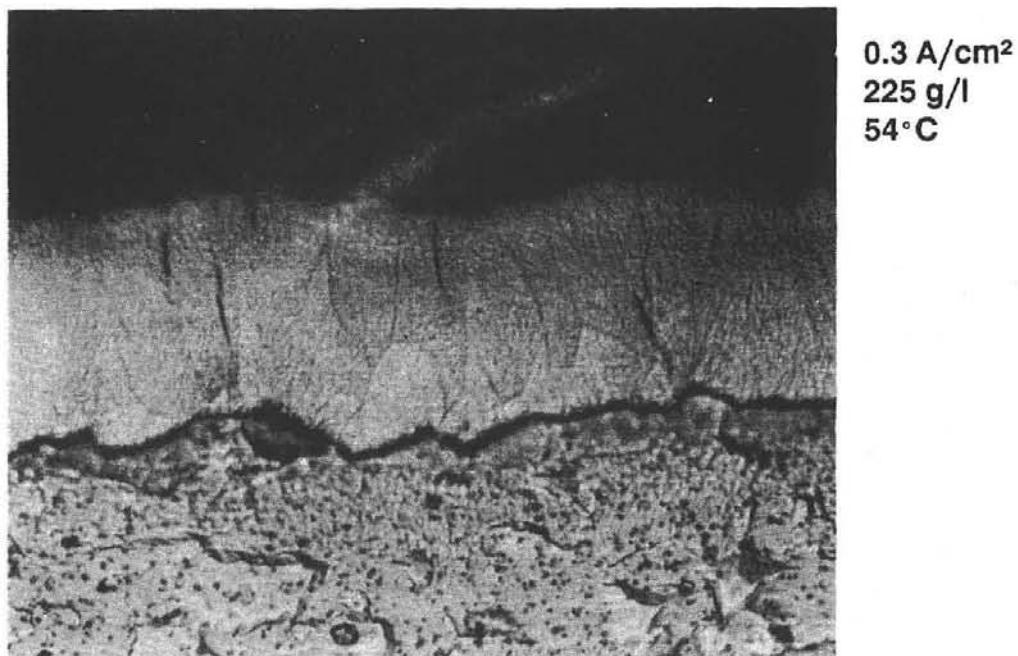
Figure 5-13. Scanning Electron Micrographs and Optical Micrographs of Chromium Deposits Produced Using the Original FACC Plating Conditions

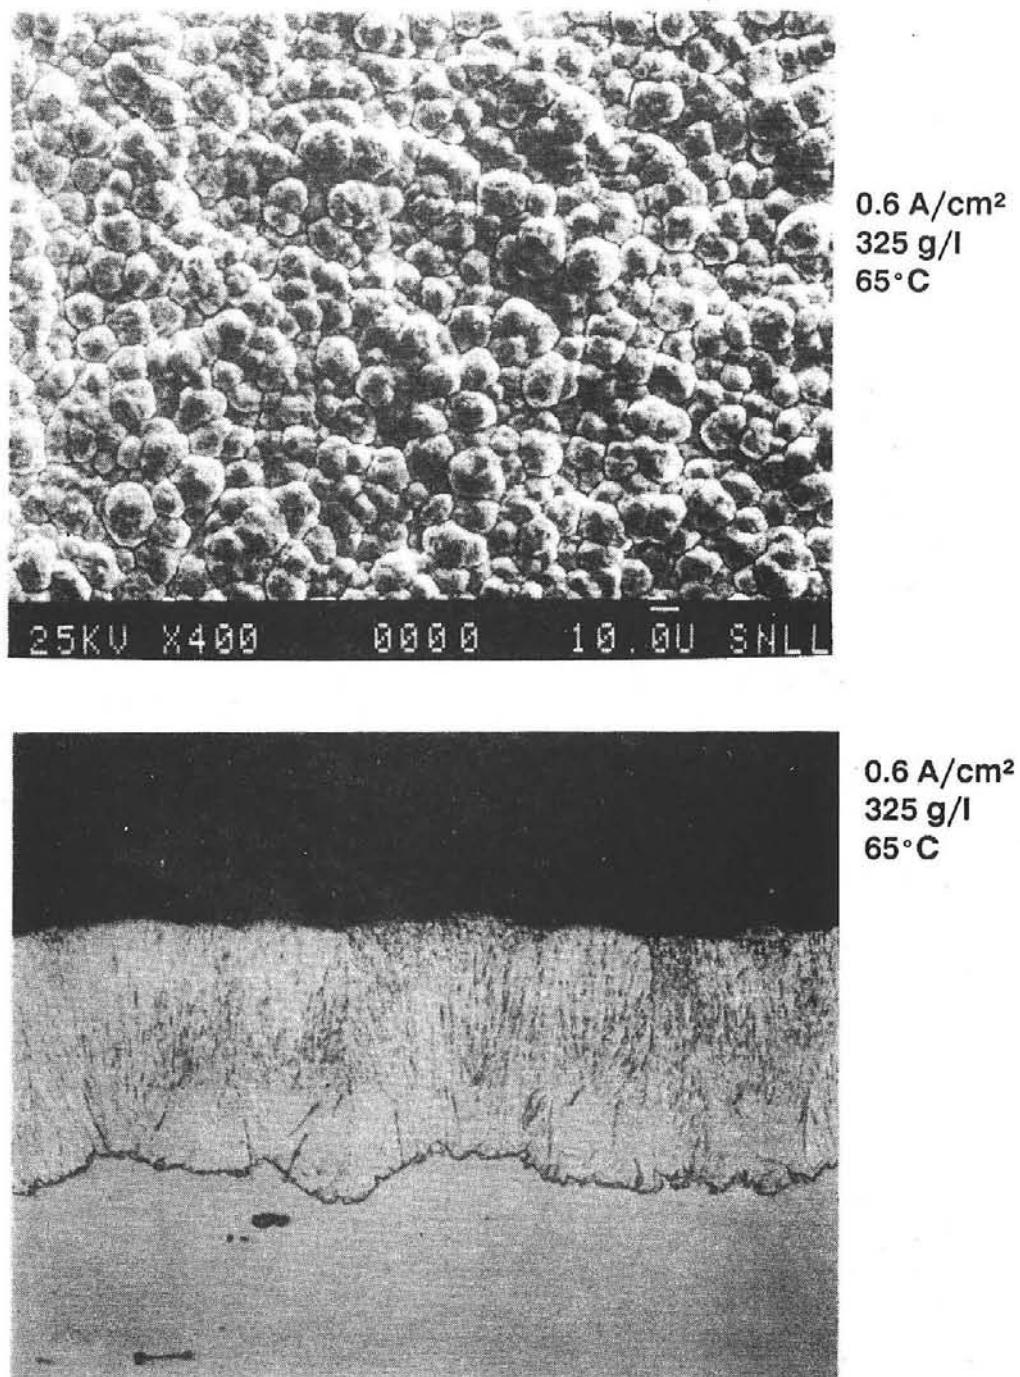
Figure 5-14. Scanning Electron Micrographs and Optical Micrographs of Chromium Deposits Produced Using the Modified SNL Plating Conditions
