# Examination of VRLA Battery Cells Sampled From The Metlakatla Battery Energy Storage System

Joseph Szymborski and George Hunt  
GNB Technologies Lombard, Illinois USA

Rudolph Jungst  
Sandia National Laboratories Albuquerque, New Mexico USA

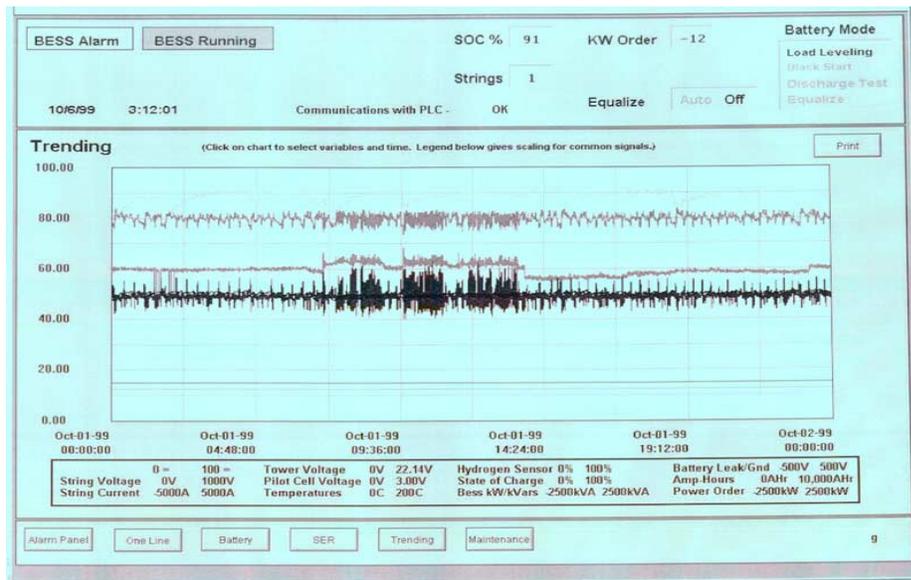
**Figure 2**

Printout of the Metlakatla BESS battery monitor screen showing system operation on a typical day. The dark line in the center of the screen represents the current flowing into and out of the battery.

The PCS provides both active and reactive power to counter load swings created by the log chipper. The BESS sources watts and VARs when the system load jumps higher than the average, and sinks watts and VARs when the load falls below the average. Because the BESS’ resultant net output is nearly zero, the batteries require little additional charging. When required, the AGC dispatches the hydro units to provide the minimal overcharge the battery requires. Operation of the battery is shown in *Figure 2*, which shows the printout of the battery system screen for a typical day.

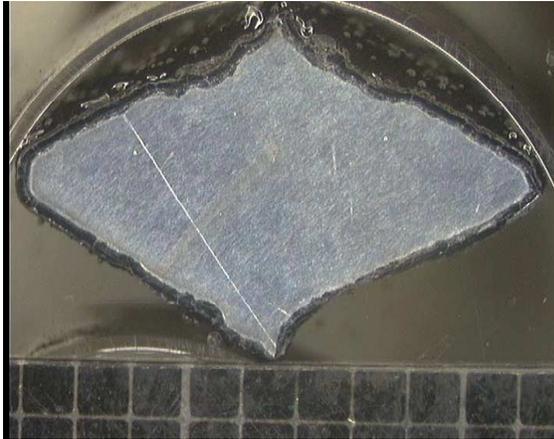
**Figure 5**

Cross section of the positive grid from a Metlakatla BESS cell shows a minimal amount of corrosion after 30 months of operation

Measurement of the corrosion layers indicate a corrosion thickness of approximately 0.13 – 0.18mm. Compared to the corrosion rate basis of 0.08mm per year used to determine the design life for the ABSOLYTE IIP product, the actual corrosion rate for these cells was 0.05 to 0.07 mm/yr. These measurements indicate that the rate of positive grid corrosion with the Metlakatla operating and charge regime is less than that experienced under pure “float” conditions. Dimensions of positive grids from both cells were measured to assess the extent of positive plate growth. Growth in the long dimension of the grid was less than 0.4%; growth in the short dimension was less than 0.12%. In either case, the amount of positive grid growth was much less than the 6% allowance provided in the design of the cell.

Positive Grids. Samples of the positive grids from the sample cells were taken, cross sectioned and polished to determine the amount of corrosion that had occurred over the lifetime of these cells. An example of the minimal amount of positive grid corrosion that has occurred is shown in *Figure 5*.

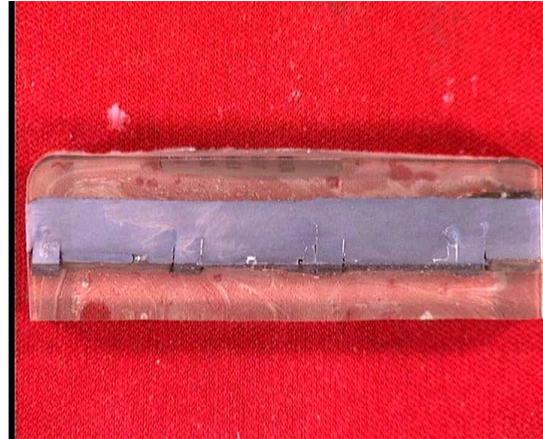
**Figure 6**

Negative plate straps from the Metlakatla BESS cells were examined. These critical connections between individual plates and the current collector exhibited no oxidation corrosion whatsoever.

terminal posts of VRLA designs. These concerns are especially associated with the negative plate hardware internal to the cell. Reaction of these lead parts with oxygen gas, and the minimum amount of negative plate polarization have been identified as contributing to this unusual type of corrosion. Samples of the negative plate busbar strap and the negative terminal post were examined to determine if these internal lead parts were experiencing unusual corrosion under the operating conditions for the Metlakatla BESS. A section of the negative plate strap is shown in *Figure 6*. The negative plate lugs are all firmly embedded within the strap, forming continuously bonded connections. There were no signs of any oxidation corrosion on the negative strap material itself. Similarly, there were no signs of any corrosion of the negative terminal post material or the cover seal bushing.
