Annex F
Photographs of Defect Types Used in the Test Bed

This annex provides photographs of all defect types used in the test bed. Both naturally occurring and fabricated defects are shown.

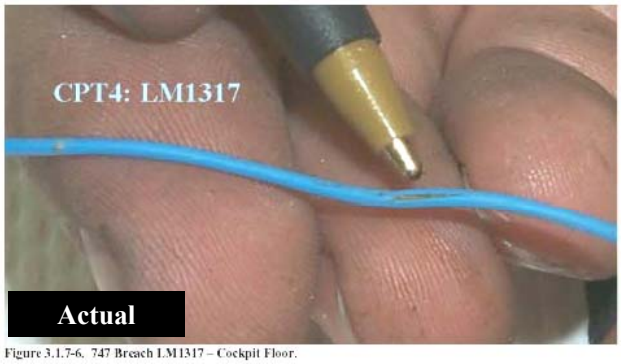
Chaffed Defects (DT-1)

Figure 3.1.7-6. 747 Breach LM1317 – Cockpit Floor.
