Sandia National Laboratories

Results of the Technical Areas III and V RCRA Facility Investigation

June 1996

RESULTS OF THE TECHNICAL AREAS III AND V RCRA FACILITY INVESTIGATION

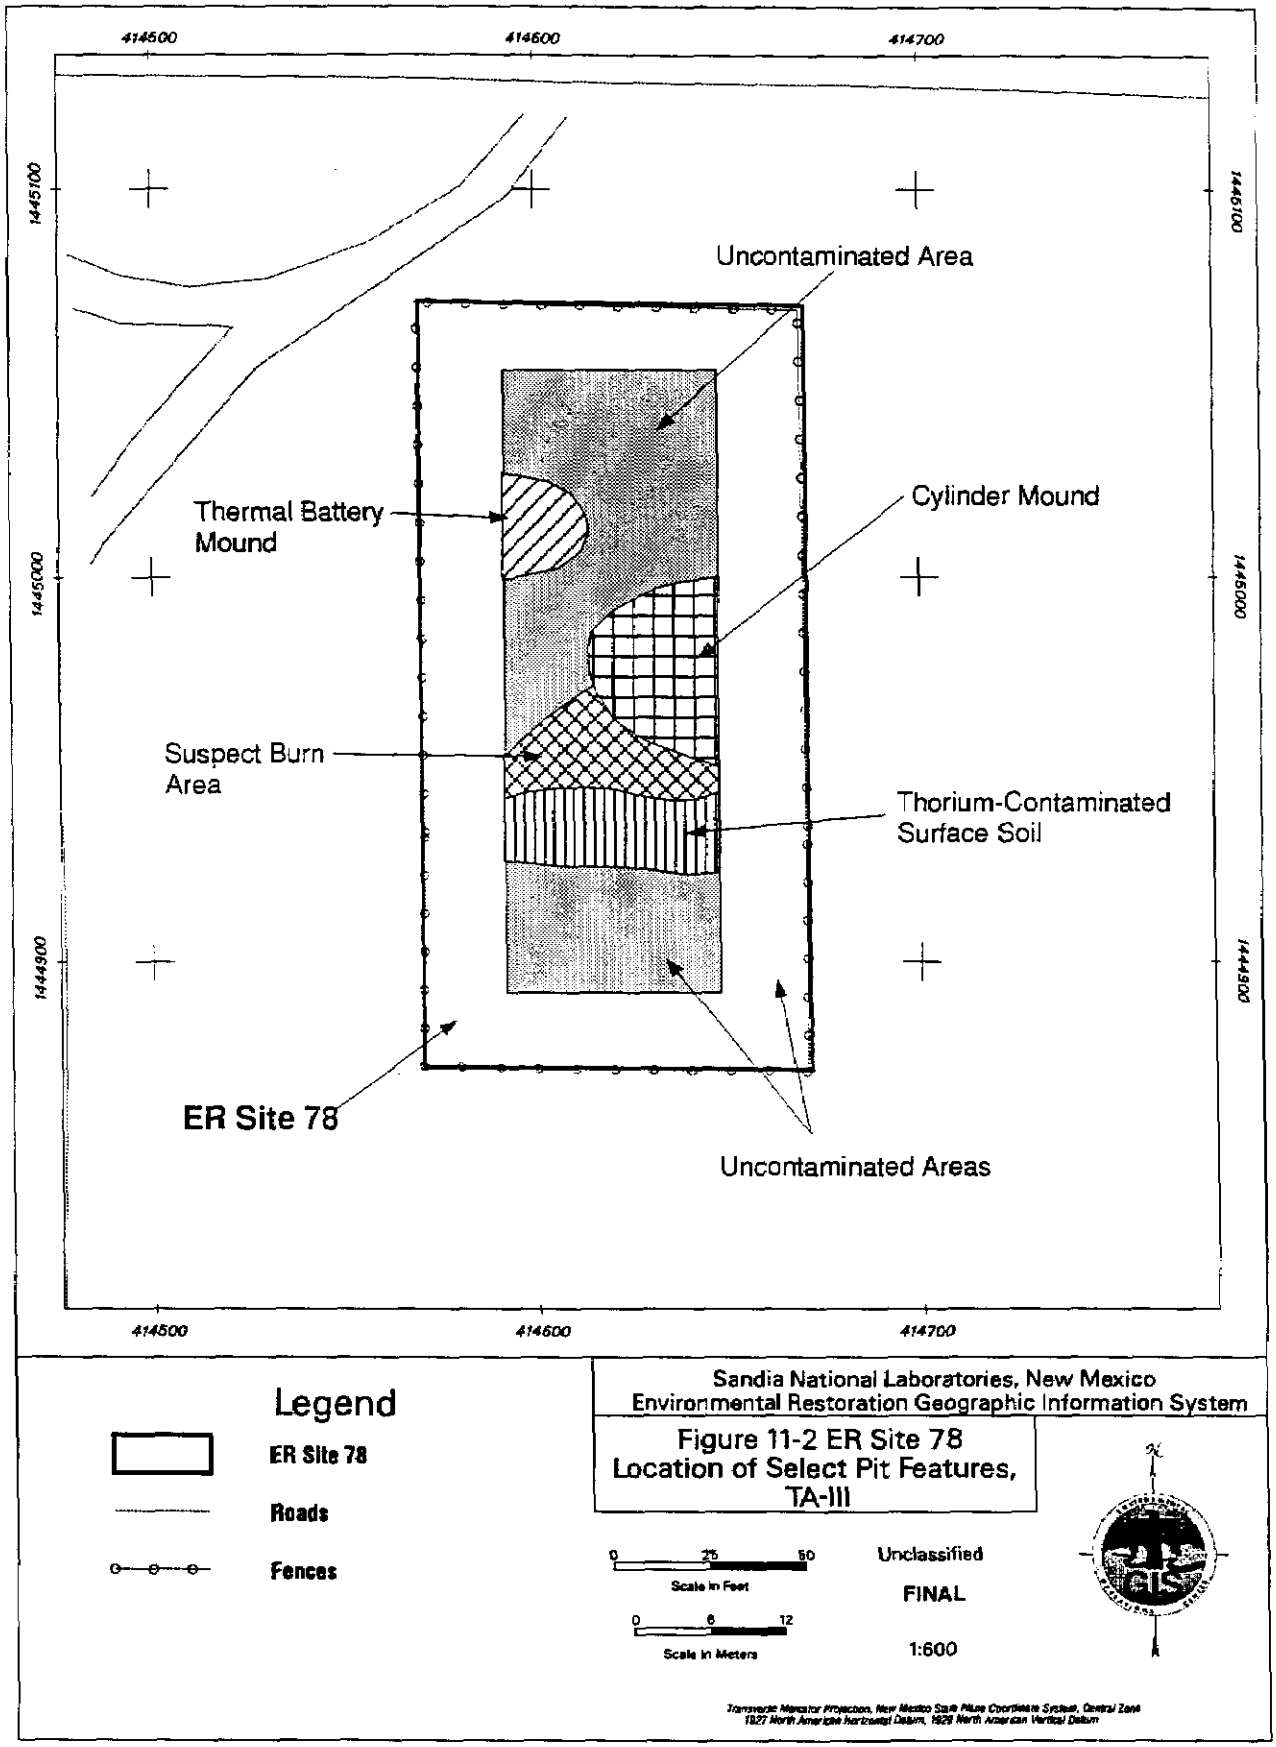
Elevated radiological materials were identified as a gray, cement-like material, located on the surface of the soils toward the south end of the GCDP (Area D) (Figure 11-2). The preliminary radiation survey was used to determine that the southern area of the GCDP would be designated as a RMMA. A RMMA is a DOE designation of an area where reasonable potential exists for contamination of hazardous waste because of the presence of unencapsulated or unconfined radioactive material. This area did not extend into the Thermal Battery Mound (subdivision A), the Cylinder Mound (subdivision B), or the Suspect Burn Area (subdivision C) in the GCDP.

Thorium-contaminated soil was drummed directly in the GCDP and subsequently staged on site. Chromium-contaminated soil (associated with a group of ruptured and intact thermal batteries) was removed from the GCDP. Suspect soil was removed and staged until waste characterization was completed (this soil was to be placed back into the GCDP). Thermal batteries, lithium metal, rubidium metal, unknown chemicals, and gas cylinders approximately a quarter of which contained inert, flammable, toxic, corrosive, or oxidizing gases, were removed and managed to minimize waste. Table 11-2 summarizes these waste streams and the quantities of materials removed from the GCDP.

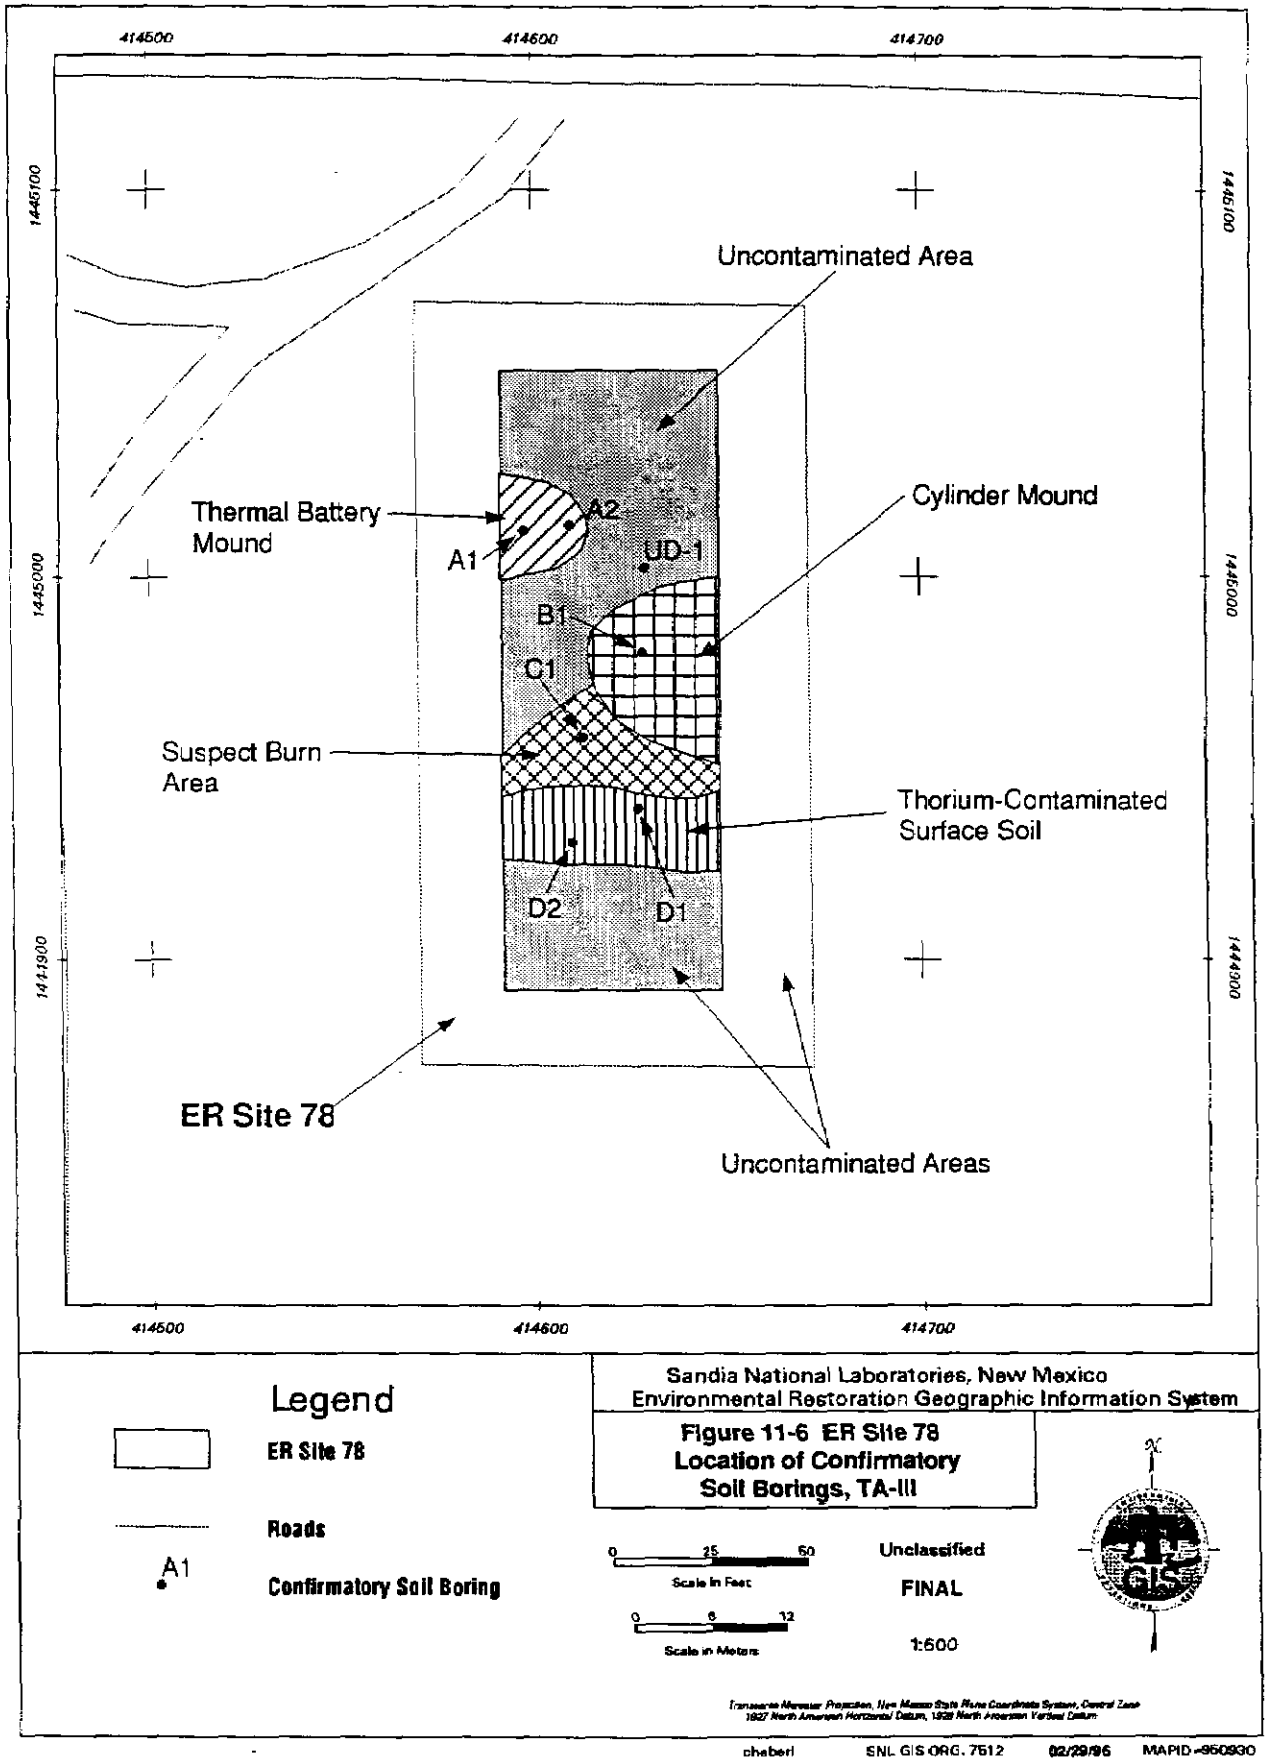
Table 11-4
Summary of Detected Constituents of Concern in Site 78 Verification Soil Samples

Only chromium exceeded the statistical background (UTL of 26.2 mg/kg) (Table 11-5). It was detected at a concentration of 39.7 mg/kg total chromium in a sample from the 1-ft level in a borehole from the uncontaminated portion of the GCDP; the total chromium concentration was 5.2 mg/kg in the sample from the 5-ft level in the same borehole. Both of these concentrations were below the most conservative proposed RCRA Subpart S soil action level for chromium (i.e., chromium-VI, 400 mg/kg).

A statistical comparison of the arsenic population to the TA-III/V background level was not possible because no site-wide background data for arsenic had been collected at the time the statistical analyses were completed. The recently revised site-wide background report (IT 1996) indicates that the maximum concentration at the site (7.4 mg/kg) exceeds the site-wide background UTL for arsenic (5.6 mg/kg); however, it does not exceed the proposed RCRA Subpart S soil action level of 20 mg/kg.
