INTERNATIONAL ASSOCIATION OF FIRE FIGHTERS

Energy Storage Systems and Fire Fighter Response Safety

Sean DeCrane, Director
Health and Safety Operational Services

June 6, 2023

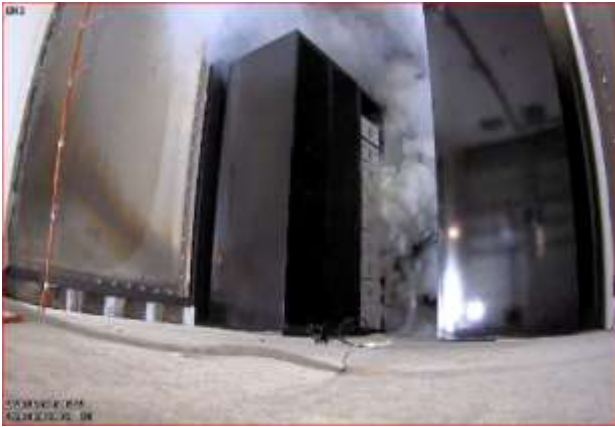
Smoke accumulation
[TR + 00:00:31]

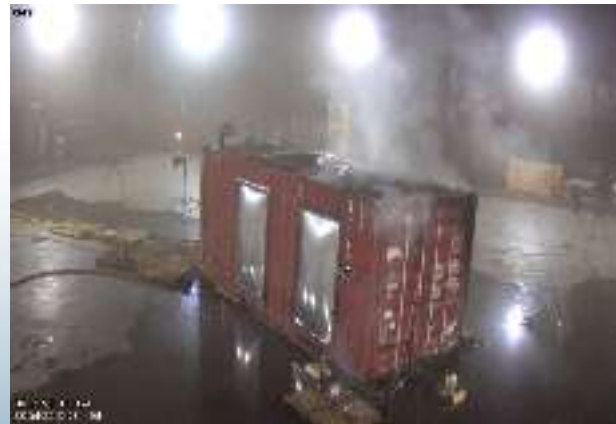
TR propagation continues after
water flow restart [TR + 01:49:54]
