Solar Connectors-  
Tranquillity Solar  
Cantua Creek,  
CA

# Tranquillity Solar

- Location: Cantua Creek, CA
- COD: July 2016
- Size: 200 MW, 1894 acres
- OEMs
  - Inverter: TMEIC Samurai 1833
  - MVT: ABB 34.5kV
  - Module: REC Polycrystalline
  - Tracker: ATI
- Team Lead: Glen Parker
- Site Technicians:
  - Ken Wicker
  - Nick Roussin
  - Anthony Munoz
  - Nickolaus Soerjono

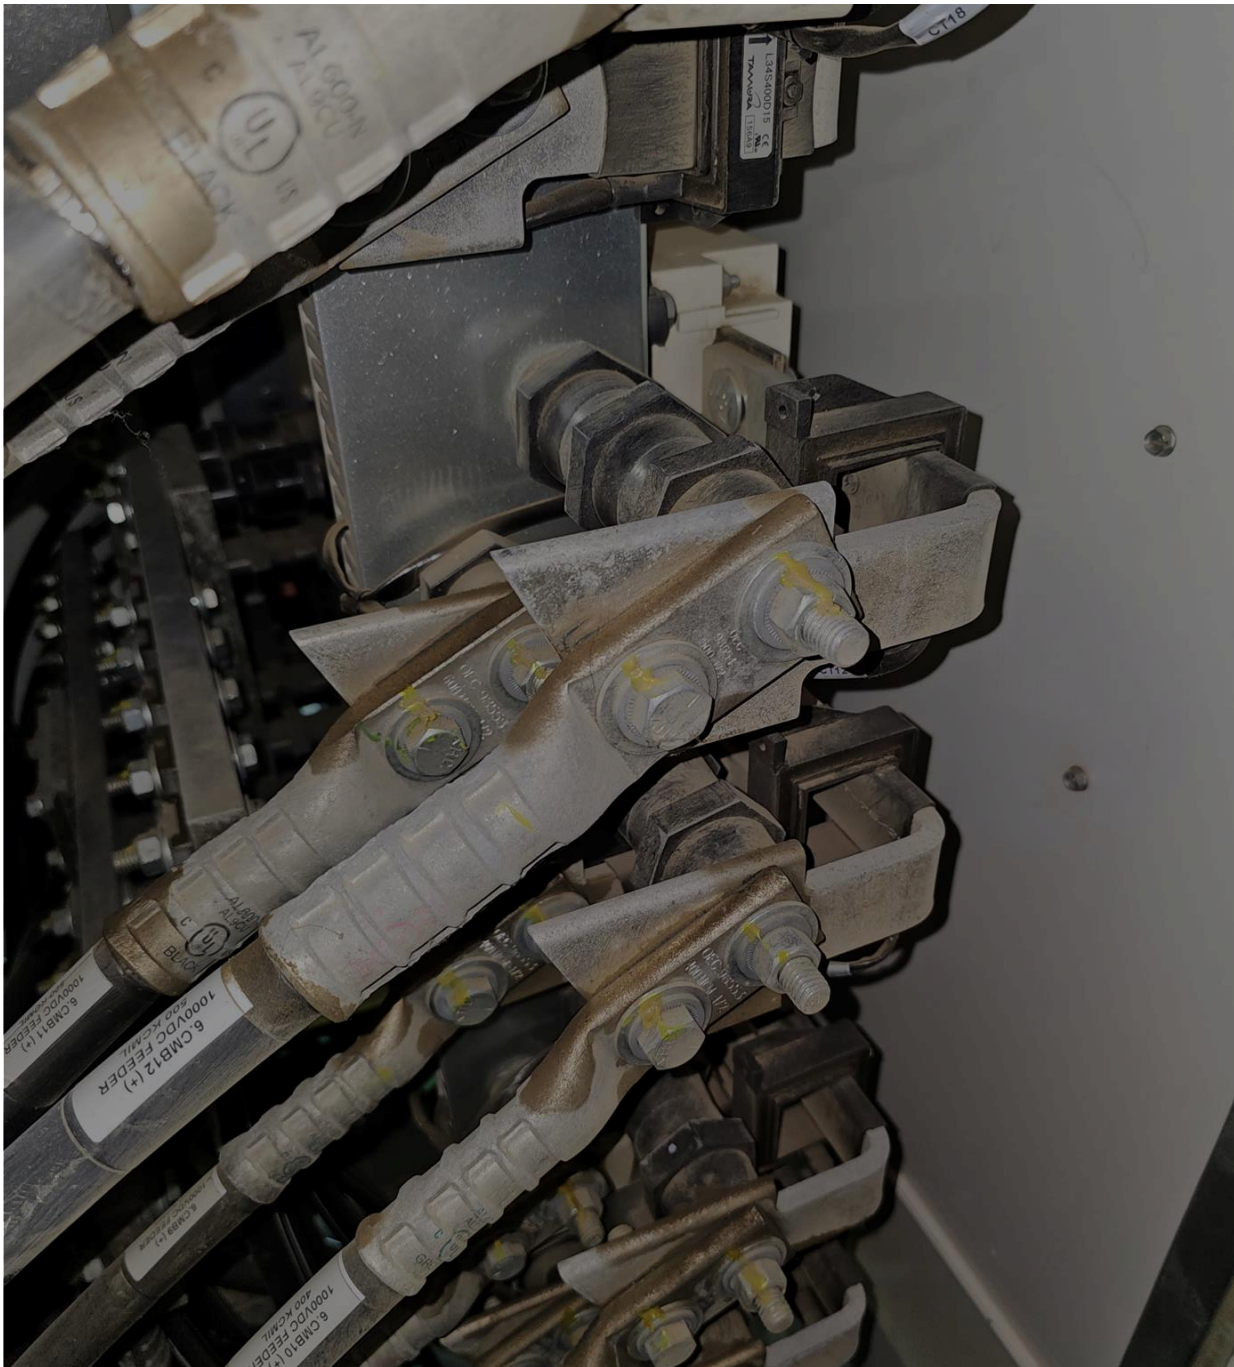
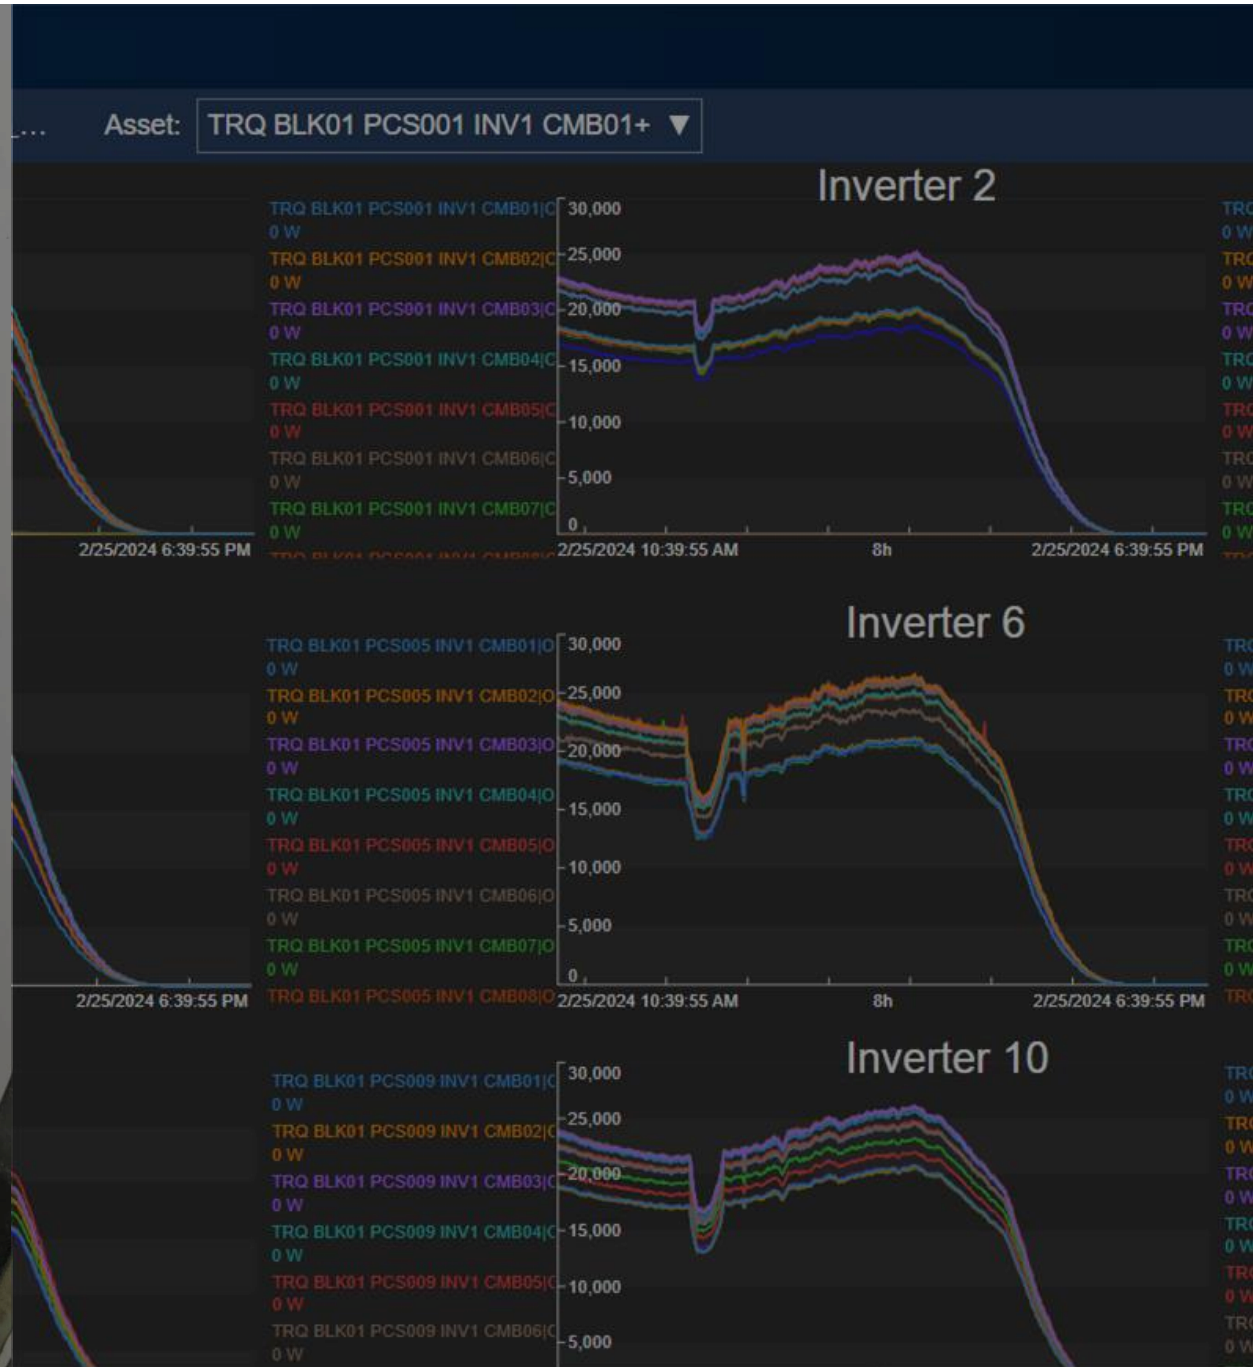
- Over 8000 new MC4 connectors installed
- There have been no new connector failures in the areas that have been remediated
- Modest impact on production
- Improved system reliability with fewer inverter trips and blown fuses
