Sandia
National
Laboratories

Burn Site Groundwater (BSG) Investigation

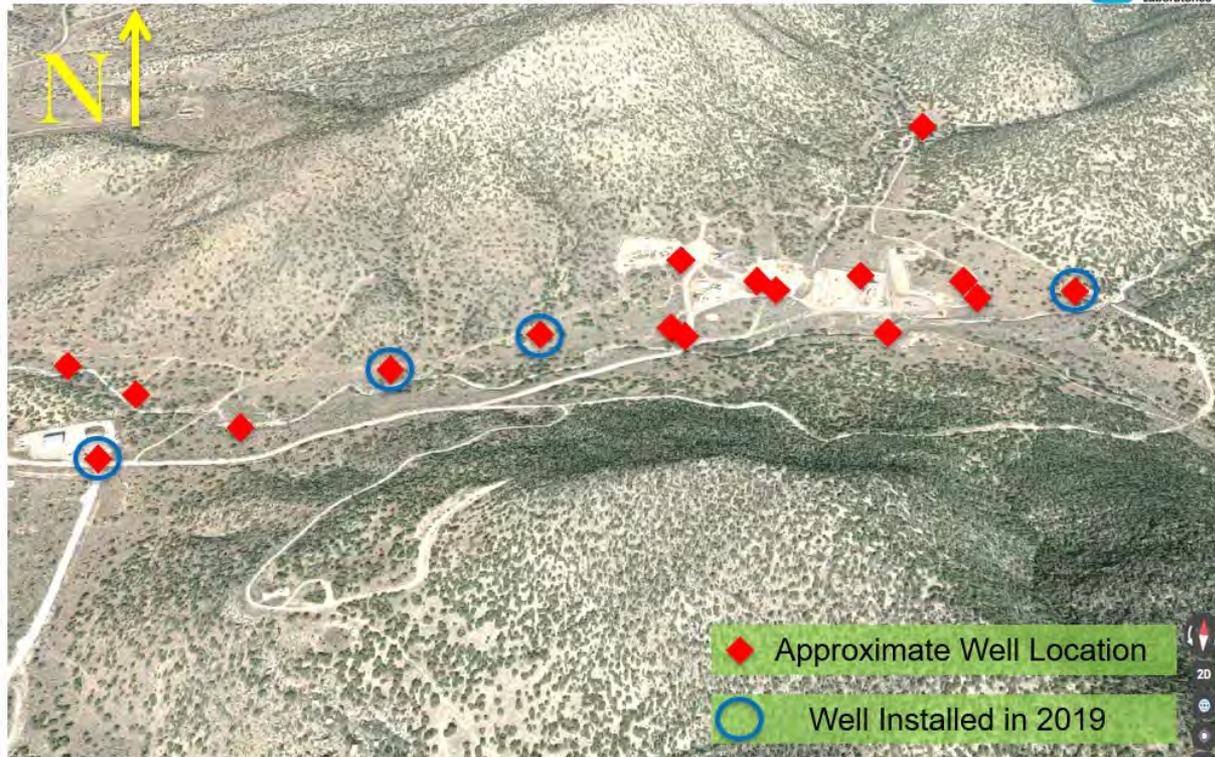
Oblique Aerial View of the BSG AOC; View is toward the North

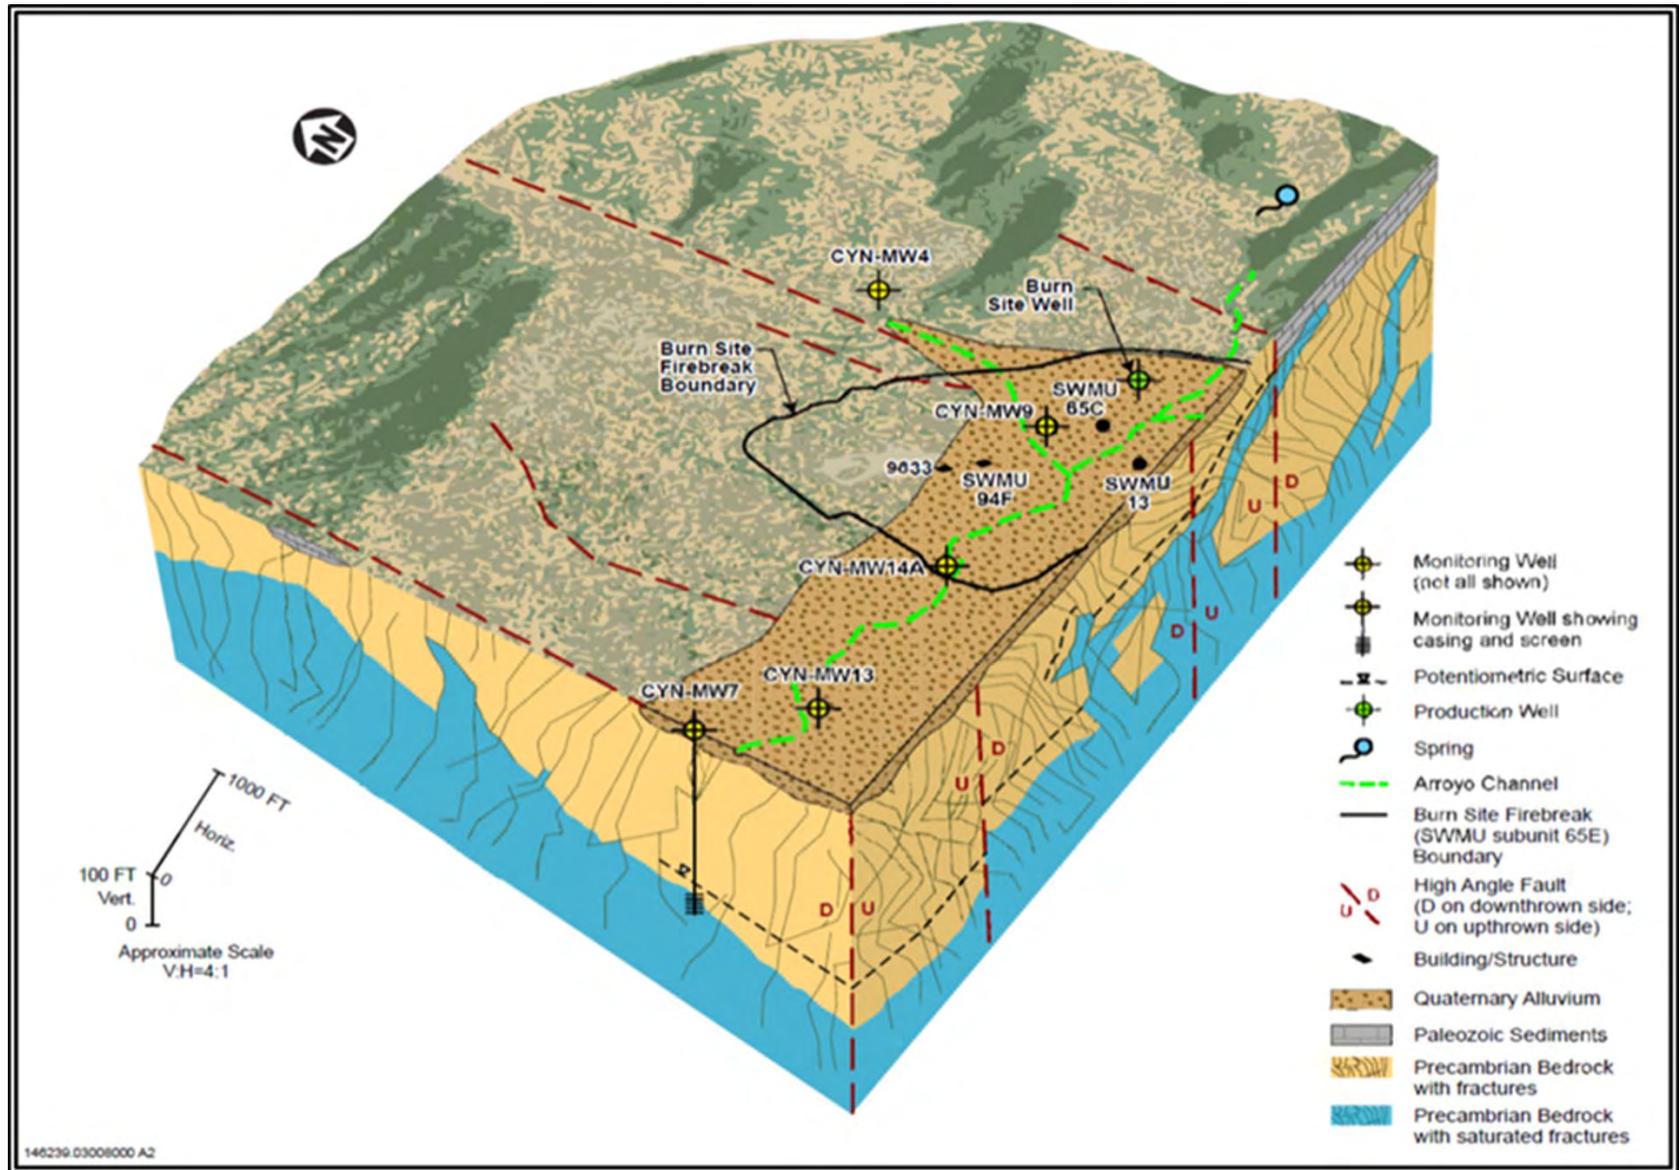
Conceptual Site Model for the BSG AOC

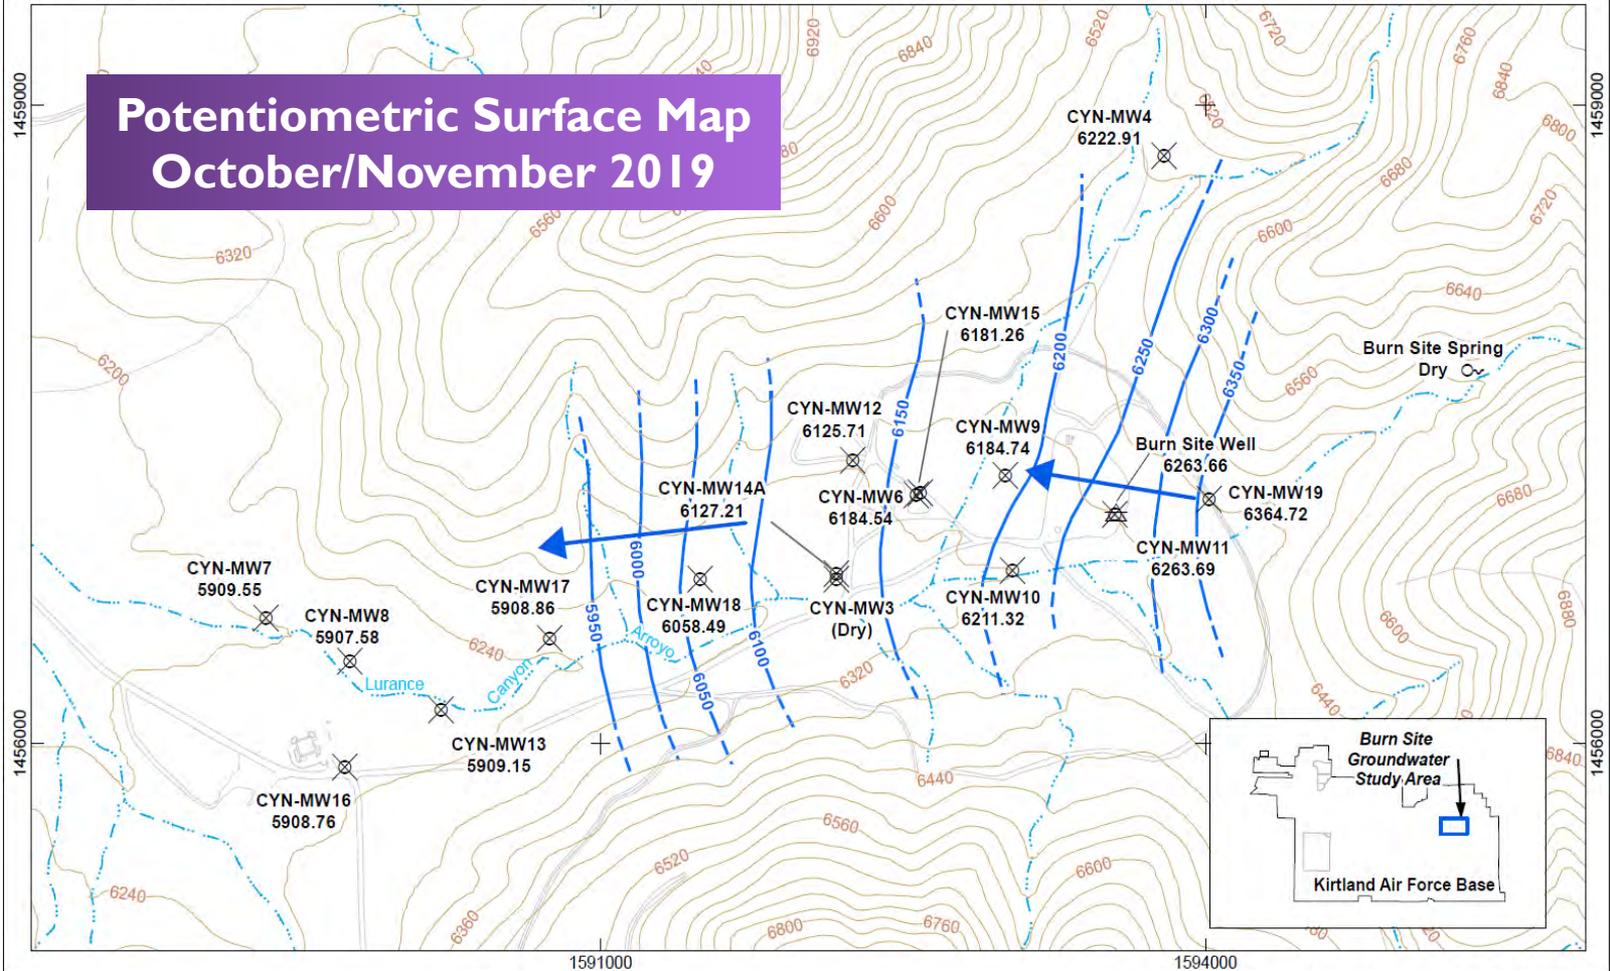
Map ID = sc20105 1/24/2020 SNL EGIS 0643

Potentiometric Surface Map October/November 2019

- Groundwater monitoring began in 1996.
- Depth to groundwater ranges from 45 to 360 feet below ground surface and groundwater flows to the west.
- The monitoring network consists of 16 monitoring wells and an inactive production well, with 4 newest wells installed in October/November 2019.
