INTERNATIONAL ASSOCIATION OF FIRE FIGHTERS

Energy Storage Systems and Fire Fighter Response Safety

Sean DeCrane, Director
Health and Safety Operational Services

June 6, 2023

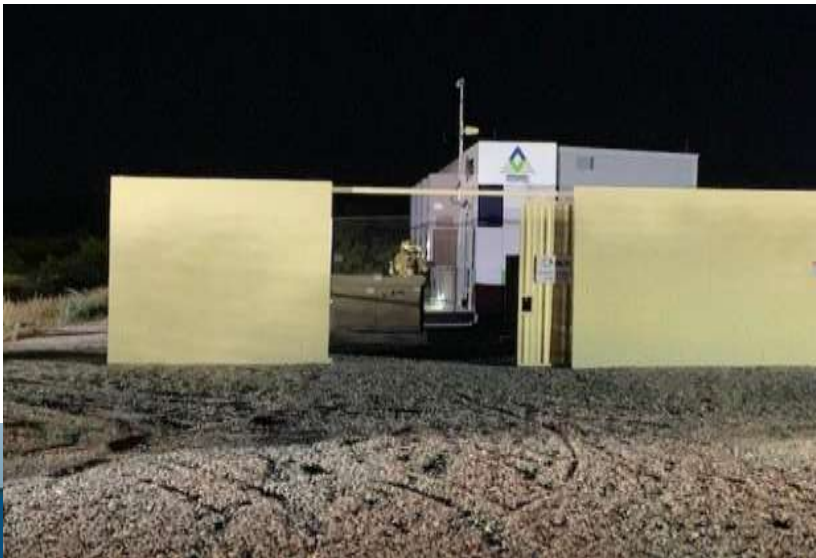
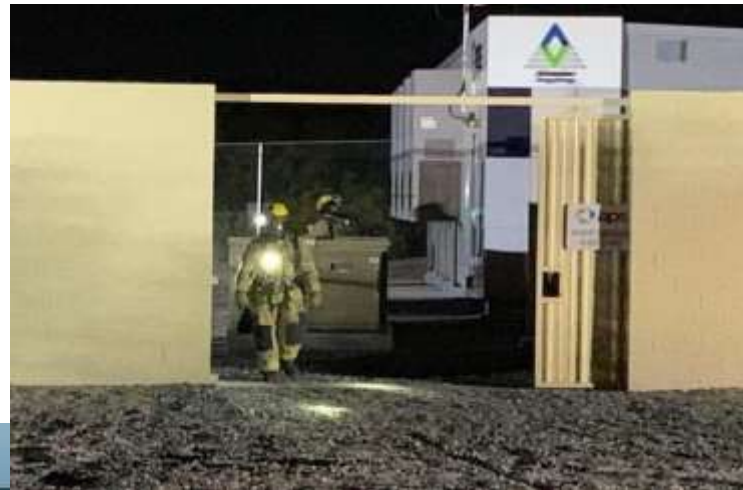
19:50 — The visible gas/vapor mixture was no longer leaking out of the ESS.

19:52:24 — HAZMAT team made final entry into the fenced area around the ESS.

19:58:03 — HAZMAT team pulled hose line to ESS to prepare to open door.

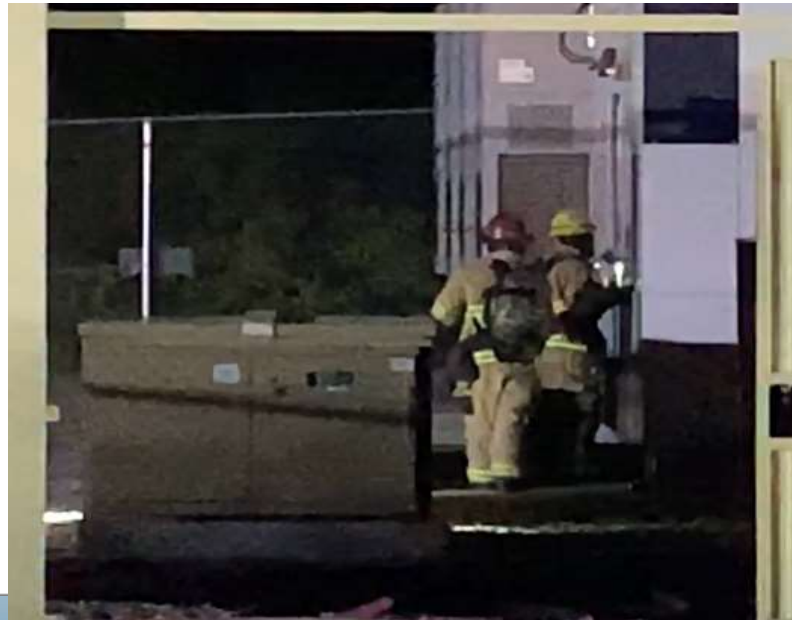
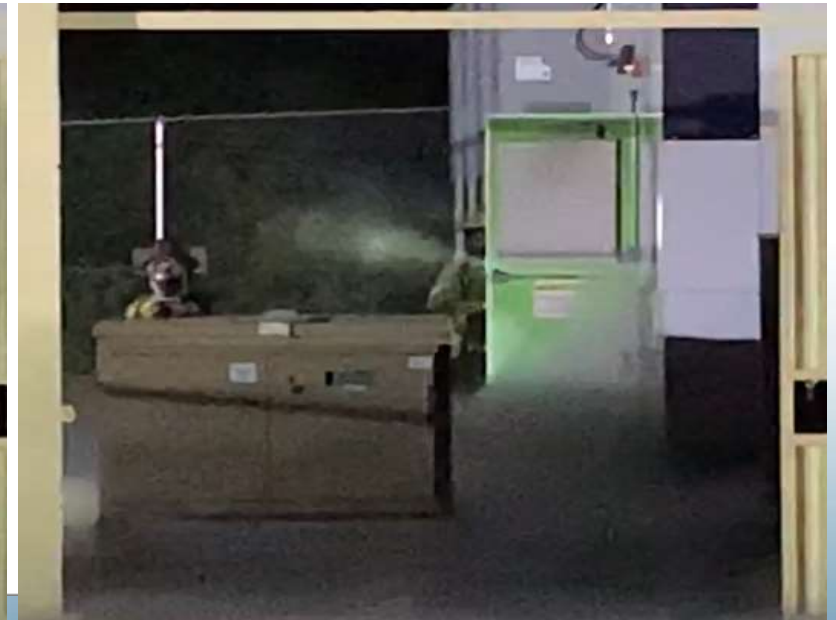
Photos courtesy of APS

20:00:54 — HAZMAT team opened the door to the ESS.

20:03:49 — Mayday call

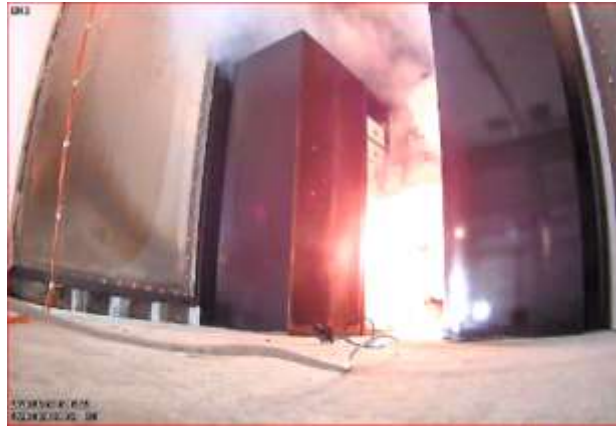
Ignition
[TR + 00:00:31]

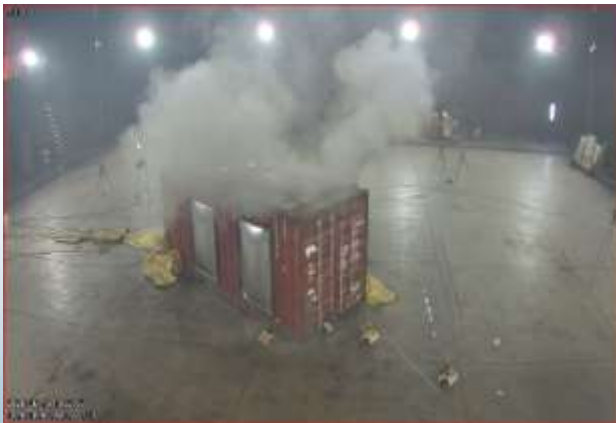
TR propagation for 3 hours
[TR + 00:11:54]

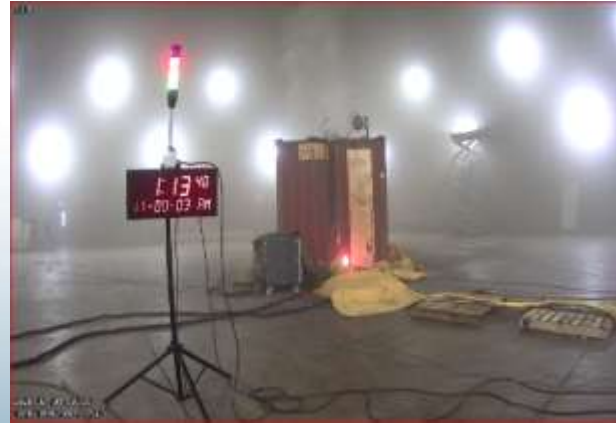
Flaming outside container
[TR + 00:47:18]

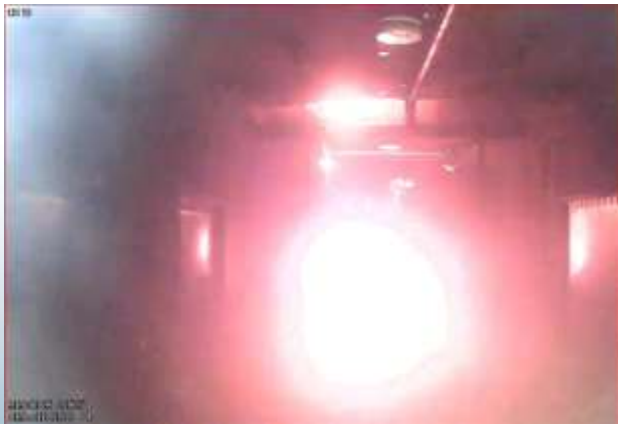
Ignition
[TR + 00:28:32]

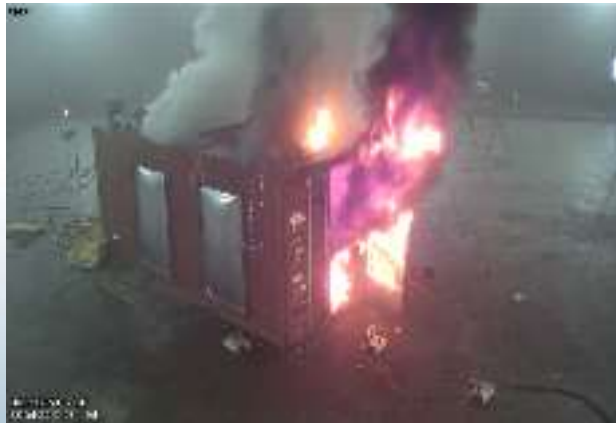
Flashover conditions and
flaming from open door
[TR + 02:09:48]

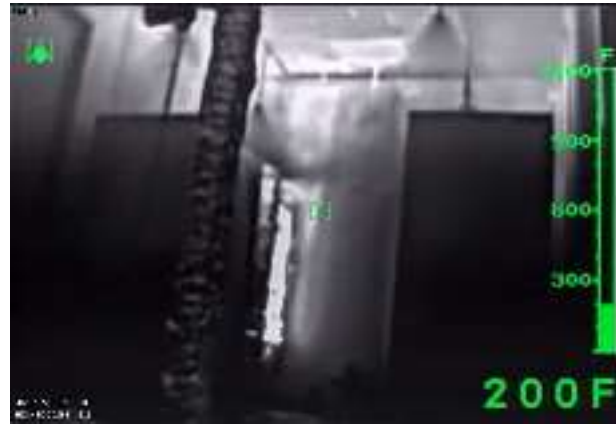
Waterflow @ 0.5 gpm/ft²
[TR + 00:10:13]

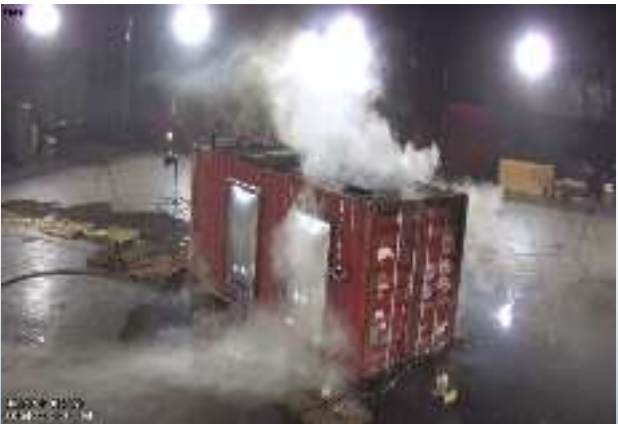
TR propagation after water flow off
[TR + 01:13:05]
